Summary recent discussions
and trouble-shooting of various
beam problems originating at
injector

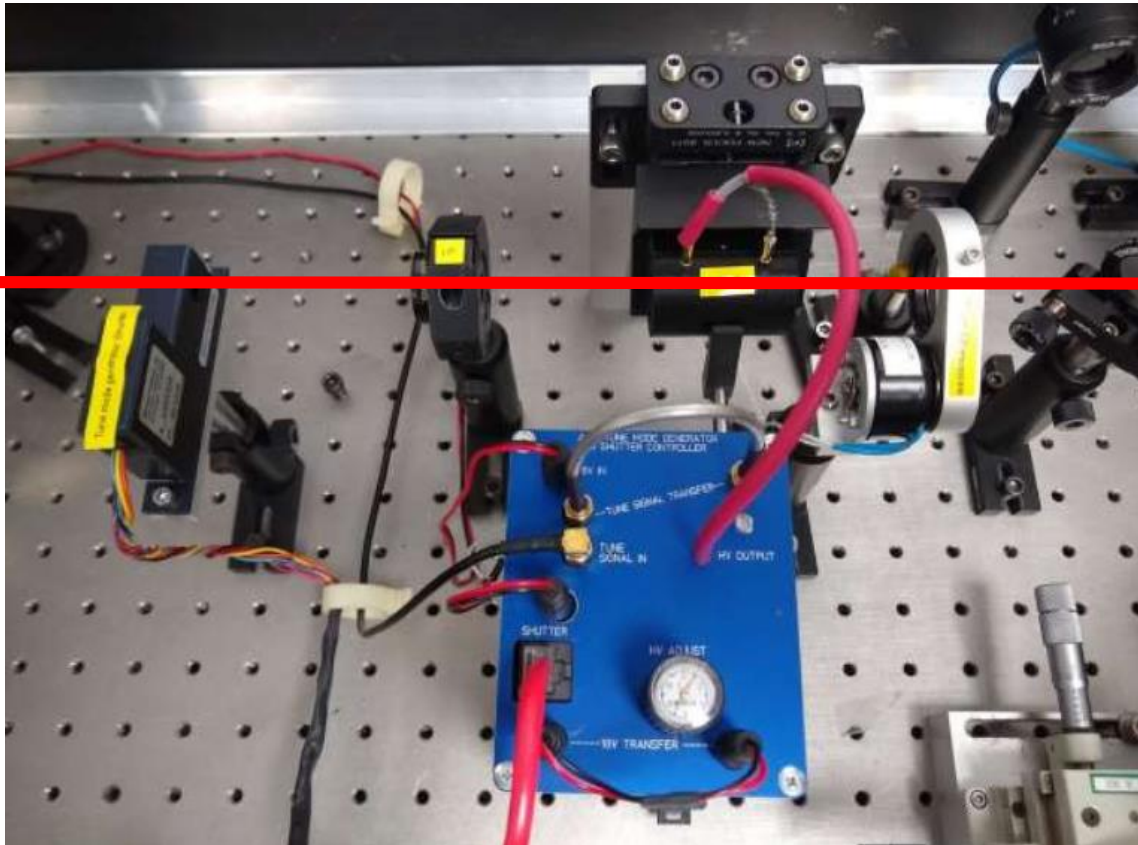
Beam Mode	Pockels cell High Voltage	half wave plate	Shutter
Beam OFF	OFF	Inserted	Closed
Viewer-Limited	Pulsing	Inserted	Open
Tune	Pulsing	Inserted	Open
CW	OFF	Retracted	Open

Halfwave plate and/or shutter might not be responding as requested when the common power supply is asked to perform multiple tasks simultaneously

“Easy Button” now configured to implement steps consecutively
