Jefferson Lab Report

Work Order No: **212171 (Samples AA, BB, CC, DD)**

East Carolina
Metal Treating,
Inc.

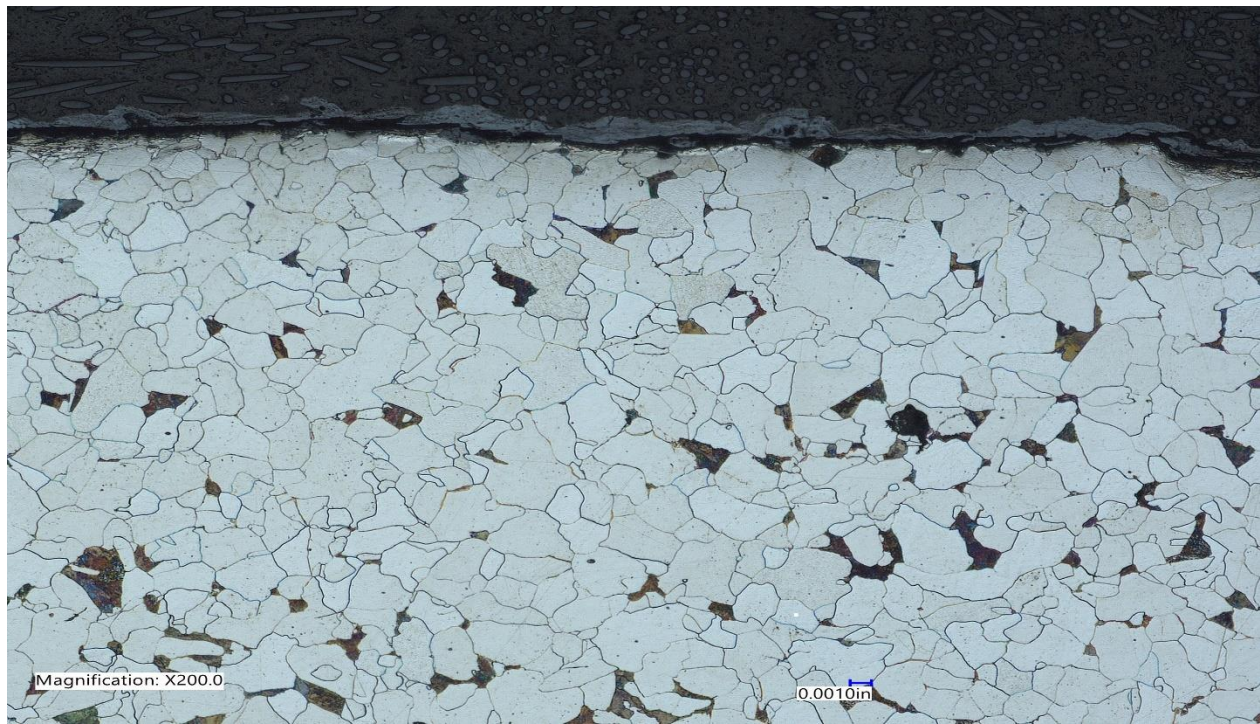
212171_BB:

Has the same results with slightly?

Higher hardness but still in negative and Micro Structure same identical.

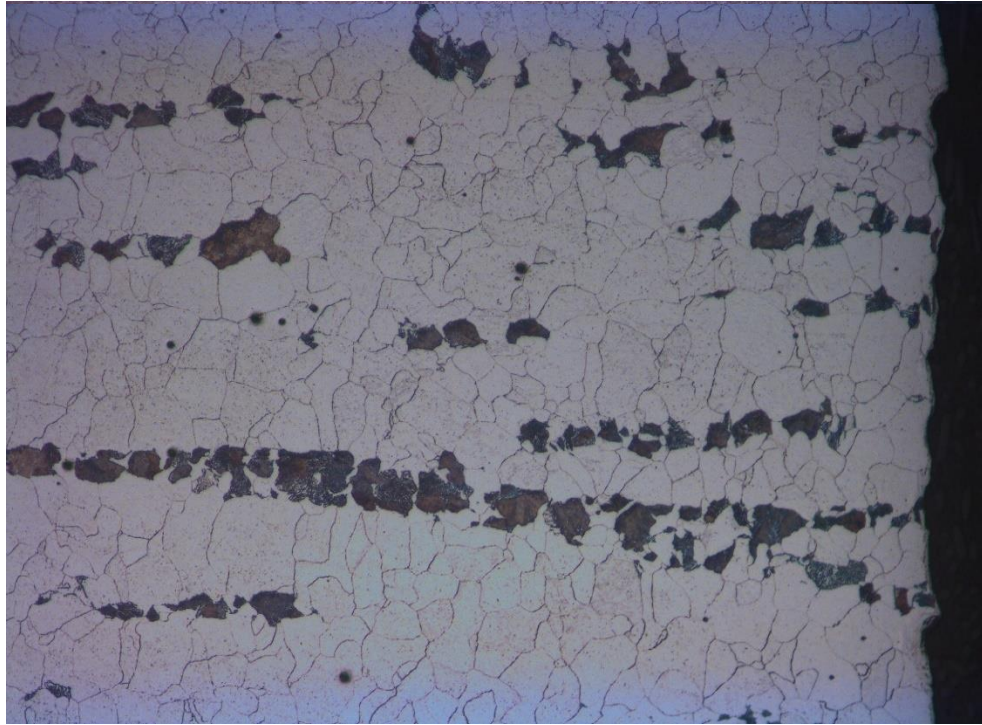
212171_CC:

Same Hardness value but Micro Structure is different, this sample appears to have Homogenize process performed very very poor process, without properly cooling. Micro Structure also reveals that there is decent amount of Iron Carbon distribution, Carbides are formatted with large Grain; subject sample does not have any evidence of proper Normalize, Temper or any other Heat-treating evidence.

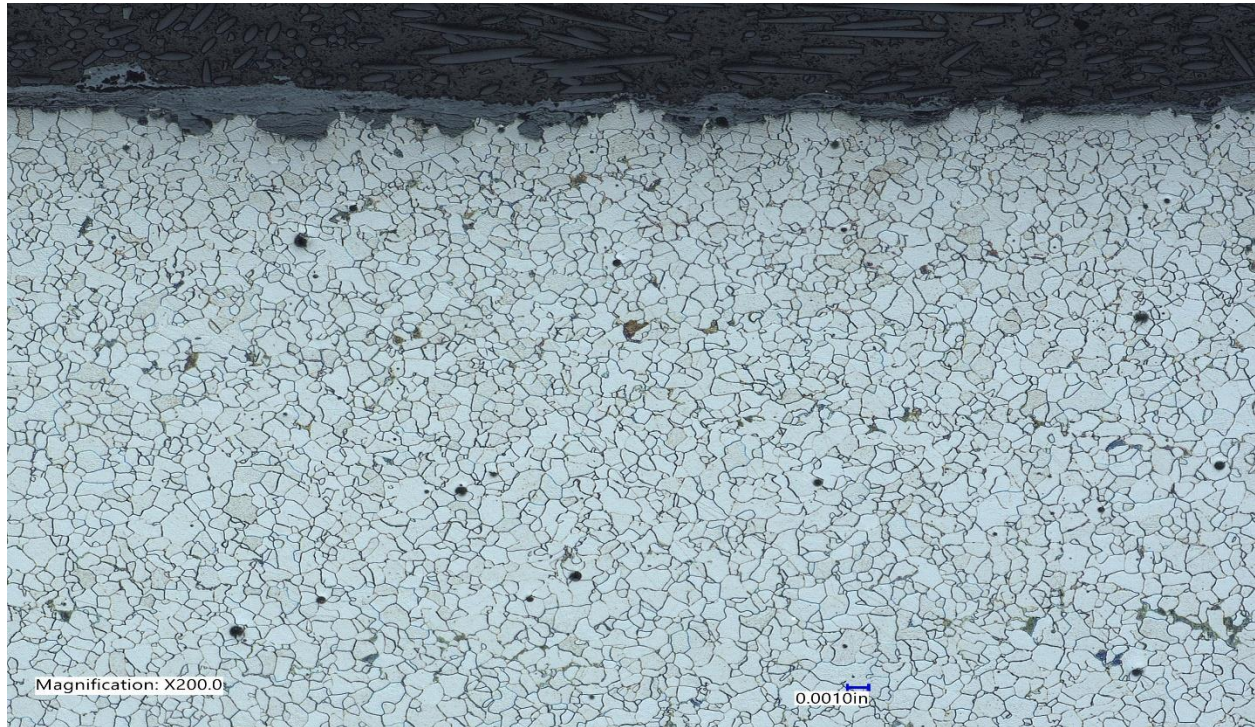
Surface microstructure 200x: DD

Similar pattern of hardness but Micro Structure appears to have gone through decent Homogenize, Decent Normalized but not properly tempered.

Micro Structure appears to be the best of all samples, with proper Martensetic structure, Normal Grain size and no more than normal Grain Boundaries.
