U.S. DEPARTMENT OF  
**ENERGY**

Office of  
Science

## **Accident Investigation Report**

**Electrical Shock Accident  
Resulting in Employee Injury at SLAC  
on December 27, 2022**

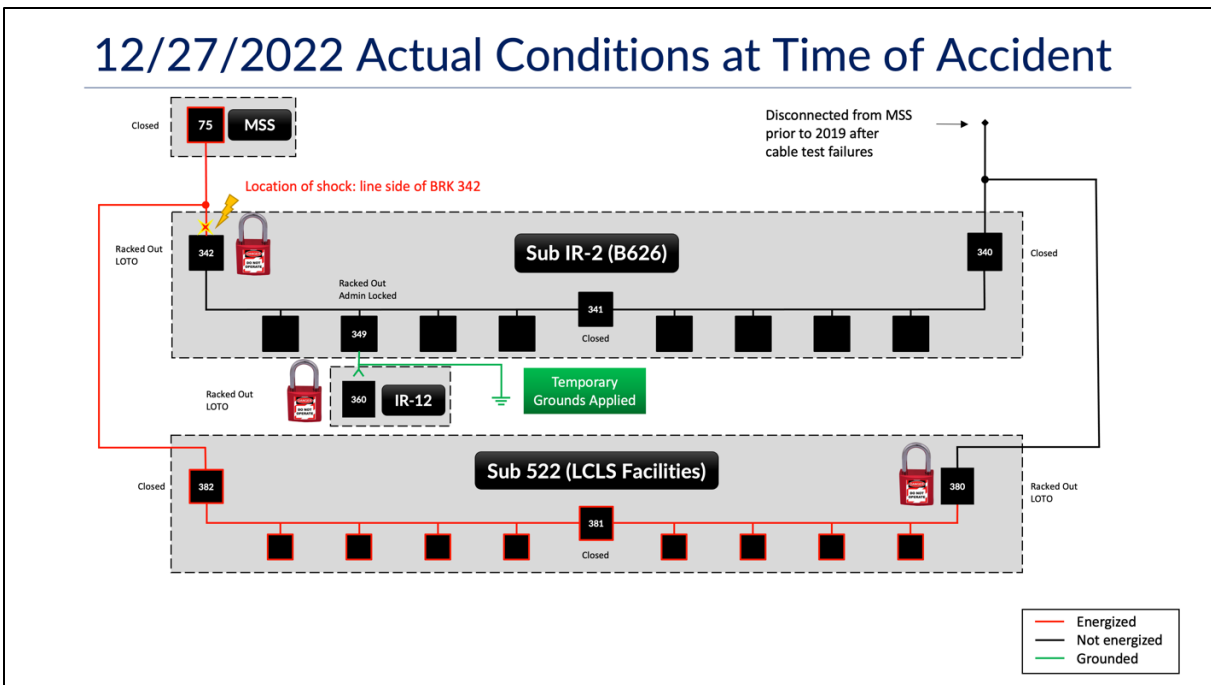
**Figure 2-2: Location of and conditions at the time of the accident.**

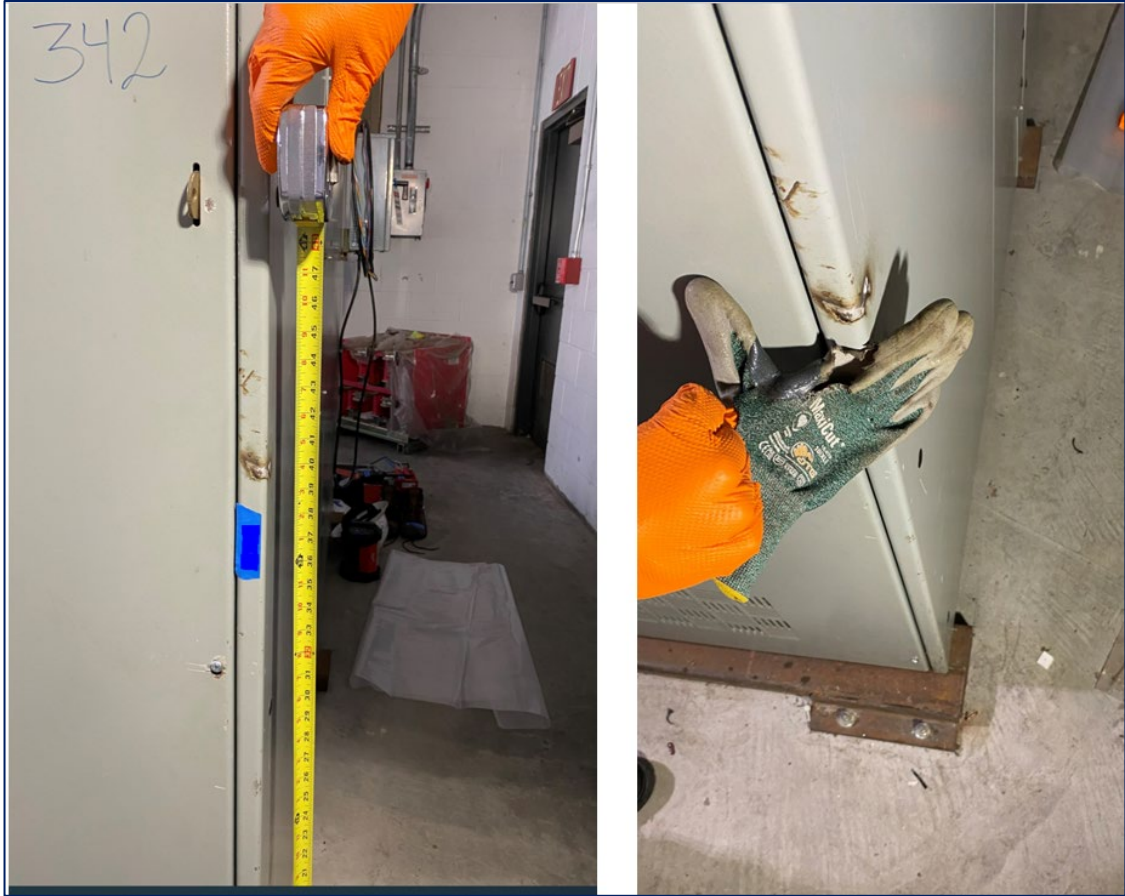
The point of contact for the right hand is clearly visible halfway up the edge of the open enclosure. There is a blackened and heat-damaged area, with some of the paint missing in the middle (Figure 2-15). The pattern was verified to be consistent in size and shape with the right-hand glove inside web between the thumb and index finger.

**Figure 2-15: Back of BRK342 Cubicle.**

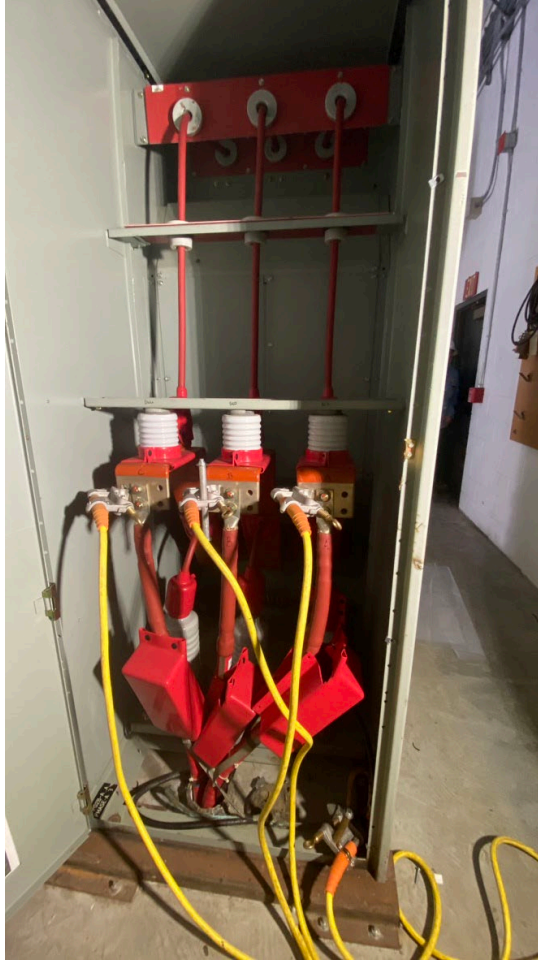
The damage on the top connector of the surge arrester was not immediately apparent until close inspection with a camera. On the front there is a small, slight metal discoloration. On the back of the threaded connector there are some charred deposits, either organic or from the work glove. The insulating boot has a small area of black deposits along the lower edge. There is no other damage or marking inside the switchgear enclosure. In addition, the enclosure appeared clean, without debris or dust. There was no visible evidence of insulator degradation or contamination, and no evidence of tracking. See Figures 2-16 to 2-19.

**Figure 2-16: BRK342 rear cubicle after it was placed in an electrically safe work condition for the Board.** The protective grounds were added for the Board and were not in place at the time of the accident.

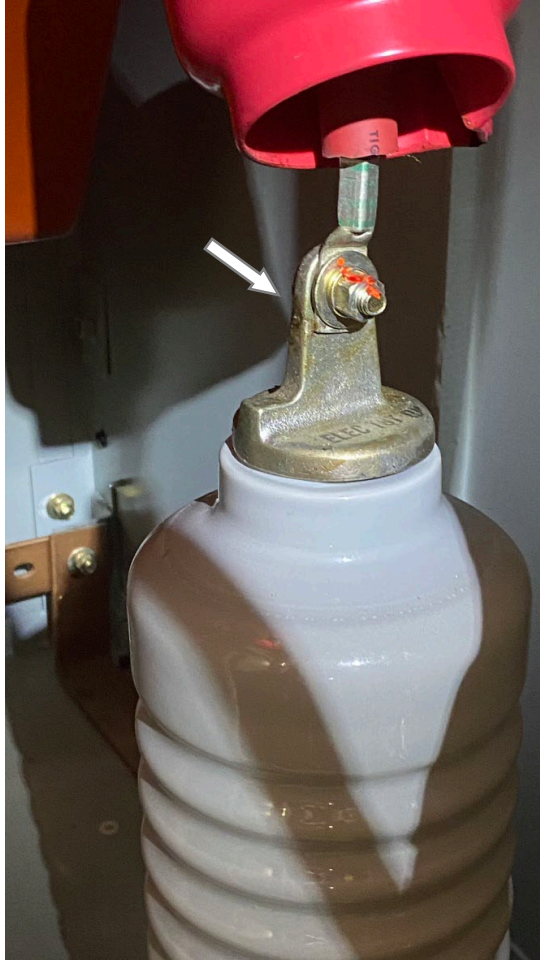
**Figure 2-17: Front view of the phase A surge arrester bolted connection showing minor thermal discoloration.**

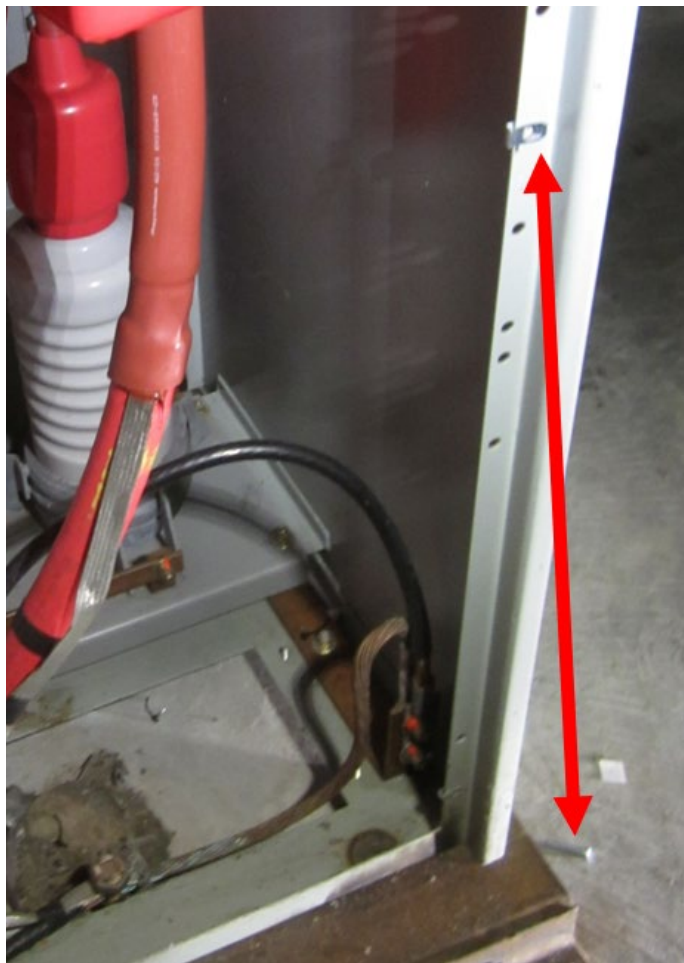
The 1/3/2023 entry video provided by SLAC revealed several items of interest to the Board Members. The back panel door for BRK342 is designed to be secured (closed) either through the use of bolts, a lock and hasp, or a combination of both. One detail noted in the video was a hex head bolt, laying on the ground, near the outer corner of the BRK342 cubicle. The bolt holes on the back of BRK342 door panel are not threaded and require a fixed fastener clip in which a bolt could be threaded into. The video shows one installed fixed fastener clip about halfway up the panel door. Though not confirmed, the clip appears to be capable of accepting a hex head bolt similar in size to the one laying on the floor, as seen in Figure 2-20.

**Figure 2-20: Rear of BRK342 Cubicle (Panel door opened).**

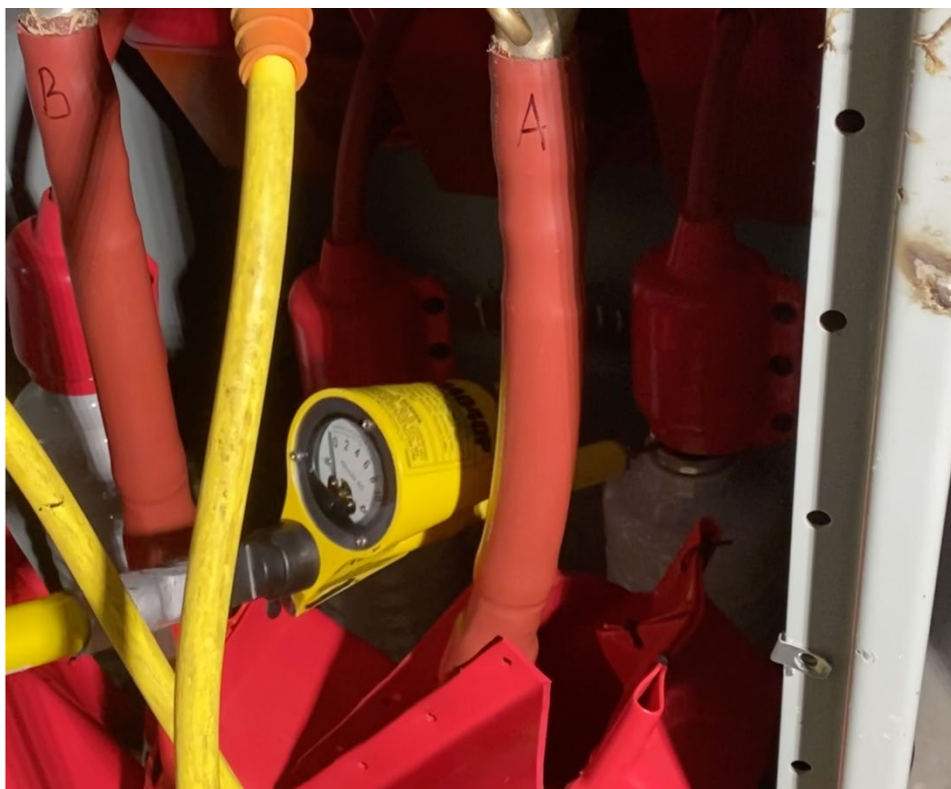
**Figure 3-7: HV Supervisor demonstrating how the contact tester is used to lift the insulating boot to barely expose the top of the surge arrester on Phase A of BRK342 cubicle (already in an electrically safe work condition).**

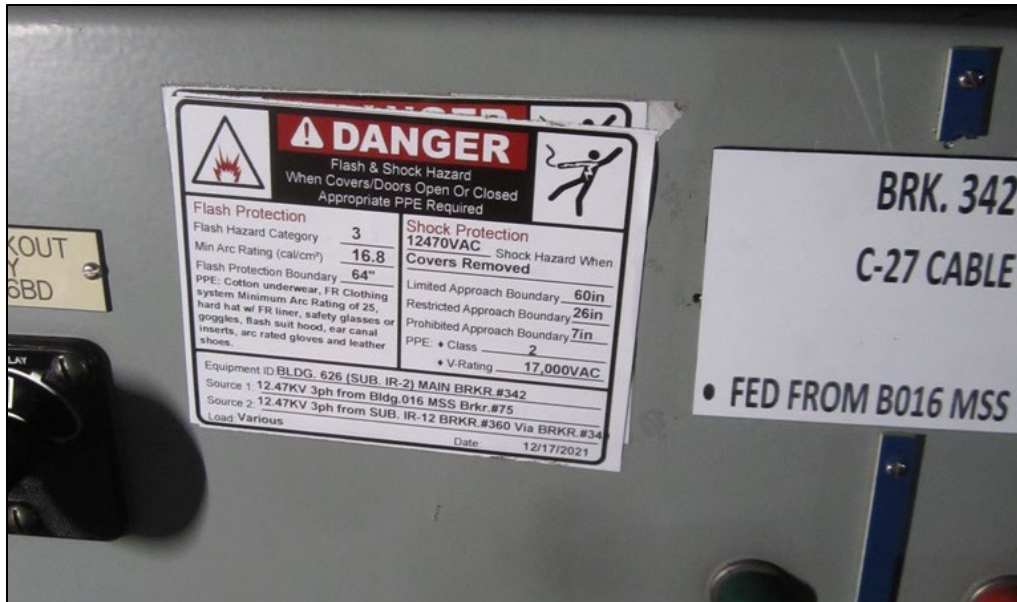
**Figure 3-8: BRK342 Arc flash label shows two (2) sources, including MSS BRK75. It also indicates an arc flash boundary of only 64,” whereas it should be 59 feet.**

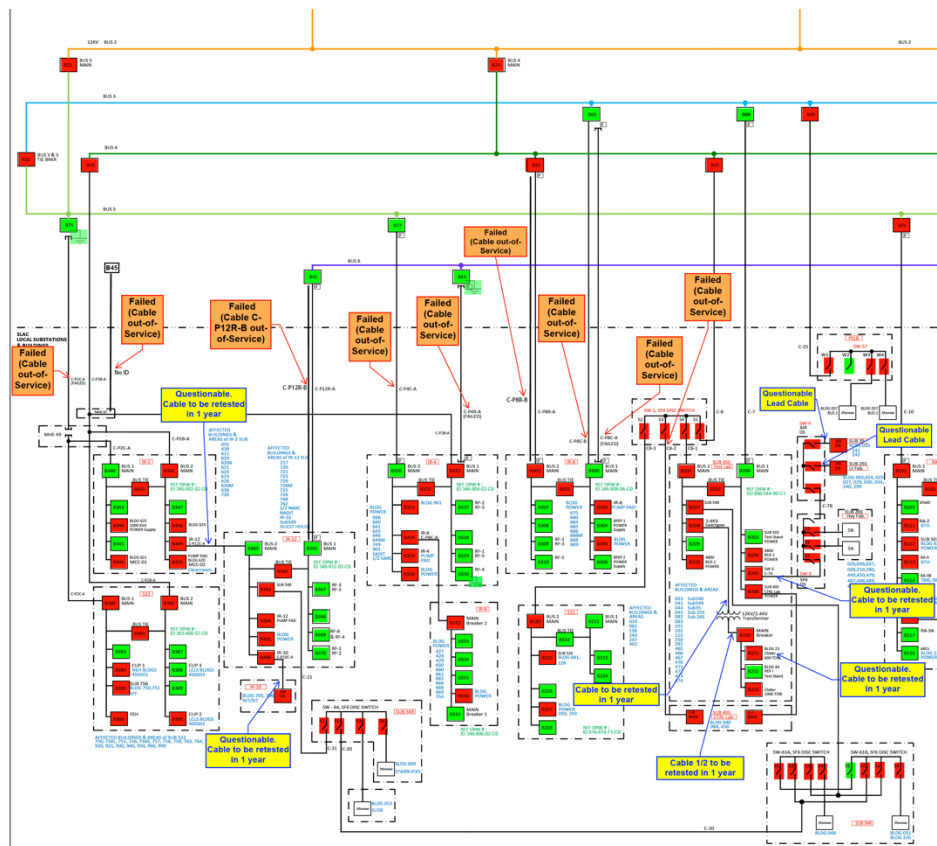
**Figure 3-13: Annotated single line drawing from 2019 showing numerous failed cables to the PEP distribution area and multiple cross-feeds. Annotations by SLAC.**

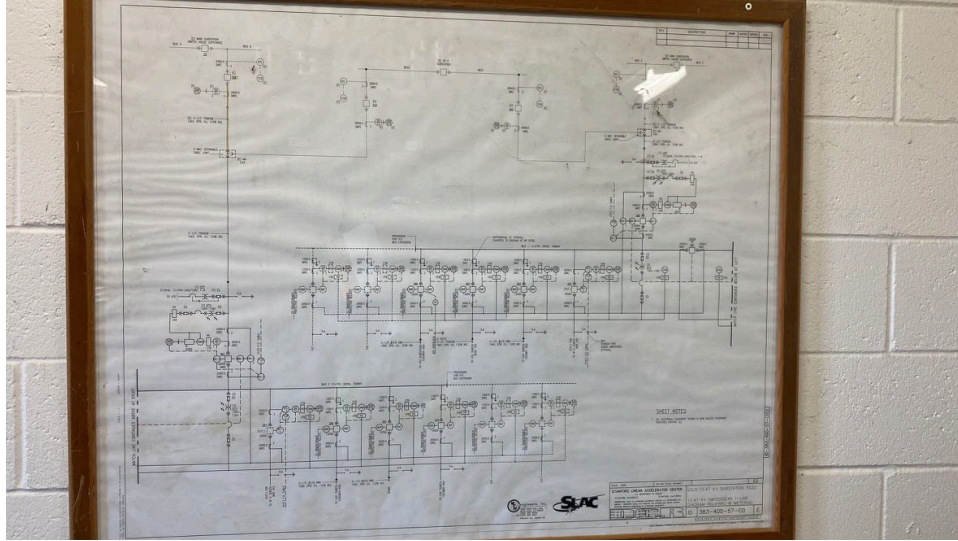
**Figure 3-14: Posted single line drawing at S522 still showing the 2011 configuration, including connection to IR-2.**

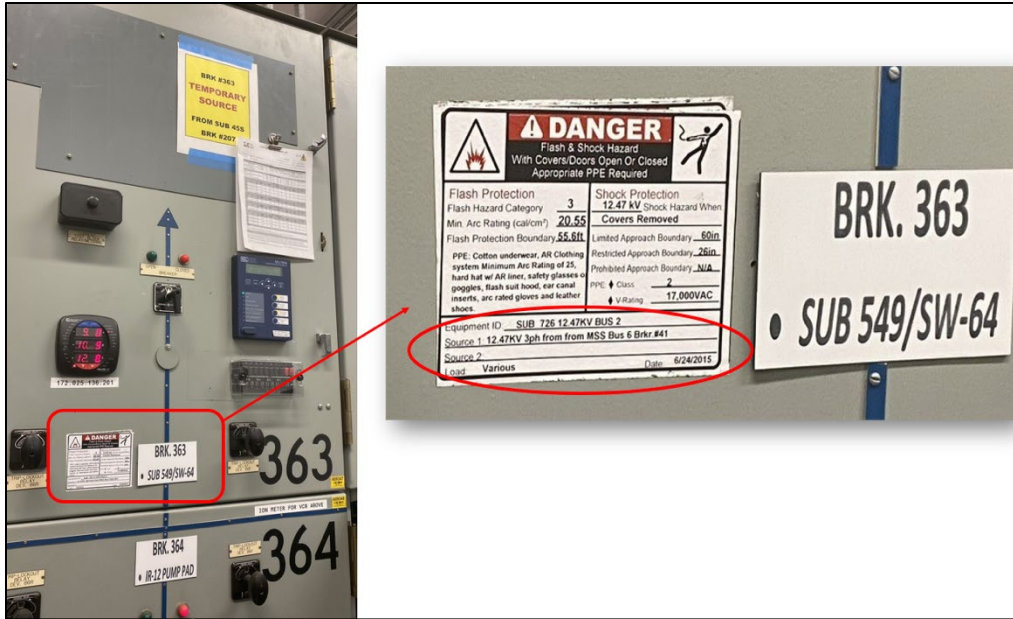
**Figure 3-19: Example of ‘temporary source’ to IR-12 from Sub 45S that has been in place since before 2019 as a result of cable failures. The arc flash label still shows a single source from BRK41, and the arc flash values do not reflect updated conditions.**

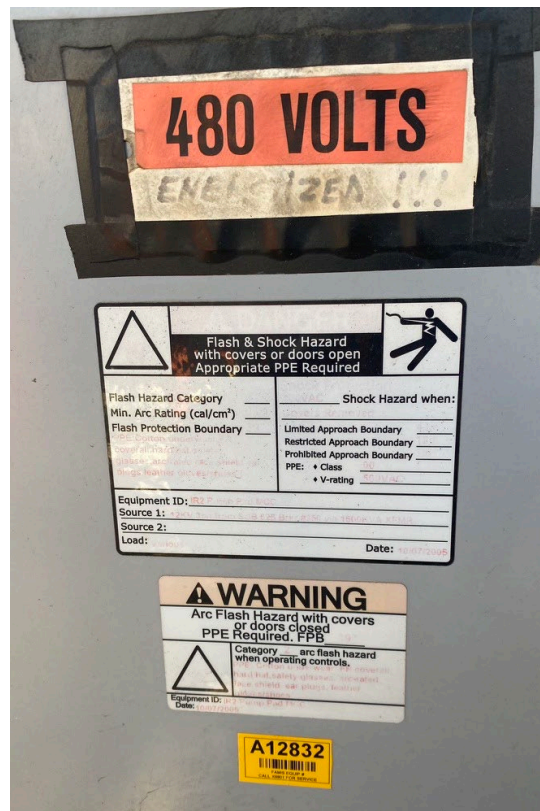
**Figure 3-20: Illegible Arc flash label on MCC #1 at IR-2 Pump Pad where a ZVV was performed on 12/27/2022.**

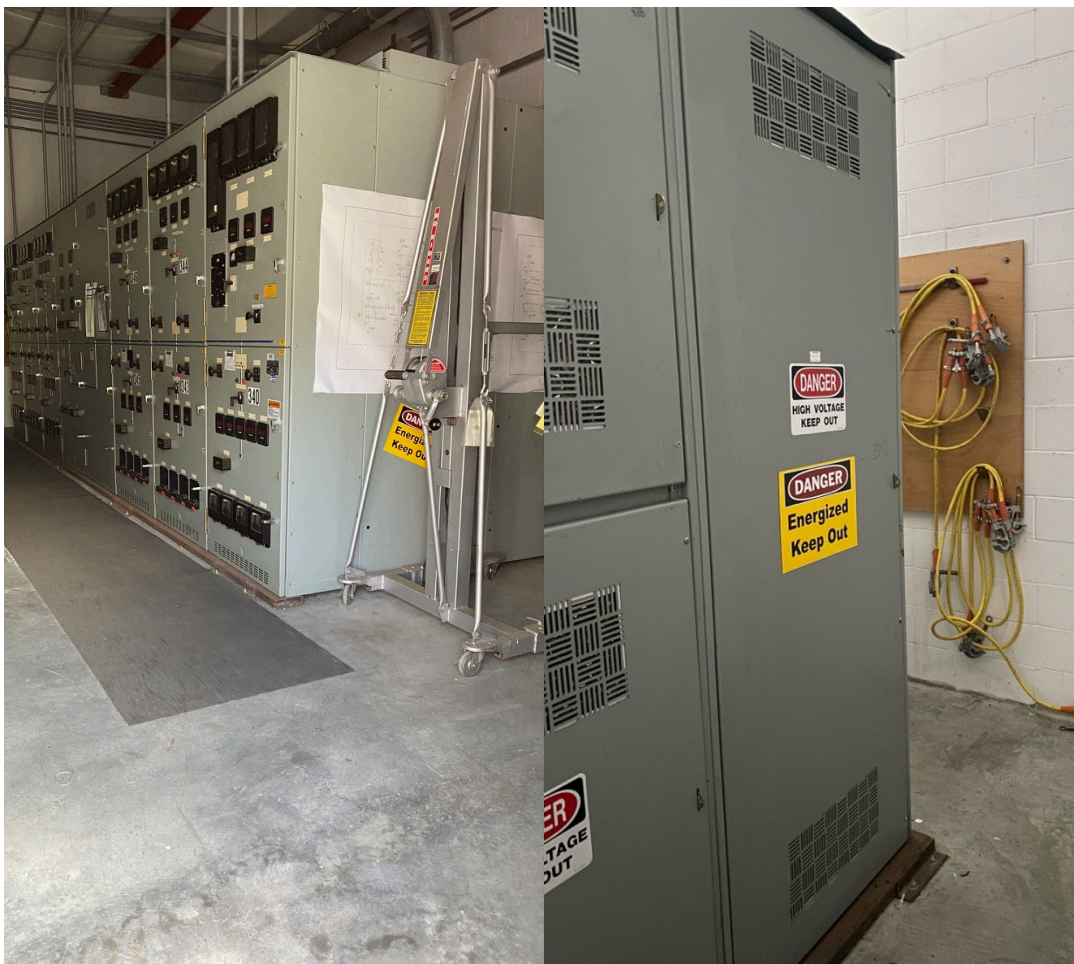
**Figure 3-21: Temporary yellow magnetic Danger sign applied to IR-2 switchgear. The photo on the left shows the sign as found by the Board on the side of the gear. The photo on the right shows the sign applied to the rear door of BRK342 cubicle after the event for demonstration purposes by the HV Supervisor.**

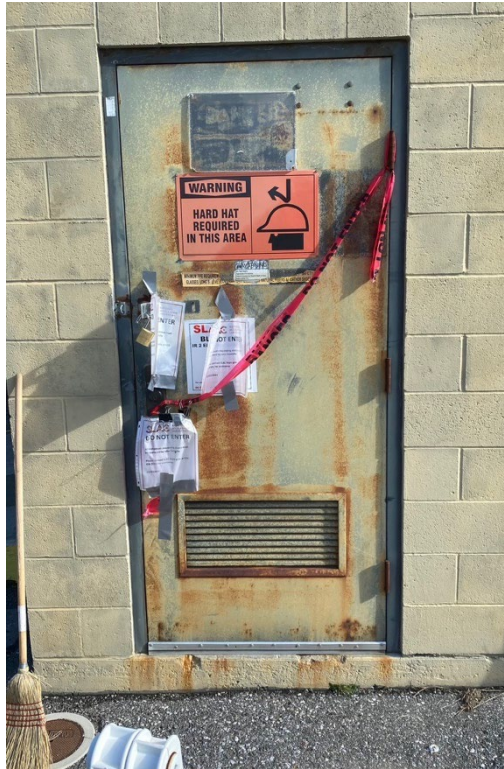
**Figure 3-23: The main door to Building 626 / IR-2 Substation features dilapidated safety signs. The Danger sign on top has come off, and the label indicating minimum PPE for entry is peeled off and illegible.**

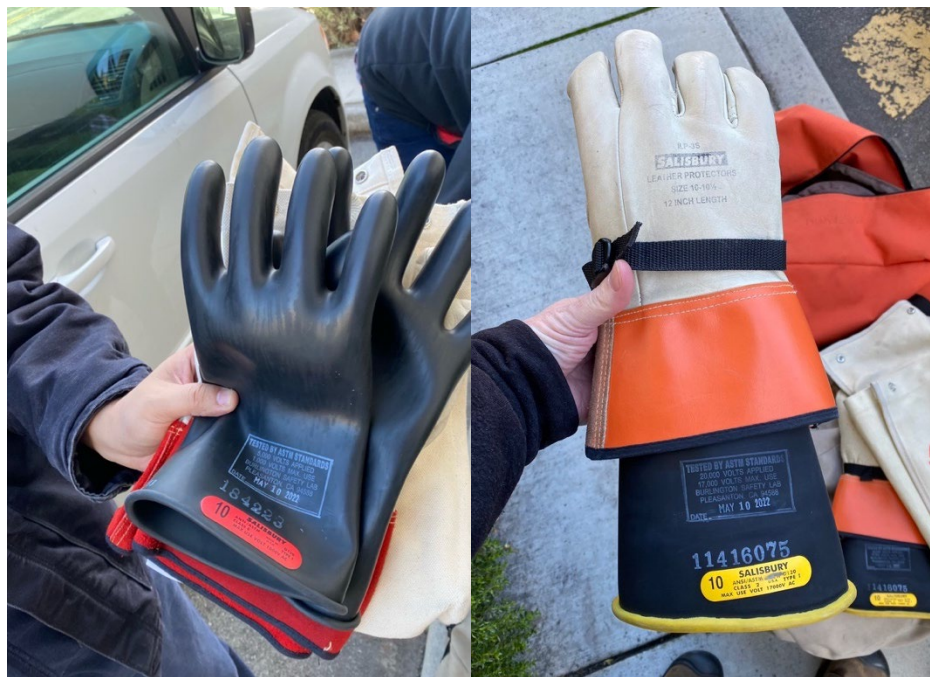
**Figure 3-24: Class 0 (left) and Class 2 (right) sets of voltage gloves found in HVE1's work vehicle.**

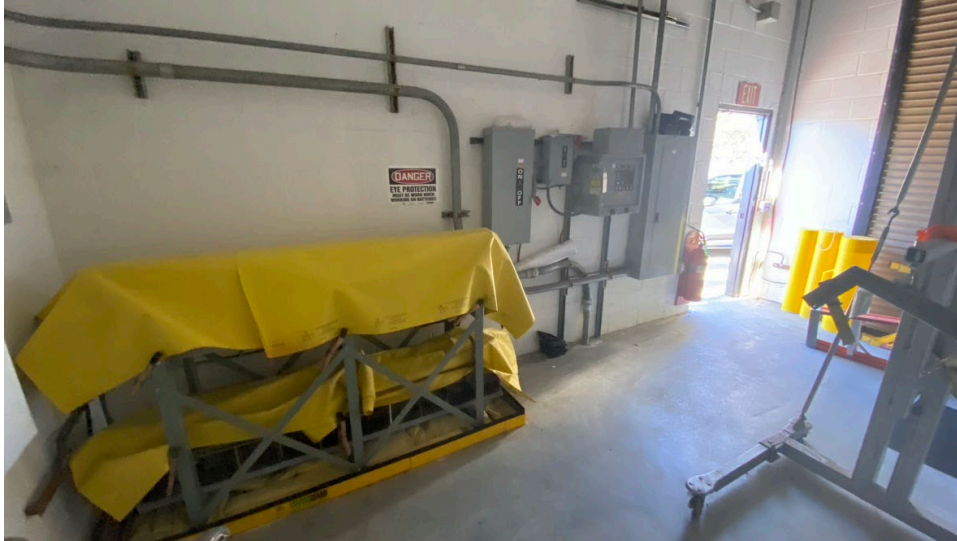
**Figure 3-25: Battery bank at IR-2 Substation with insulating blankets over exposed energized terminals.**

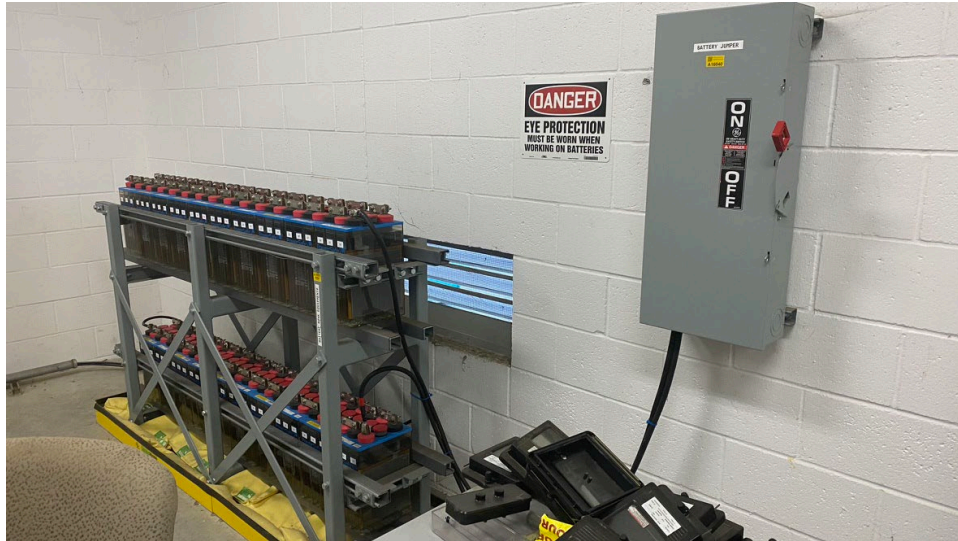
**Figure 3-27: Battery bank at S522 Substation with exposed energized terminals.**

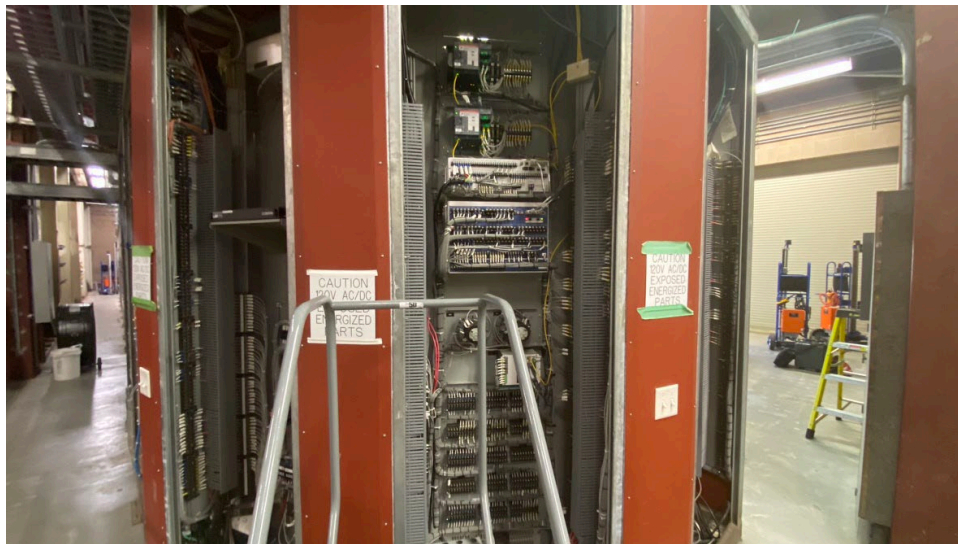
**Figure 3-28: Back of MSS SCADA racks, labeled “Caution 120V AC/DC Exposed Energized Parts” all around.**

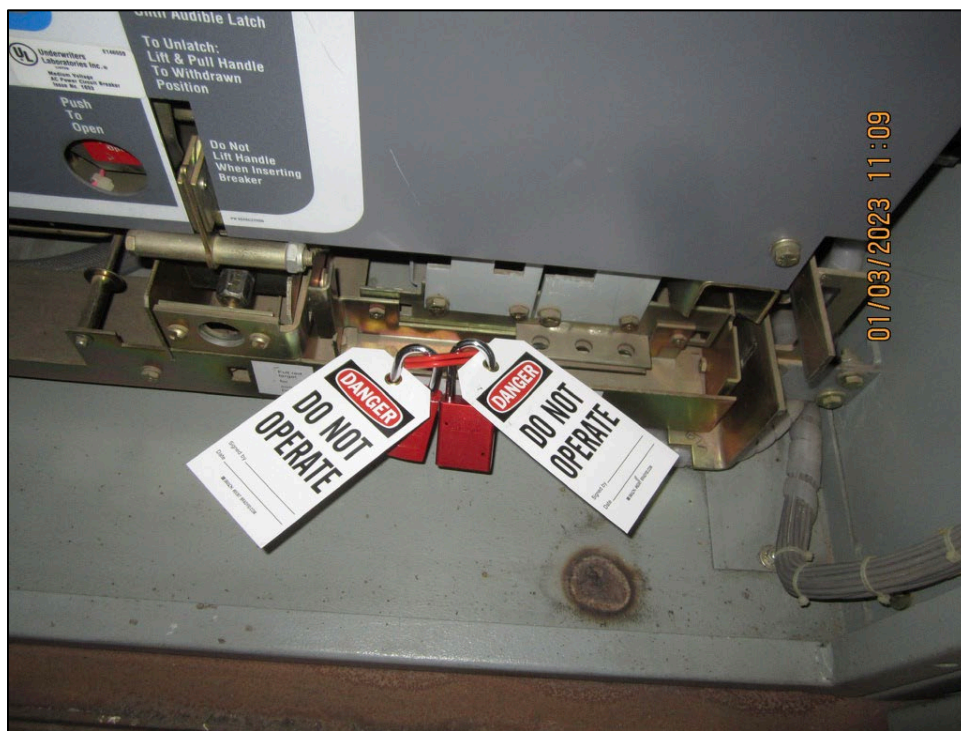
**Figure 3-29: Group LOTO locks applied to BRK342 without Group LOTO tags and without any identifying information other than the number on the lock.**

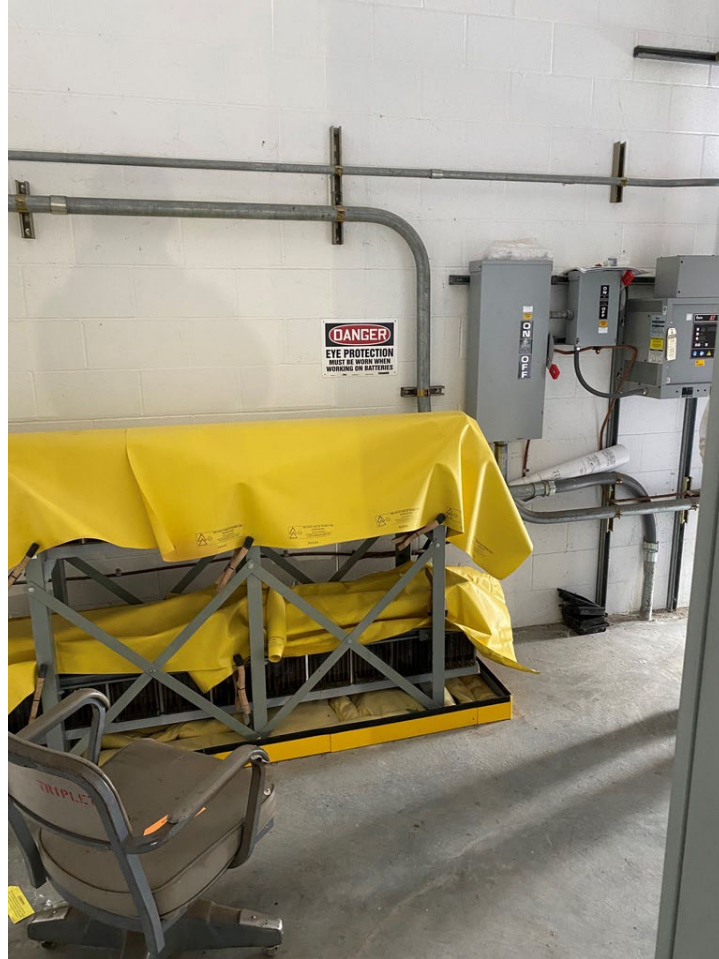
**Figure E-4: IR-2 Substation 120 VDC Battery Bank was covered in insulating sheeting on 1/19/2023. Battery disconnect immediately adjacent to the right was opened by HVE1 on 12/27/2022.**

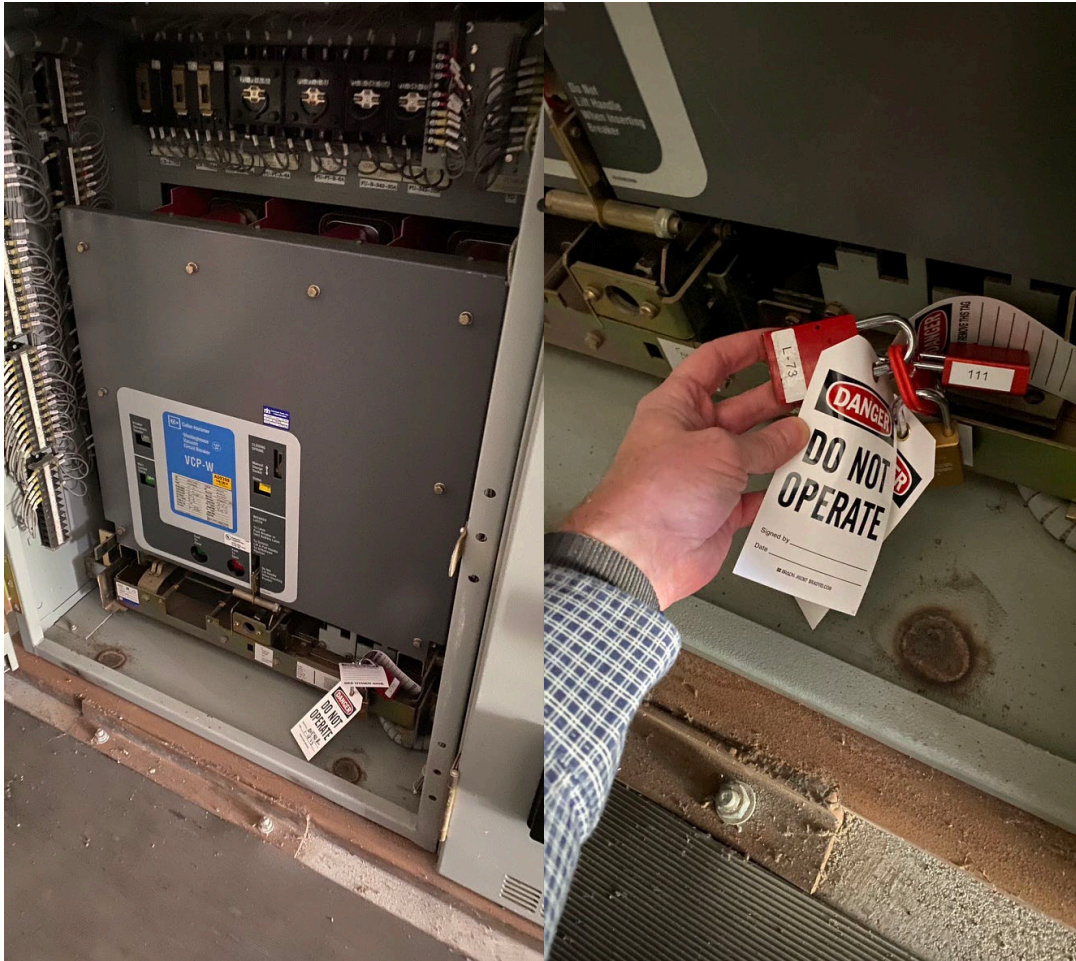
**Figure E-10: Front view of BRK342, locked out in the racked-out position. The key for Lock #73 was found in LB8, and the key for Lock #111 was found in LB6.**

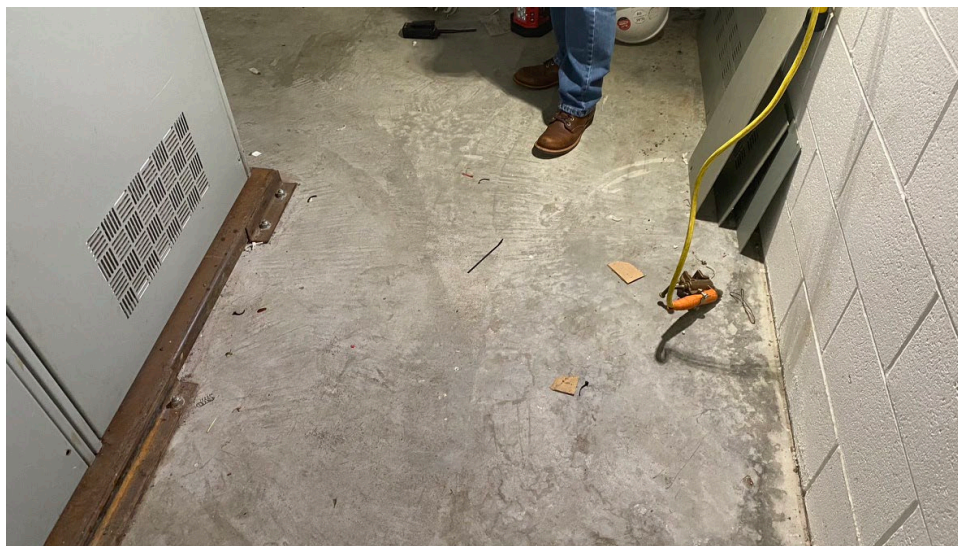
**Figure E-12: Working clearance behind BRK342 was measured at 56". The ground clamp is for the discharge stick found hanging on the wall disconnect and staged for work by HVE3.**

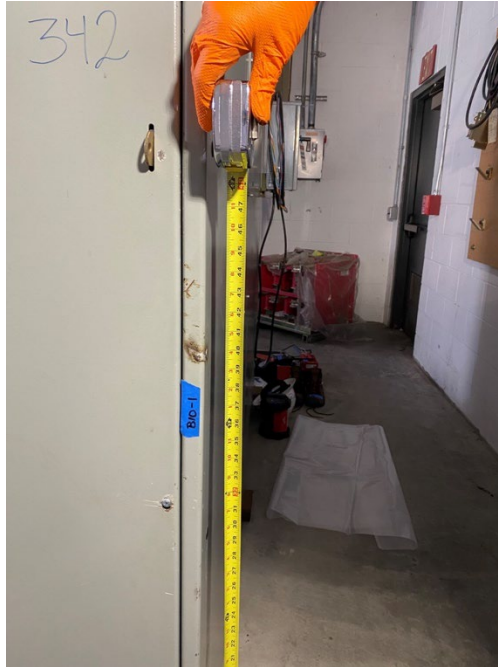
**Figure E-14: Location of shock contact area for right hand.**

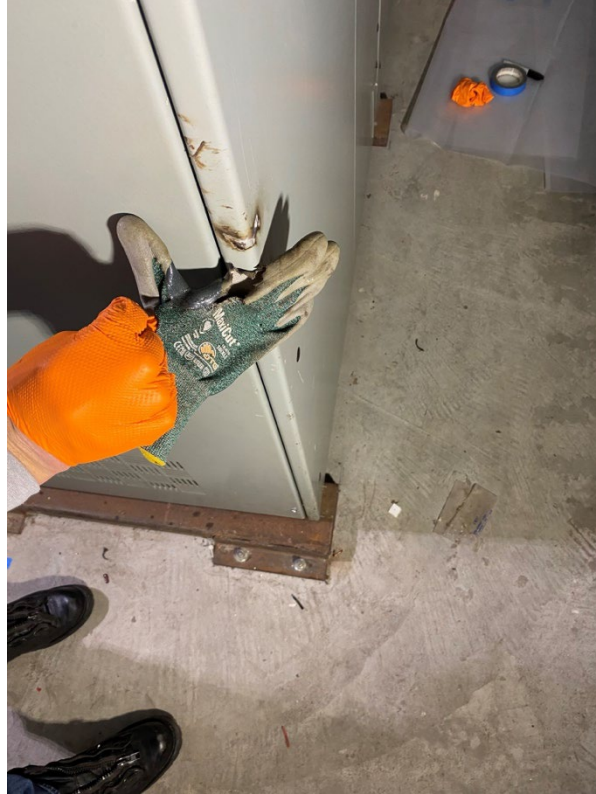
**Figure E-16: Comparison of glove damage to the shock contact area for right hand.**

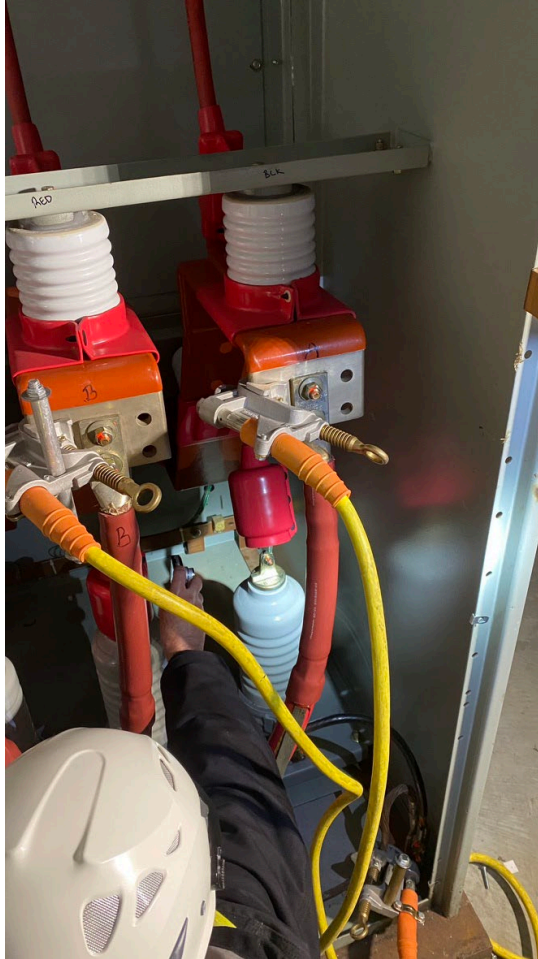
**Figure E-19: Top of Phase A Surge Arrestor with insulation boot lifted, where HVE1 left hand made contact (location of shock).**

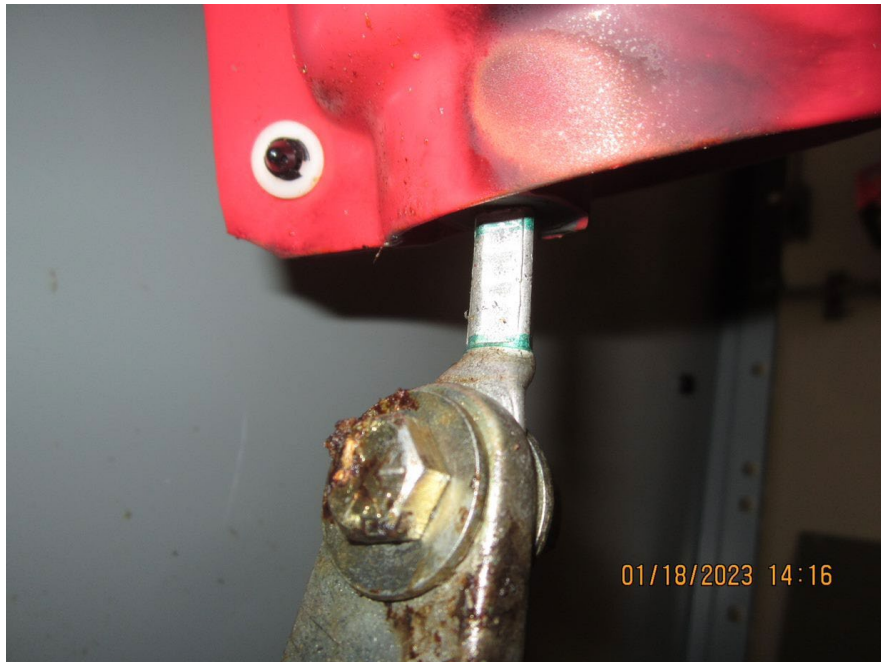
**Figure E-22: Top of Phase A Surge Arrestor showing deposits on the rear. Also visible is soot and thermal damage to the insulating boot.**

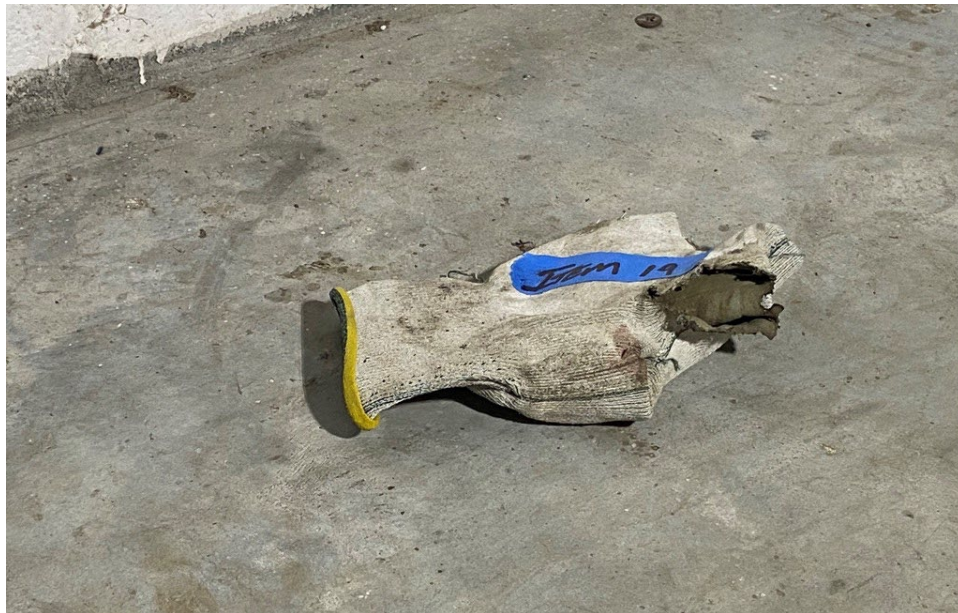
**Figure F-1: Work glove was found turned inside out in Building 626, showing tears in the web of the thumb and index finger.**

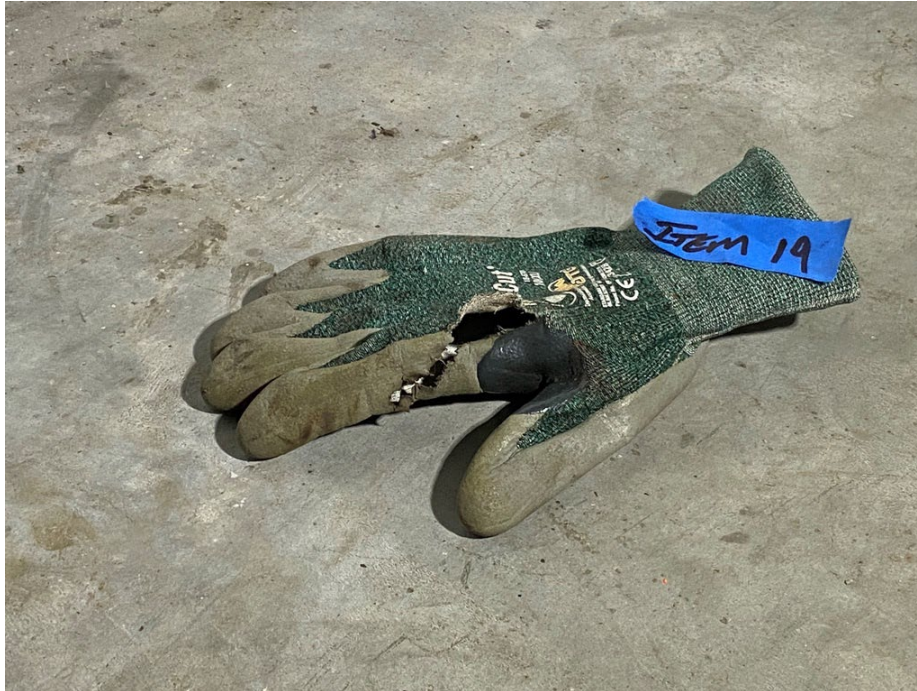
**Figure F-2: Work glove turned out showing tear across index finger.**

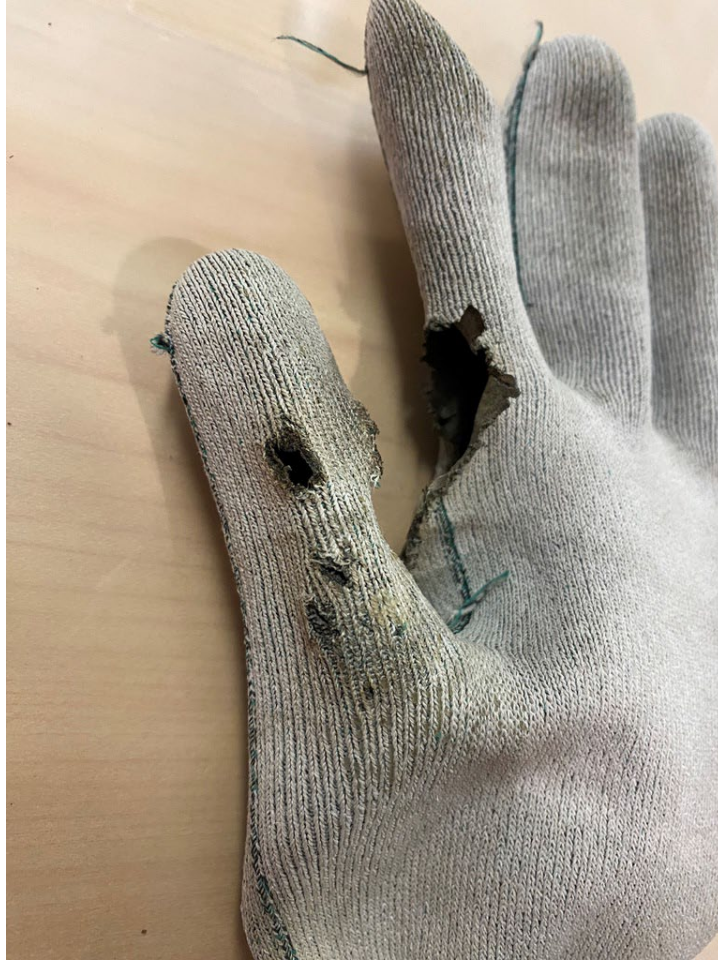
**Figure F-4: Close up of internal damage to the glove, showing multiple small holes and charring consistent with shock current and arcing along inside of thumb and index finger.**

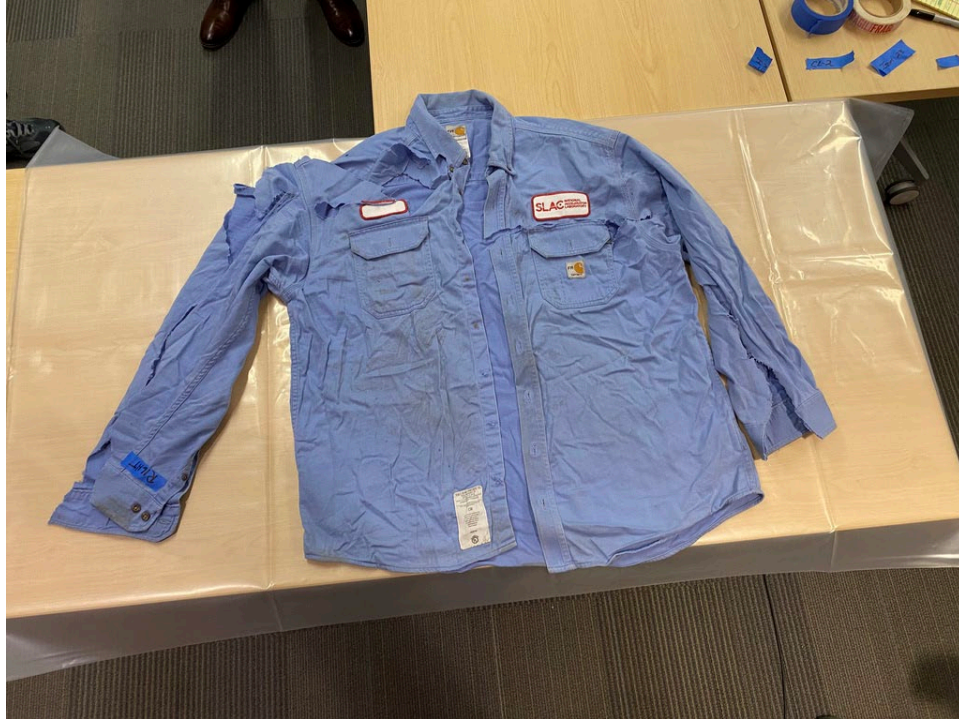
**Figure F-5: Front of arc-rated shirt showing some dirt but no sign of arc flash burning.**

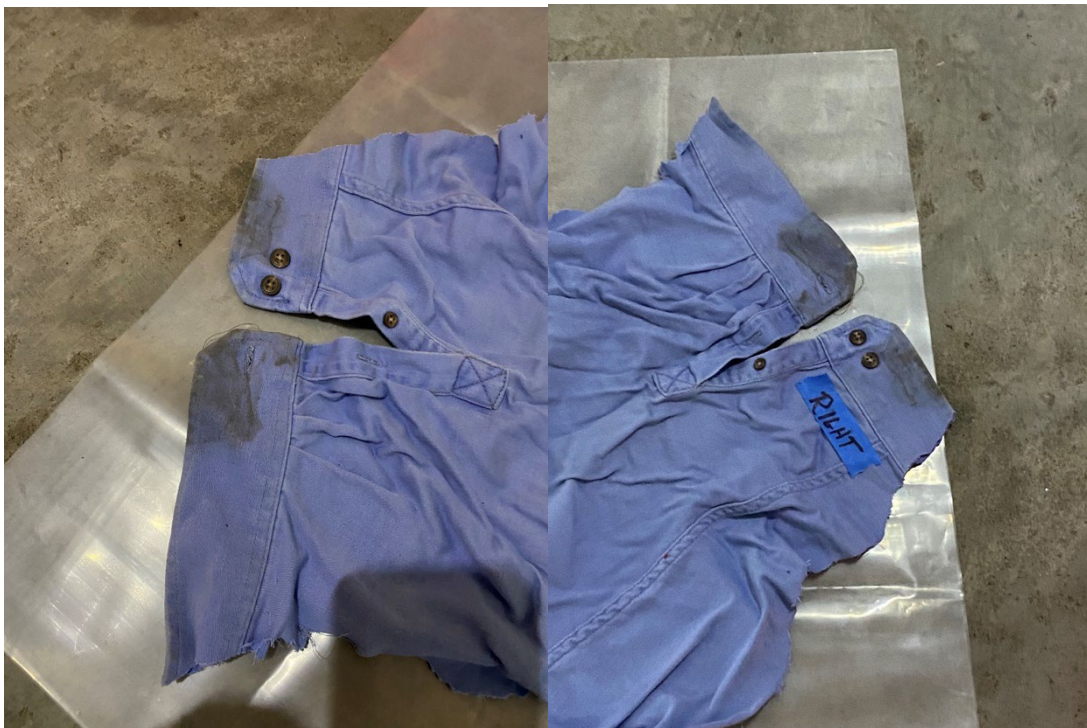
**Figure F-6: Left and Right sleeve cuffs on the arc-rated shirt showing either dirt or possible soot and slight water marks but was inconclusive.**

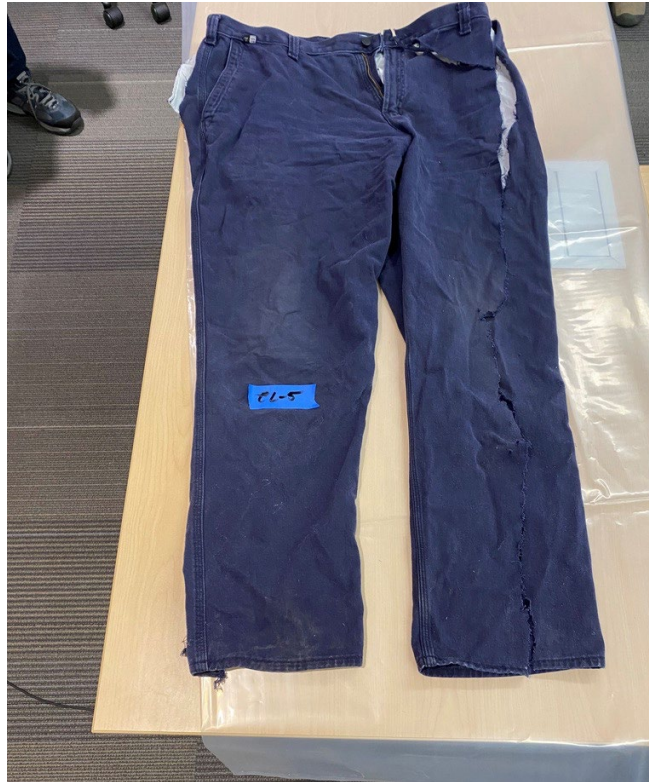
**Figure F-8: Front of arc-rated pants showing some dirt but no sign of arc flash burning.**

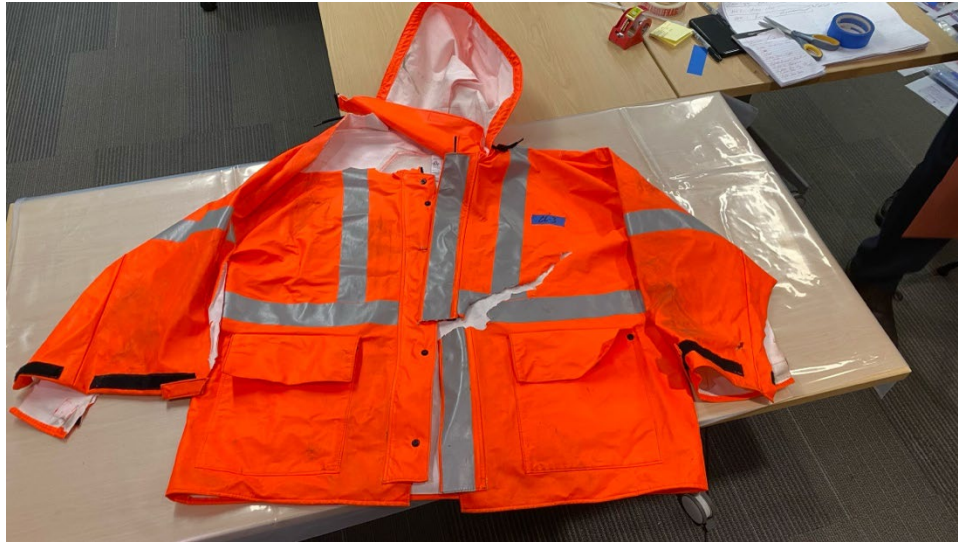
**Figure F-10: Front of arc-rated high-visibility rain jacket with no sign of arc flash damage.**

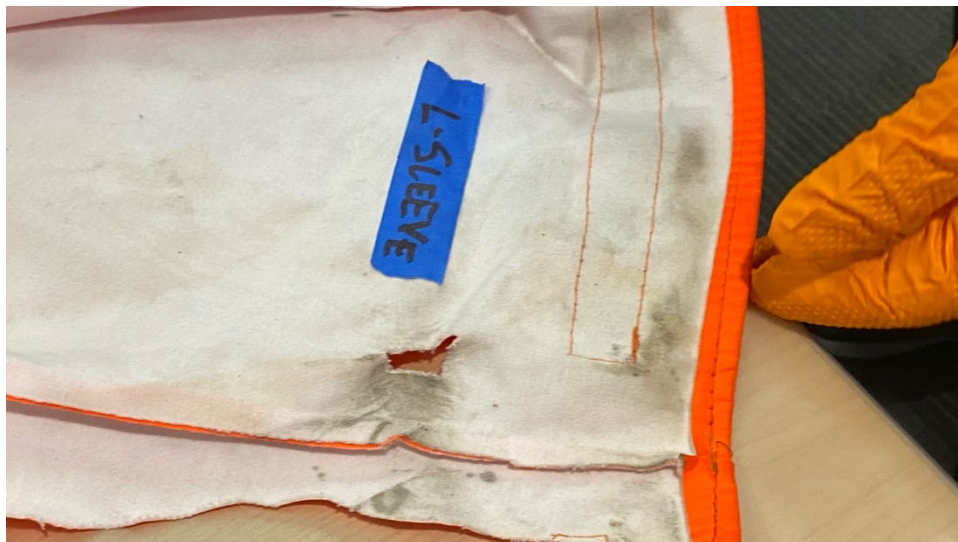
**Figure F-11: Inside of left sleeve cuff there is a small open hole with either dirt or minor soot deposits. Possible arcing point.**

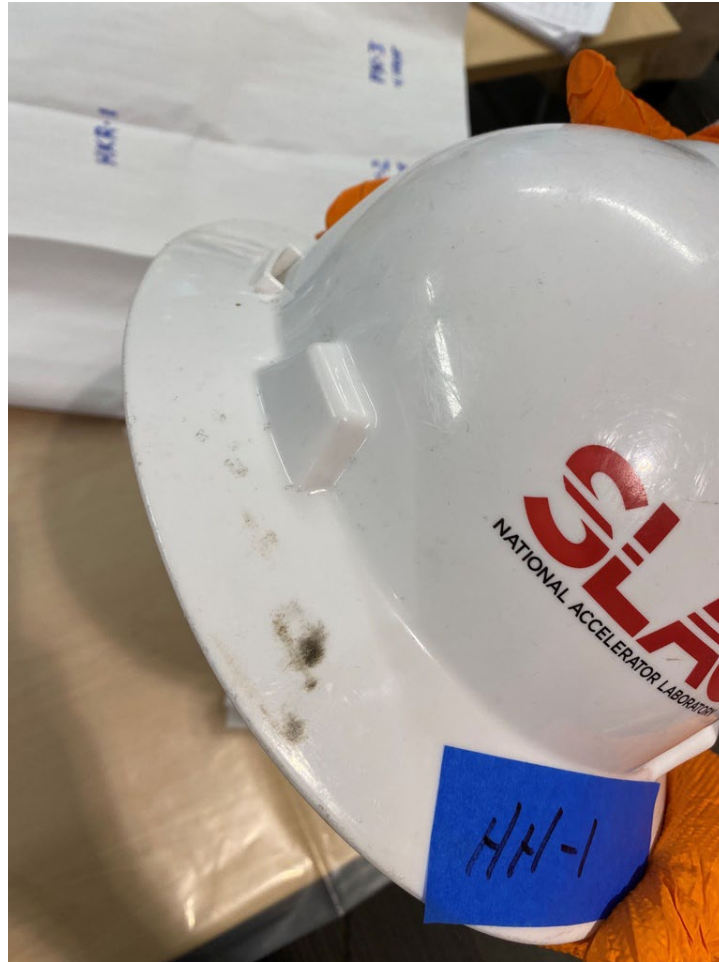
**Figure F-16:** Hard hat shows a possible soot deposit or heat damage mark. No residue will come off with rubbing.
