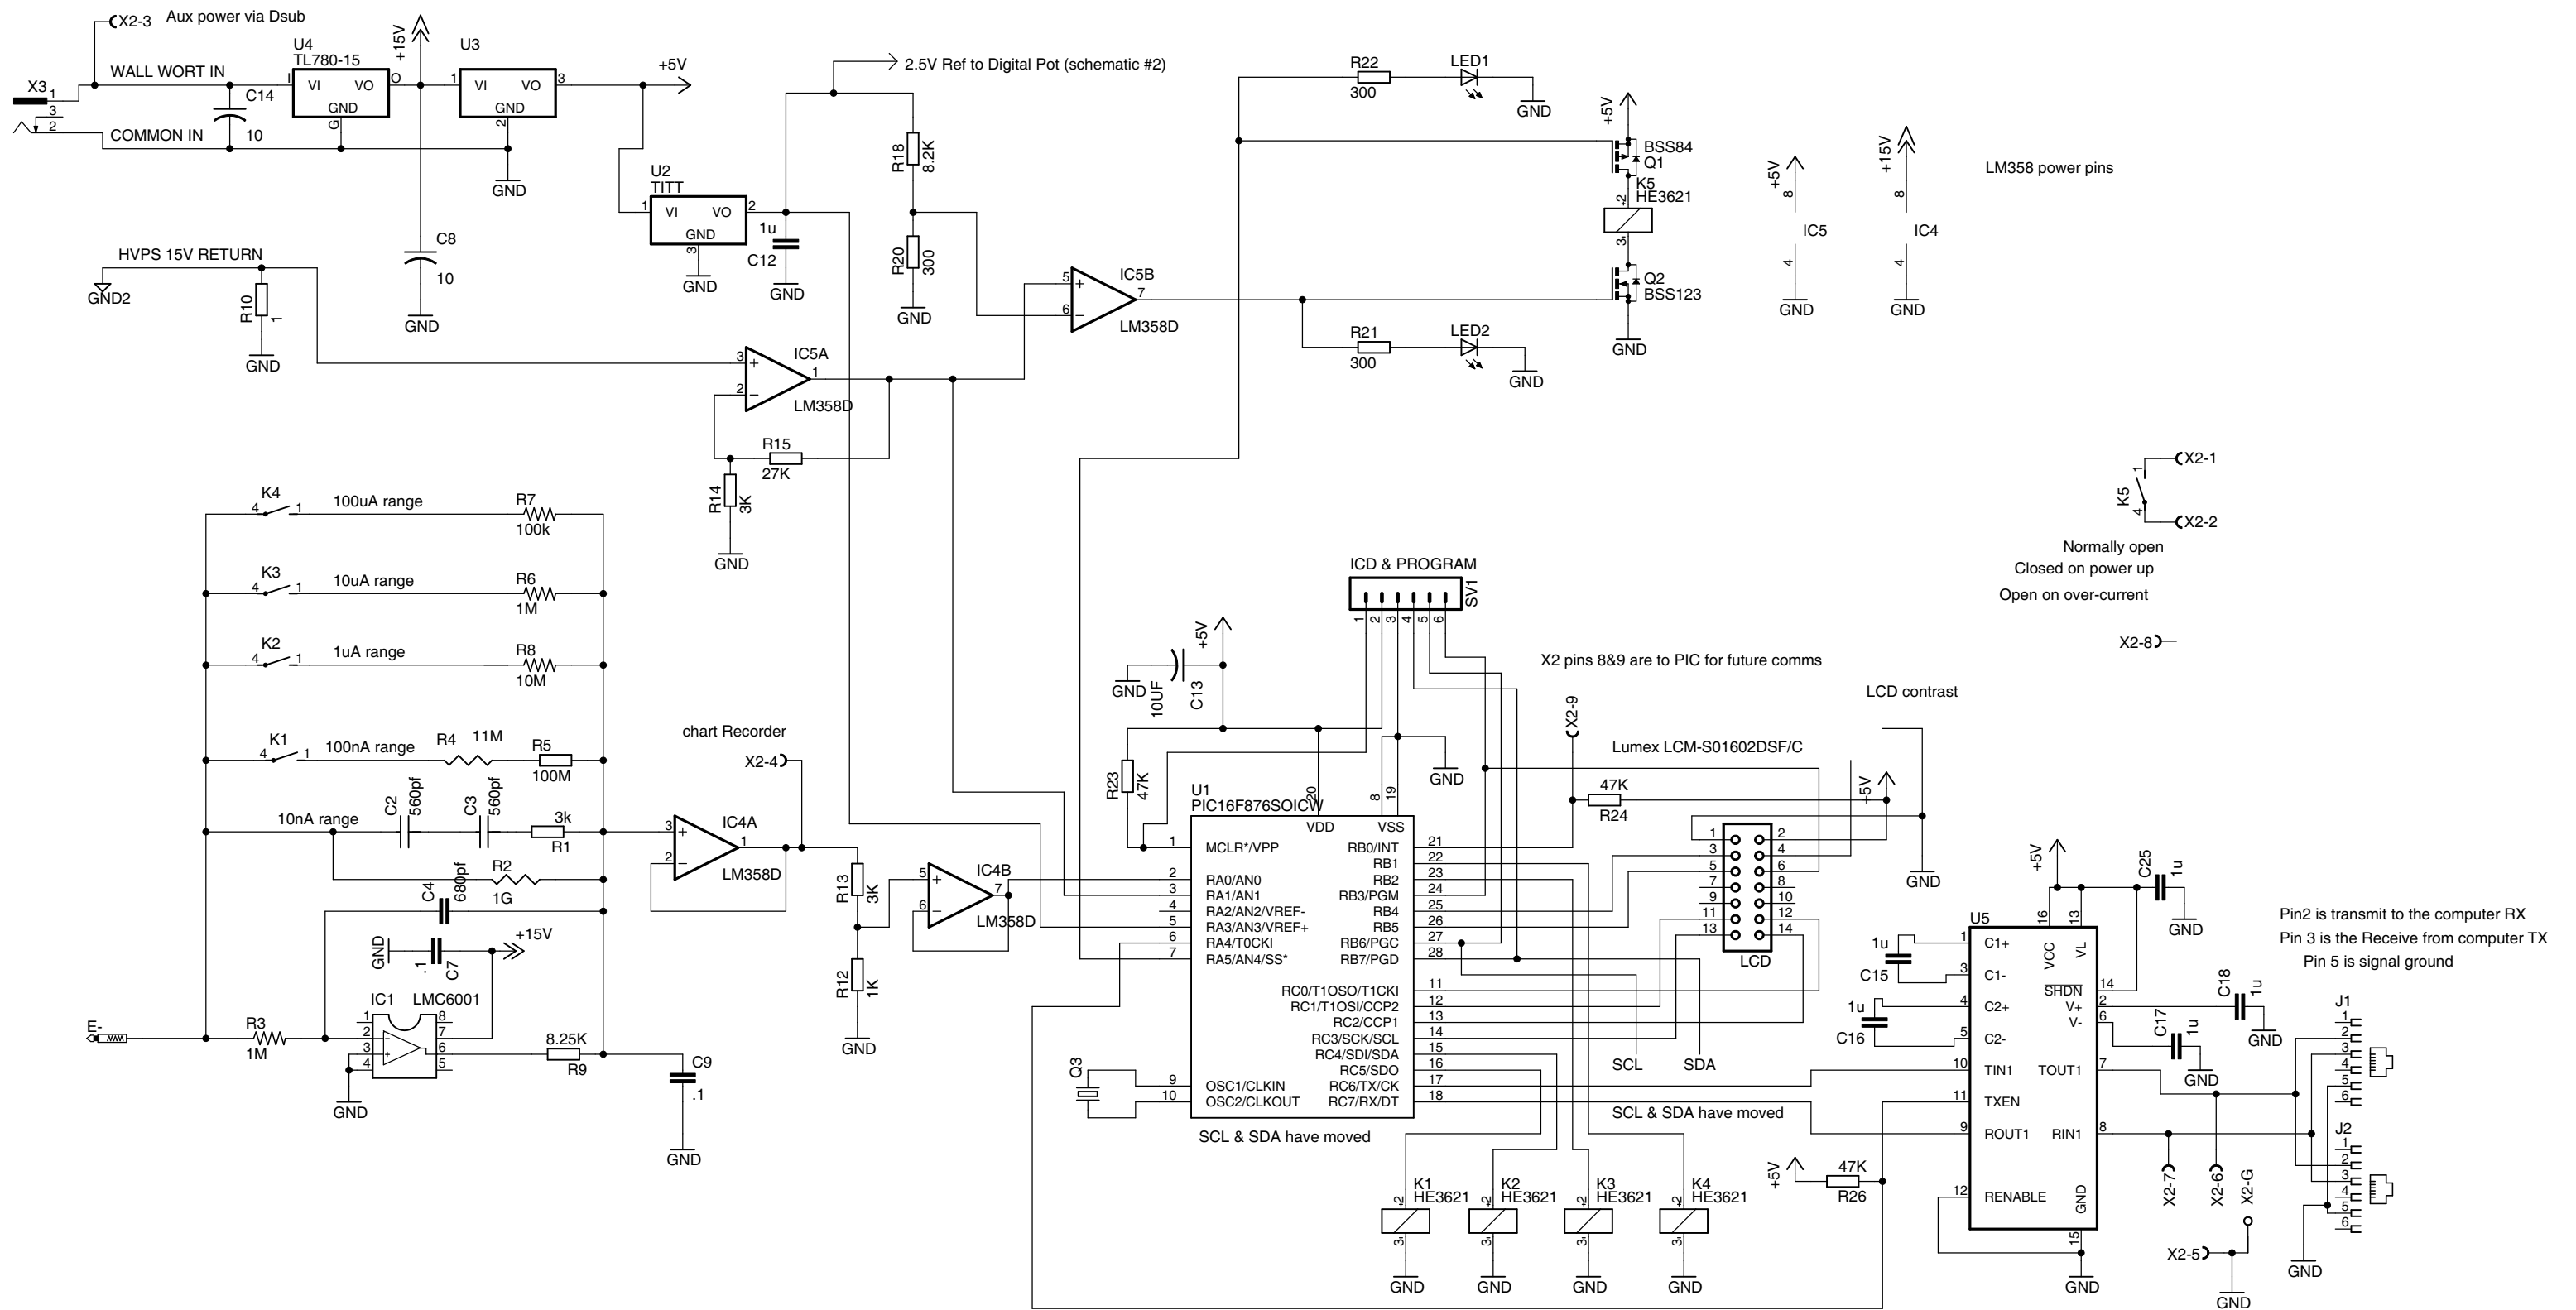
Problem.. The SDA line interferes with programming of the PIC. The line must be cut for initial programming of the bootloader and then a jumper soldered over the cut.

Problem: The 2015 edit here removes R30 and K6 and restores the original ranges.

Problem: Original Aurora board had R29. Now removed. The connection now needs to be jumpered so IC4 pin 3 ties directly to the common junction of the resistive divider section. Not to IC1 pin 6 directly.

I could have respun the board and corrected these errors, but that would make software change, and I want all UHV ion pump supplies to use identical software.
