NPS Detector Noise Mitigation Tests (addl. follow-up)

August 26 2022

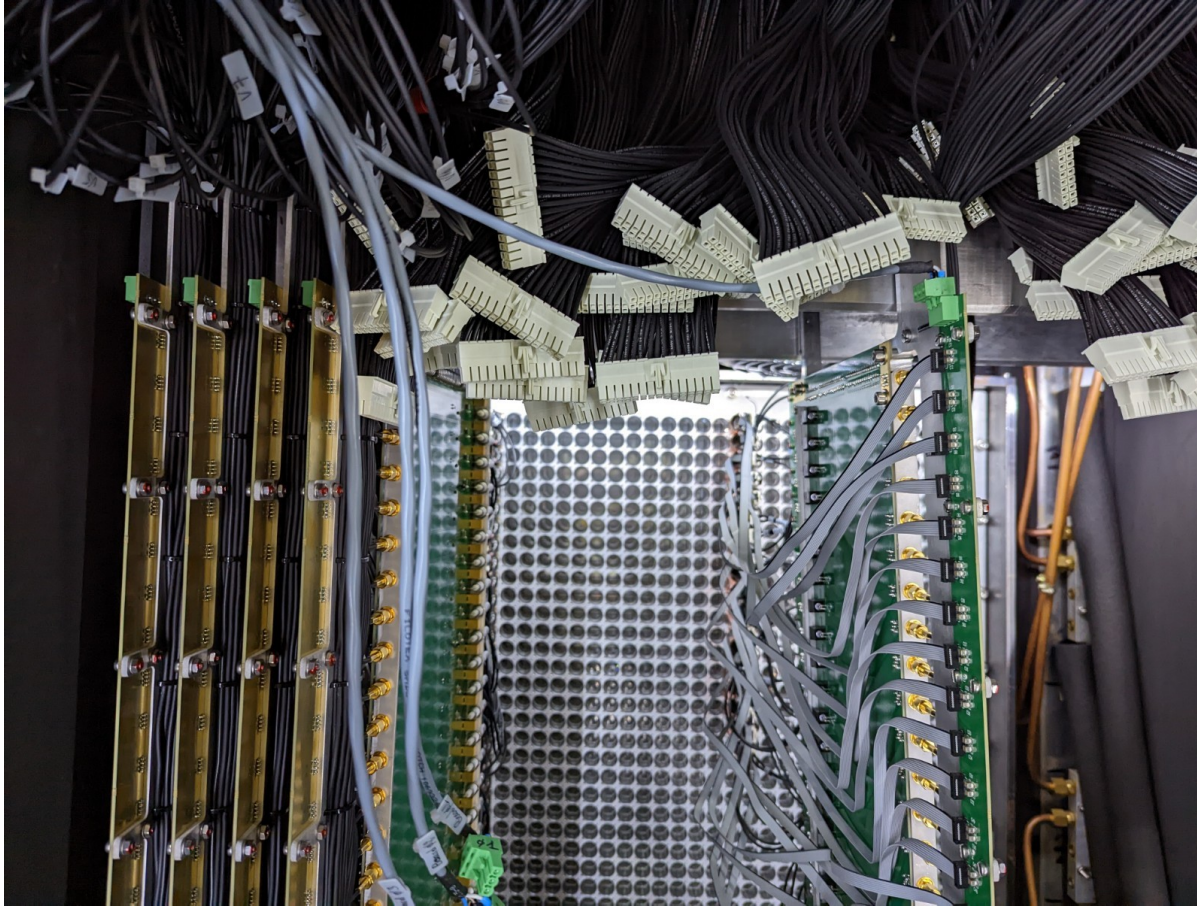
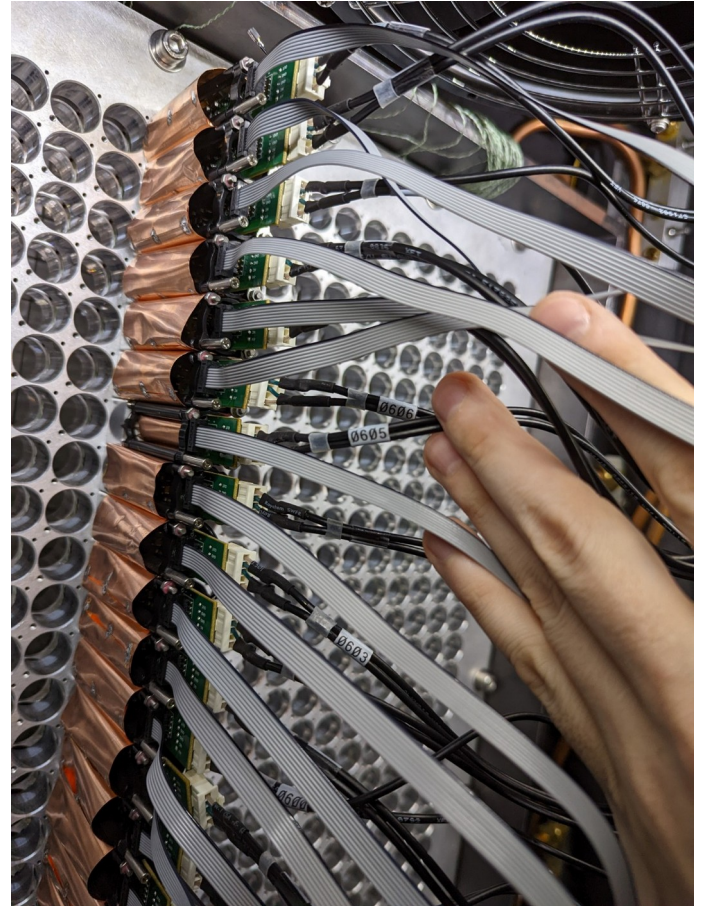
Inside the NPS (w/ 18 shielded PMTs)

- 18 shielded PMTs installed into new column in NPS
 - All PMT shields grounded through support post.
 - 7th PMT has ground shield inside the PMT holder
- Only low voltage applied
- (HV disconnected)

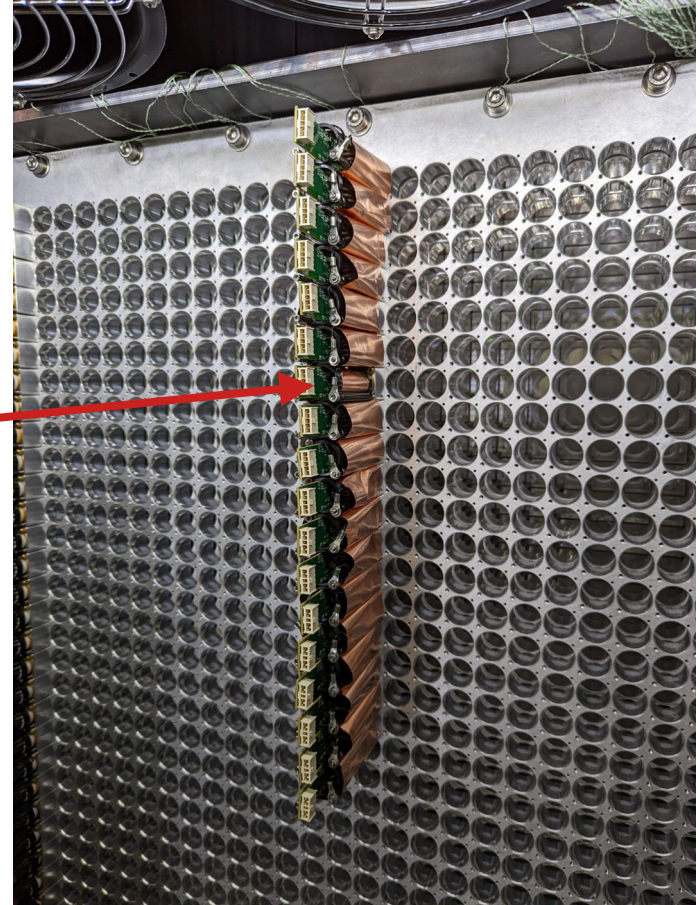
- PMT1 / Trace 1 (Top)
 - Same as PMT1 in previous test (Aug 21)
 - Shielding connected to base ground by direct connection to support rod using a crimp lug
- PMT2 (Trace 2)
 - 3rd PMT from top (arb. choice)
 - Same shielding config as above
- PMT3 (Trace 3)
 - 7th PMT from top
 - Shielding foil *inside* the PMT holder, grounded to same crimp lug as others
- Installation was challenging
 - There is zero 'extra' tolerance gap between copper shield material and adjacent PMT assemblies with 'external' shielding
 - See comments/opinions on last slide

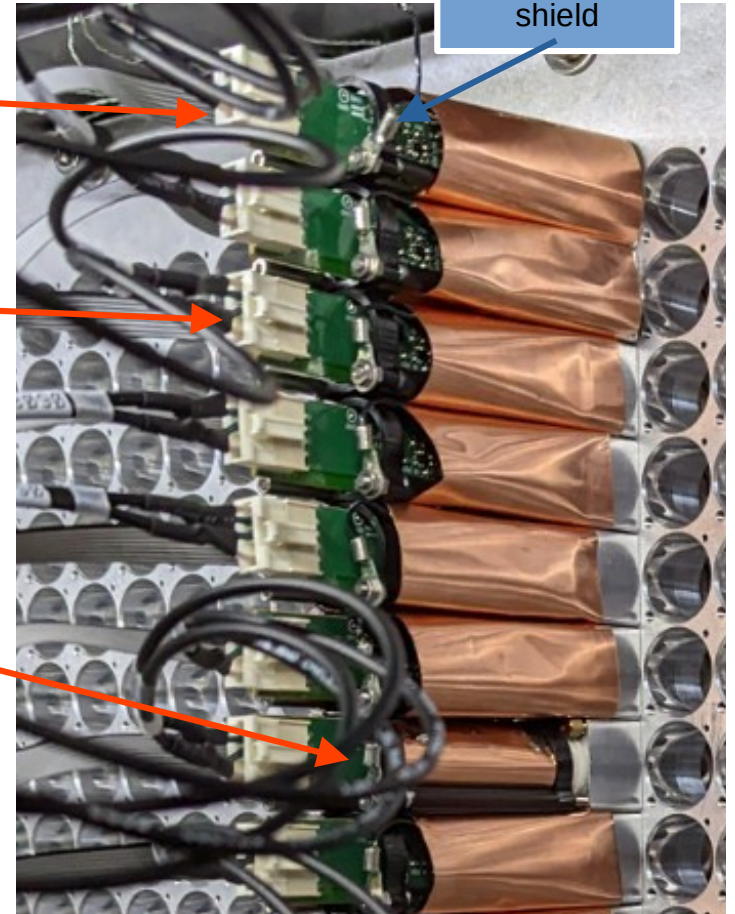
- PMT4 / Trace 4 / Bot
 - “Before” noise level as reference
 - 1st installed column of unshielded PMTs
 - PMT 12 (column 0)

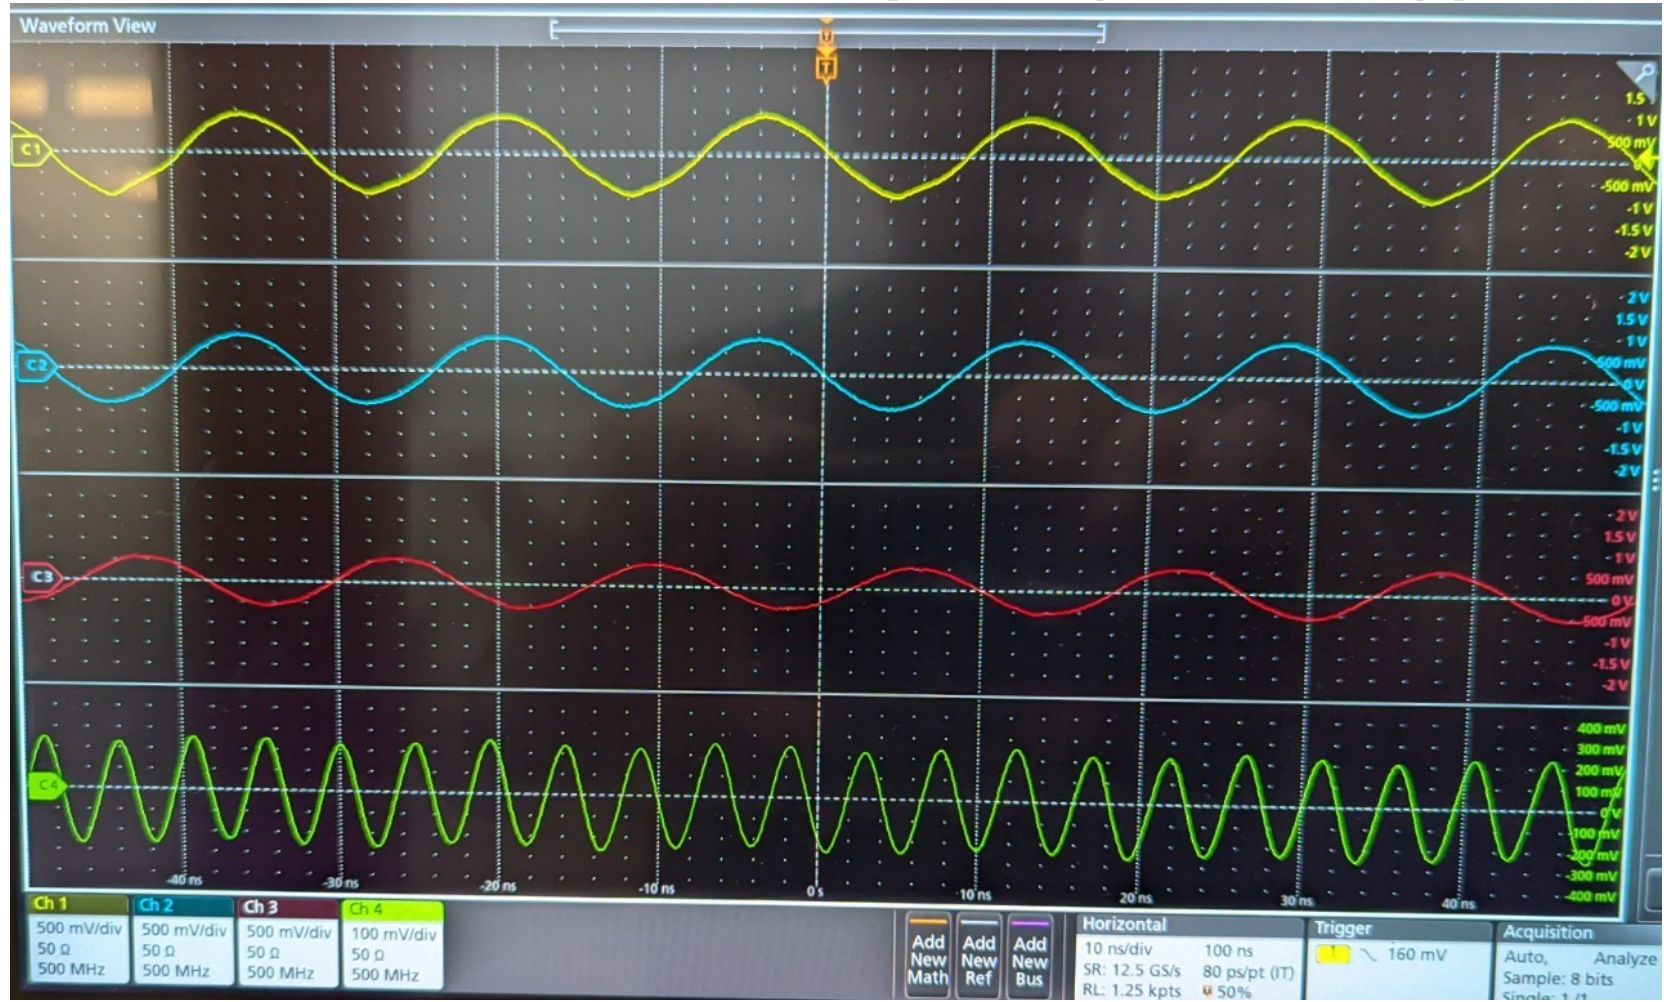
Characteristic Noise (Single Trig)

PMT1
(~2 V Pk to Pk)

PMT2
(~2 V Pk to Pk)

PMT3
(~1V Pk to Pk)

PMT4
(~500 mV Pk to Pk)

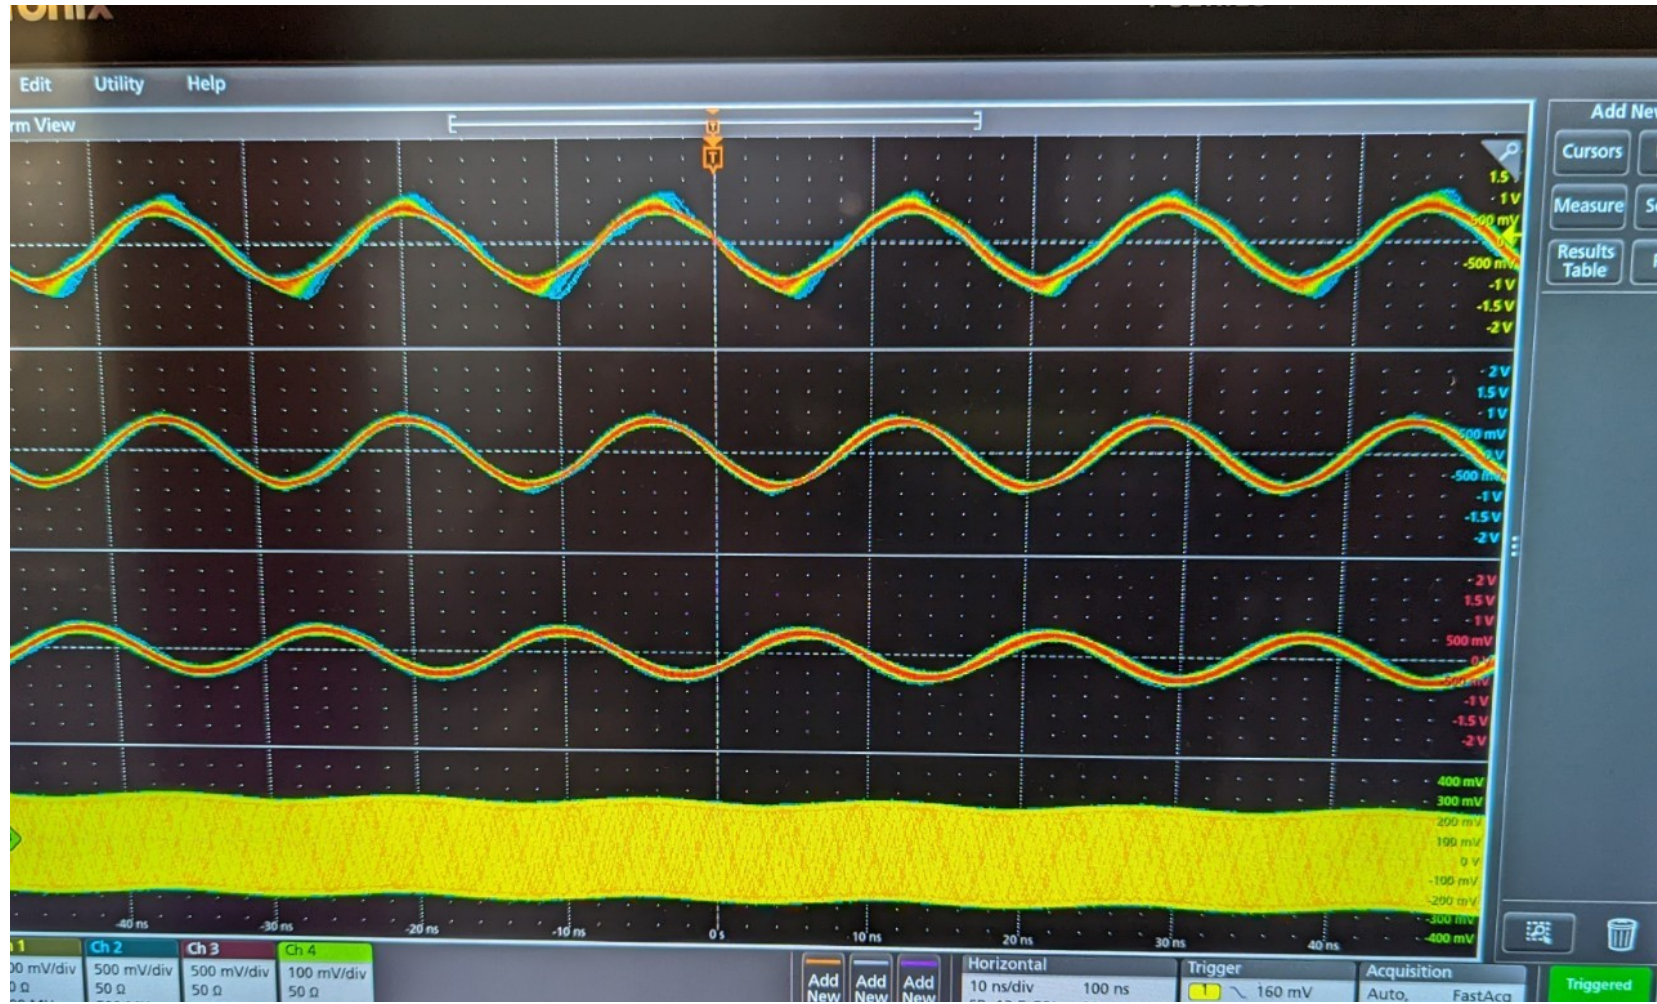
Characteristic Noise (Fast Acq. Mode)

PMT1
(~2 V Pk to Pk)

PMT2
(~2 V Pk to Pk)

PMT3
(~1V Pk to Pk)

PMT4
(~500 mV Pk to Pk)

- Noise returns when more PMTs powered up
- Characteristic noise frequency is different in shielded column, interesting...
 - Trace 1–3 in shielded column (~70 MHz)

- Trace 4 in original column (~200 MHz; as before)
 - Suggests noise is not simple antenna pickup, something in the circuit is ringing?
- Fast Acq. mode indicates triangular wave features
