CIS-ASY-R30-3
18" HV chamber with spherical electrode and CEBAF-type anode

ANODE assembly findings

Jan 31 2022
Carlos Hernández-Garcia

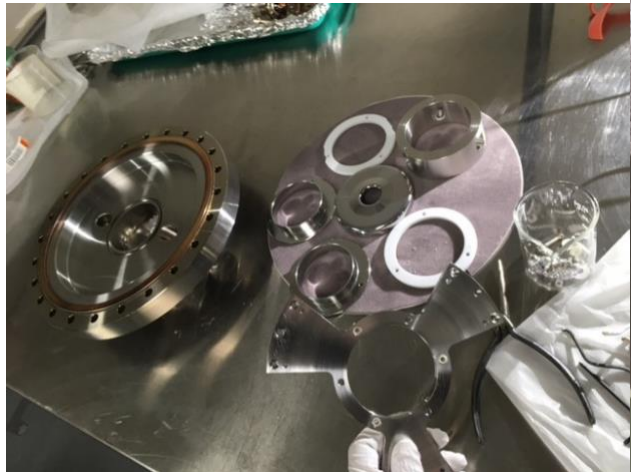
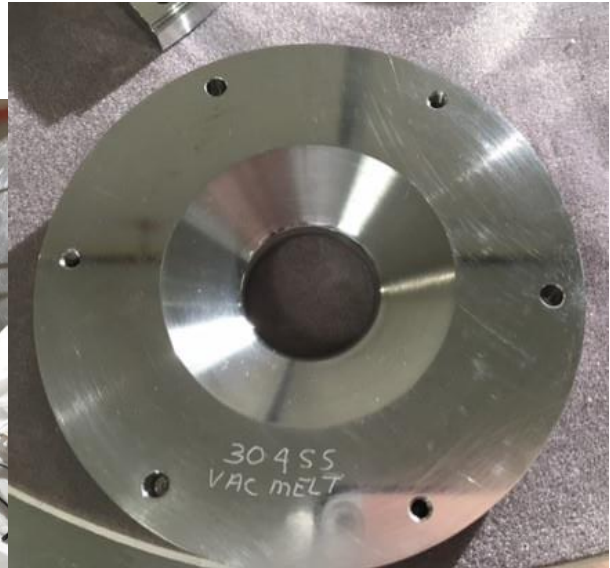
The anode assembly was measured using a Vernier caliper. Then it was taken apart and inspected, and every piece thickness was measured for checking against the measured total length.

This is the back end view of the assembly before it was taken apart. Notice there is a ceramic washer missing.

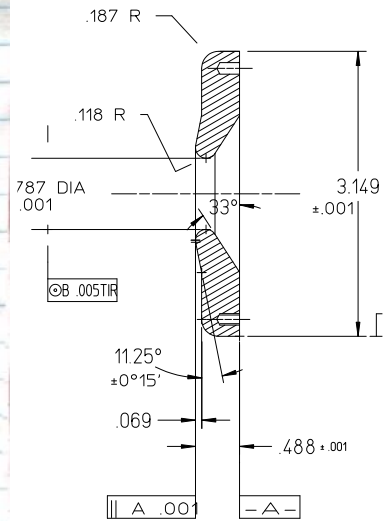
This anode has two ceramic rings that electrically isolate the anode from the tube, and the tube from the frame (spider?) at ground.

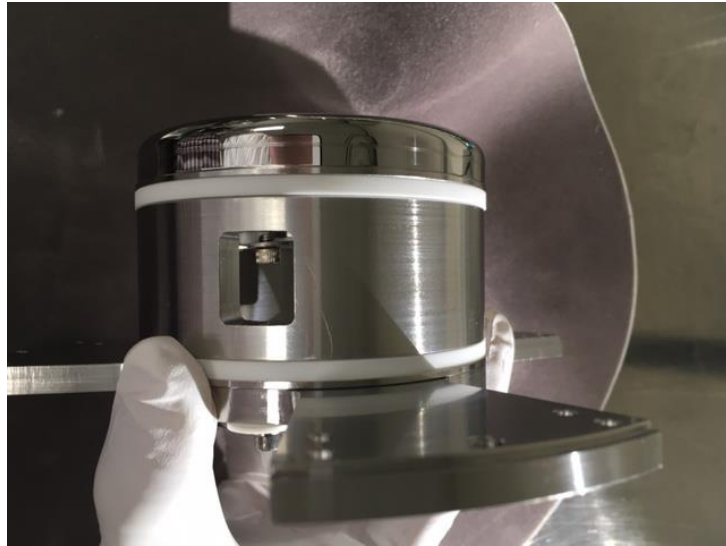
Each ceramic ring seems to be shielded from the beam line-of-sight by a thin SS short tube. One of the ceramic rings is chipped off. The other one is ok, but I do not know if there are spare ceramic rings. The ceramic bushing that isolates the screw from the anode came off in little pieces. Need to check for spares or order more.

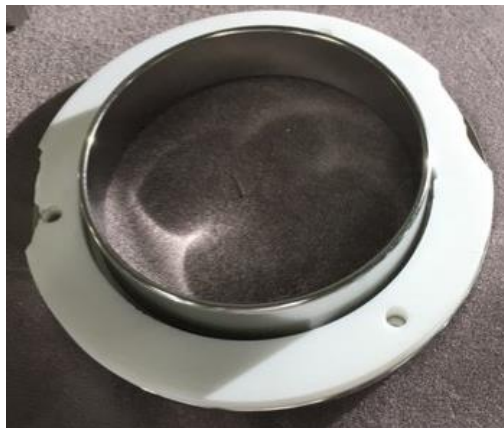
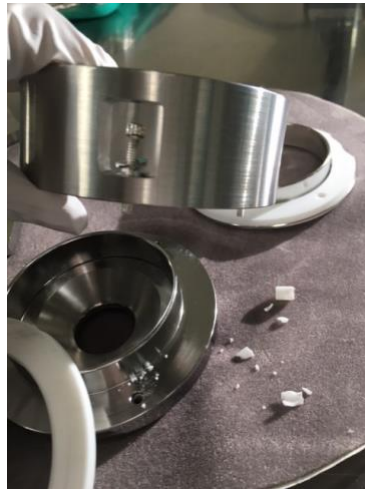
The existing screws are too long if the back ceramic ring is removed for grounding the tube.

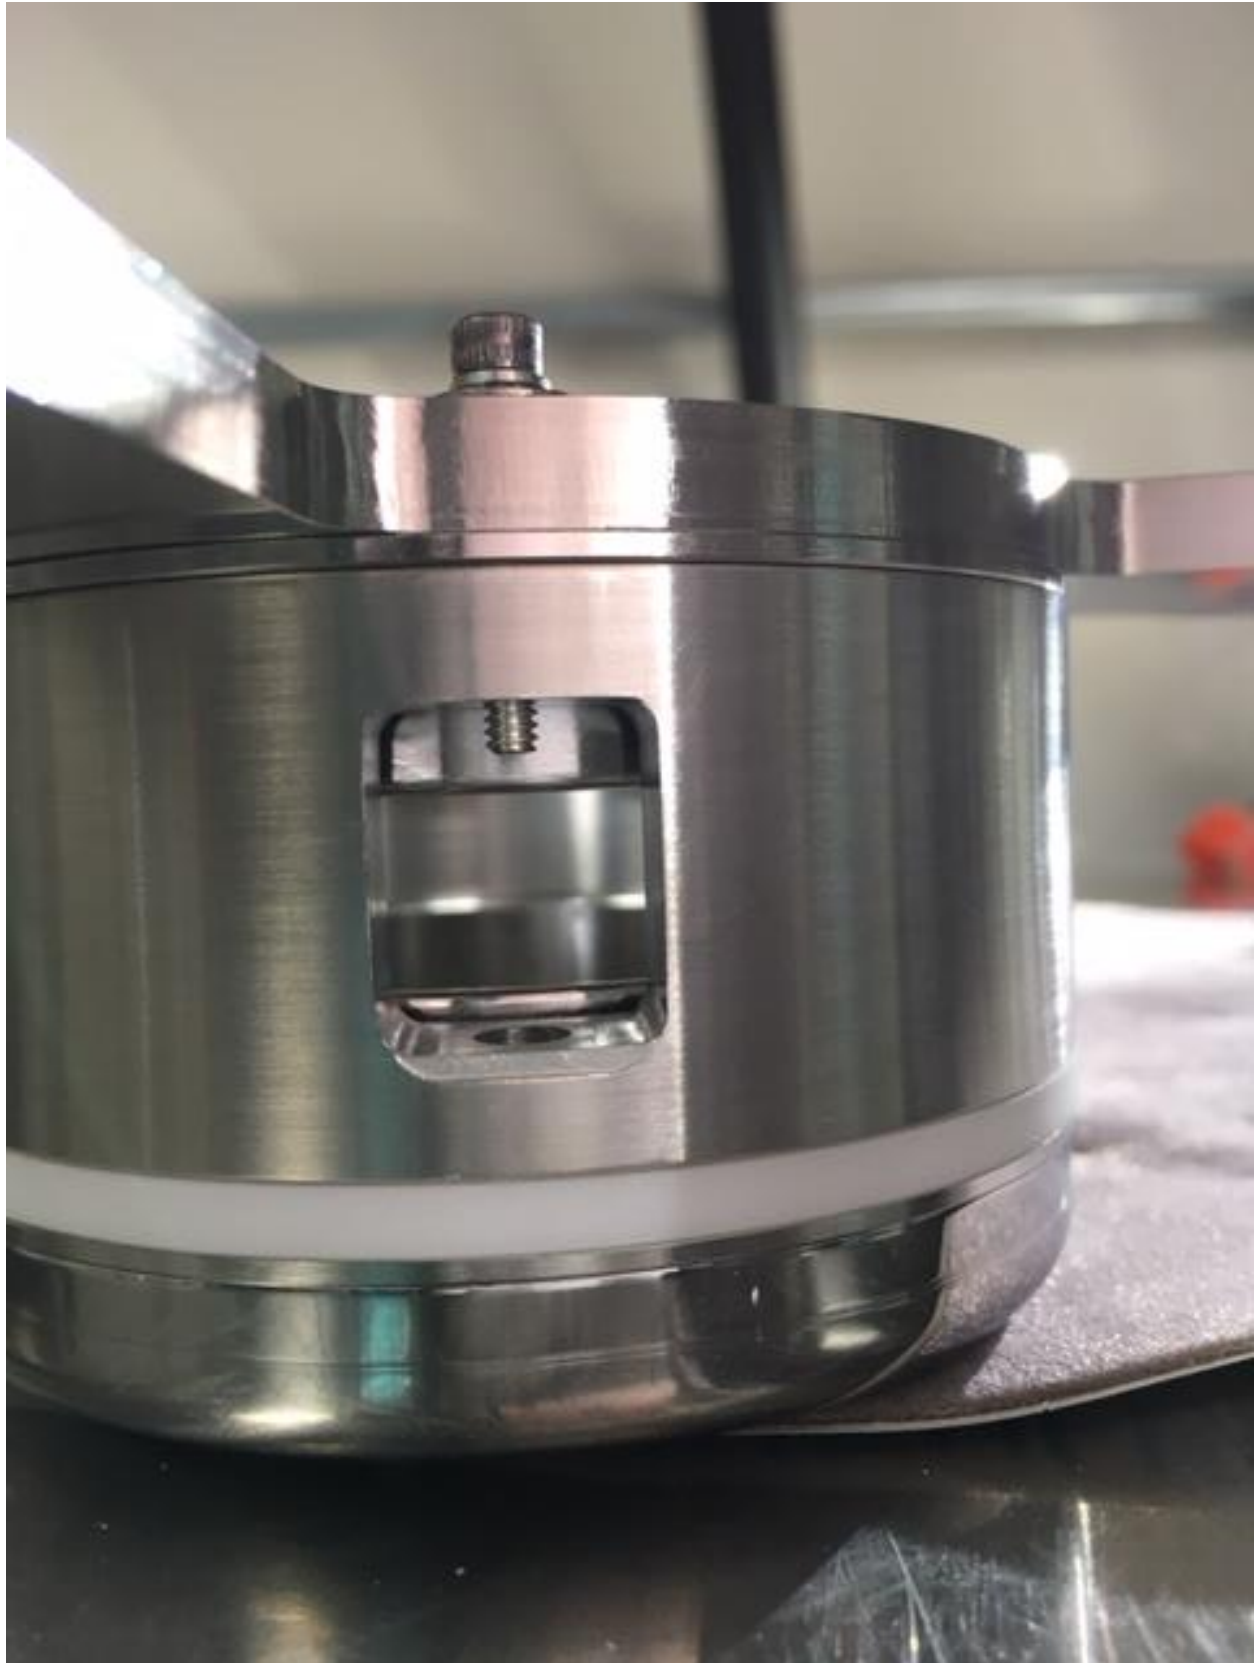
With the present anode tube 'apertures' is very difficult to insert the screw assembly to isolate the anode. A normal Allen wrench won't fit to tighten the bolt.

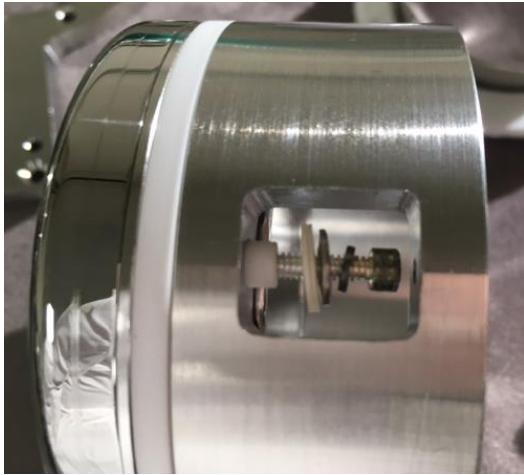
The 10" CF flange anode has two feedthroughs, one for the anode, and one for the anode tube.
