Idaho irradiation tests 17-20 February 2015

Introduction

To test the radiation hardness of the spring 2014 produced SIC PbWO₄ crystals and the efficiency of an LED-based curing system, 10 crystals were taken to Idaho Accelerator Center, where they were tested with beam on 18 Feb. and 20 Feb. Before the crystals were shipped from JLab to Idaho the following preparation procedures were carried out.

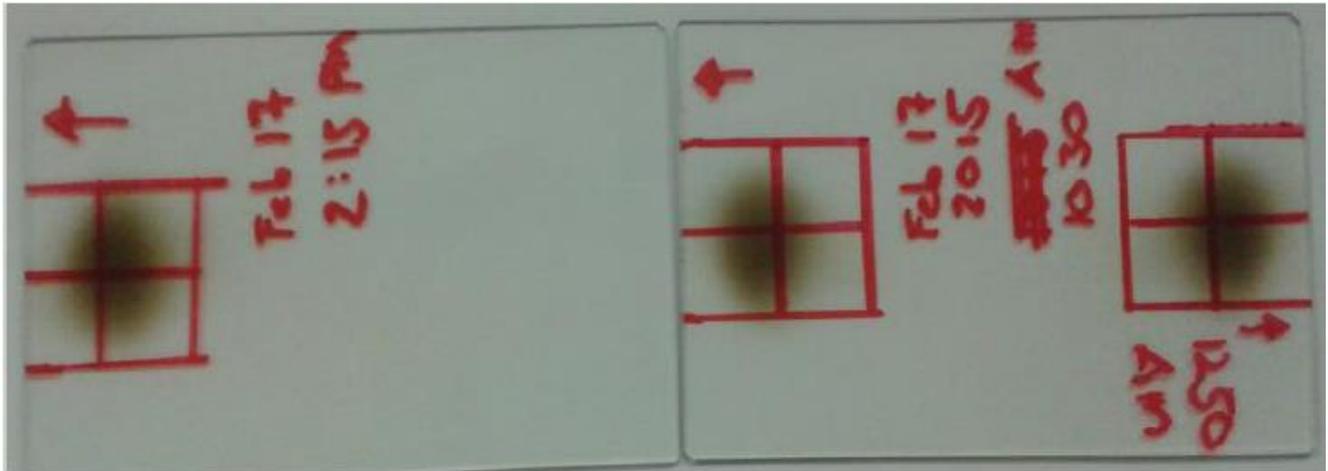
Fig.1: Examples of glass used to position the crystal (block) relative to the beam and estimate the beam distribution.

The Idaho Accelerator Center provides a 20 MeV electron beam with 100 Hz repetition rate, with $I_{\text{peak}}=111$ mA (per pulse) and 100 ns pulse width. The beam is roughly 1mm in diameter and exits through (1/1000)-in thick Ti window, a $x/X_0 = 7.1 \cdot 10^{-4}$ radiation length. Beam position and profile are measured by shooting a glass plate, some examples of which are shown in Fig. 1. Scanning the plates and fitting the intensity distribution provides a quantitative (though approximate) measurement of the position and size of the beam at the location of the plate.

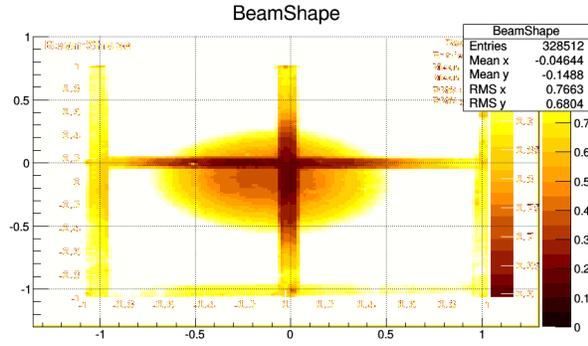
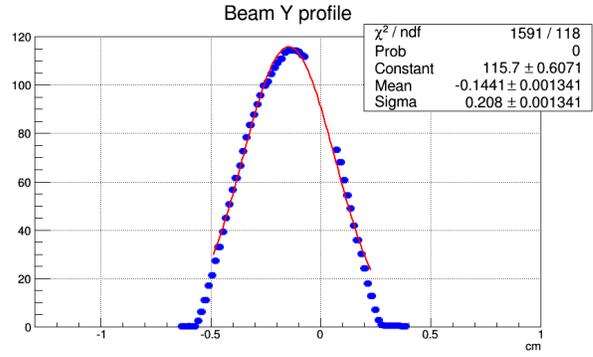
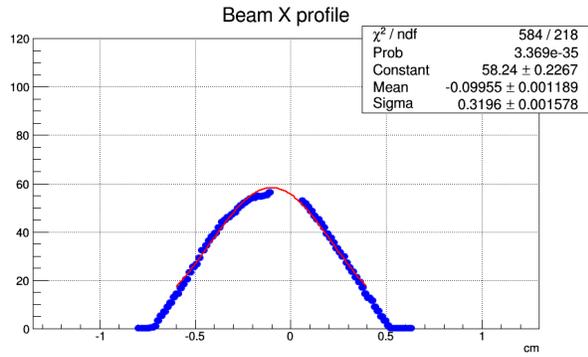
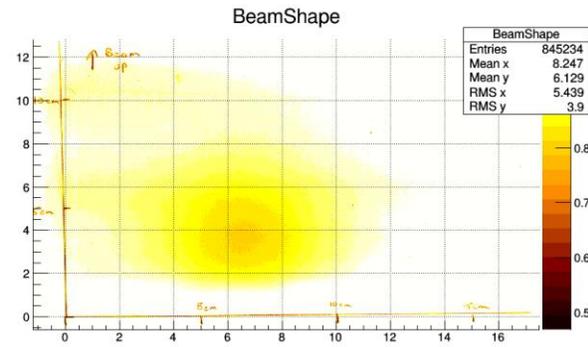
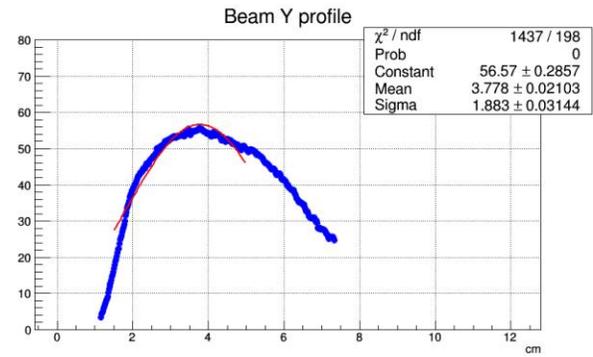
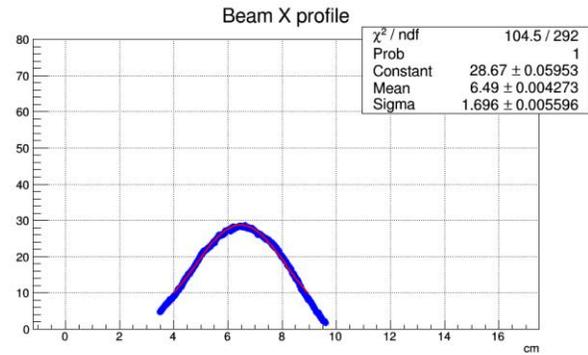
Fig. 2 documents the beam position and profile as measured during our first day (Feb 17). The front plate was placed at the position of the PbWO₄ crystal (block) front faces during irradiation that is 10.75 cm from the beam exit window. The rear plate was located at 51.15 cm from the beam exit, and shows the beam profile expansion. The beam profile at the entrance of the PbWO₄ crystals has an approximate size of 0.2-0.3 cm (sigma). This is much smaller than the transverse size of the PbWO₄ crystals, so the distance of the PbWO₄ crystals was increased the second irradiation day to 33 cm from the exit window (see below). This provides a more homogeneous irradiation and heat load on the crystals.

Fig.2: Beam profile during Feb-17's runs reconstructed from 2 plates. The front plate (top three panels) was placed at 10.75 cm from the beam exit, the rear (bottom three panels) plate at 51.15 cm. The beam profile is small at the front face of blocks (0.2-0.3 cm).

This is, however, smaller than the actual size observed at the glass plates due to the intrinsic size of the beam at the exit window.

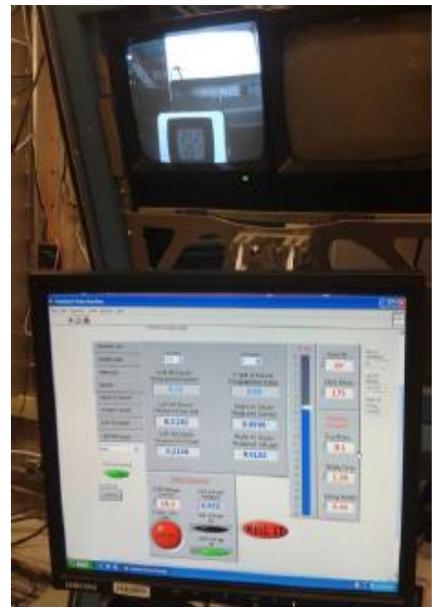
Fig.3: Idaho Accelerator operation room (left) and its main parameter LabVIEW control system (right).

or 216 krad/min. Since such radiation dose rate is too high (~13 Mrad/h), we decided to start our tests at ~1000 times lower dose rates (~13 krad/h). To achieve this dose rates, we requested to reduce the accelerator repetition rate to 0.1 Hz, but kept beam current per pulse and pulse width unchanged (111 mA and 100 ns).

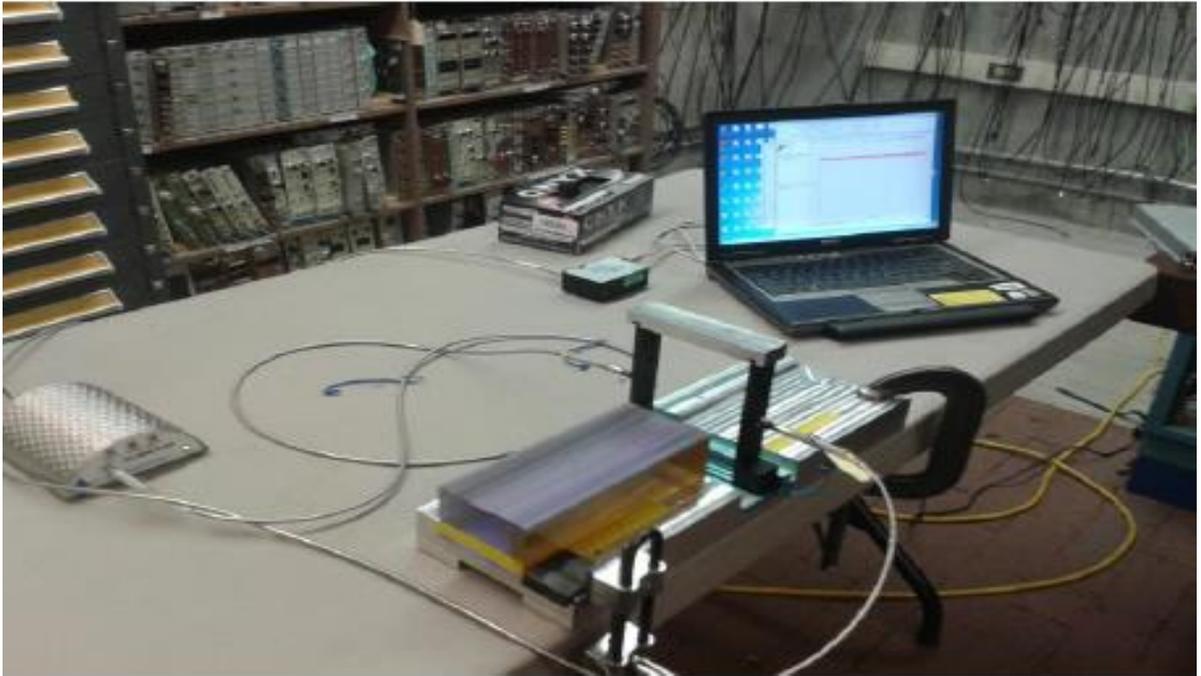
- Before irradiation, the crystals' transmission was measured in Idaho using the same setup as the one used prior to shipping the crystals from JLab. This setup is shown in Fig.4.

Fig.4: Setup used for crystals transmission measurements at JLab and Idaho.

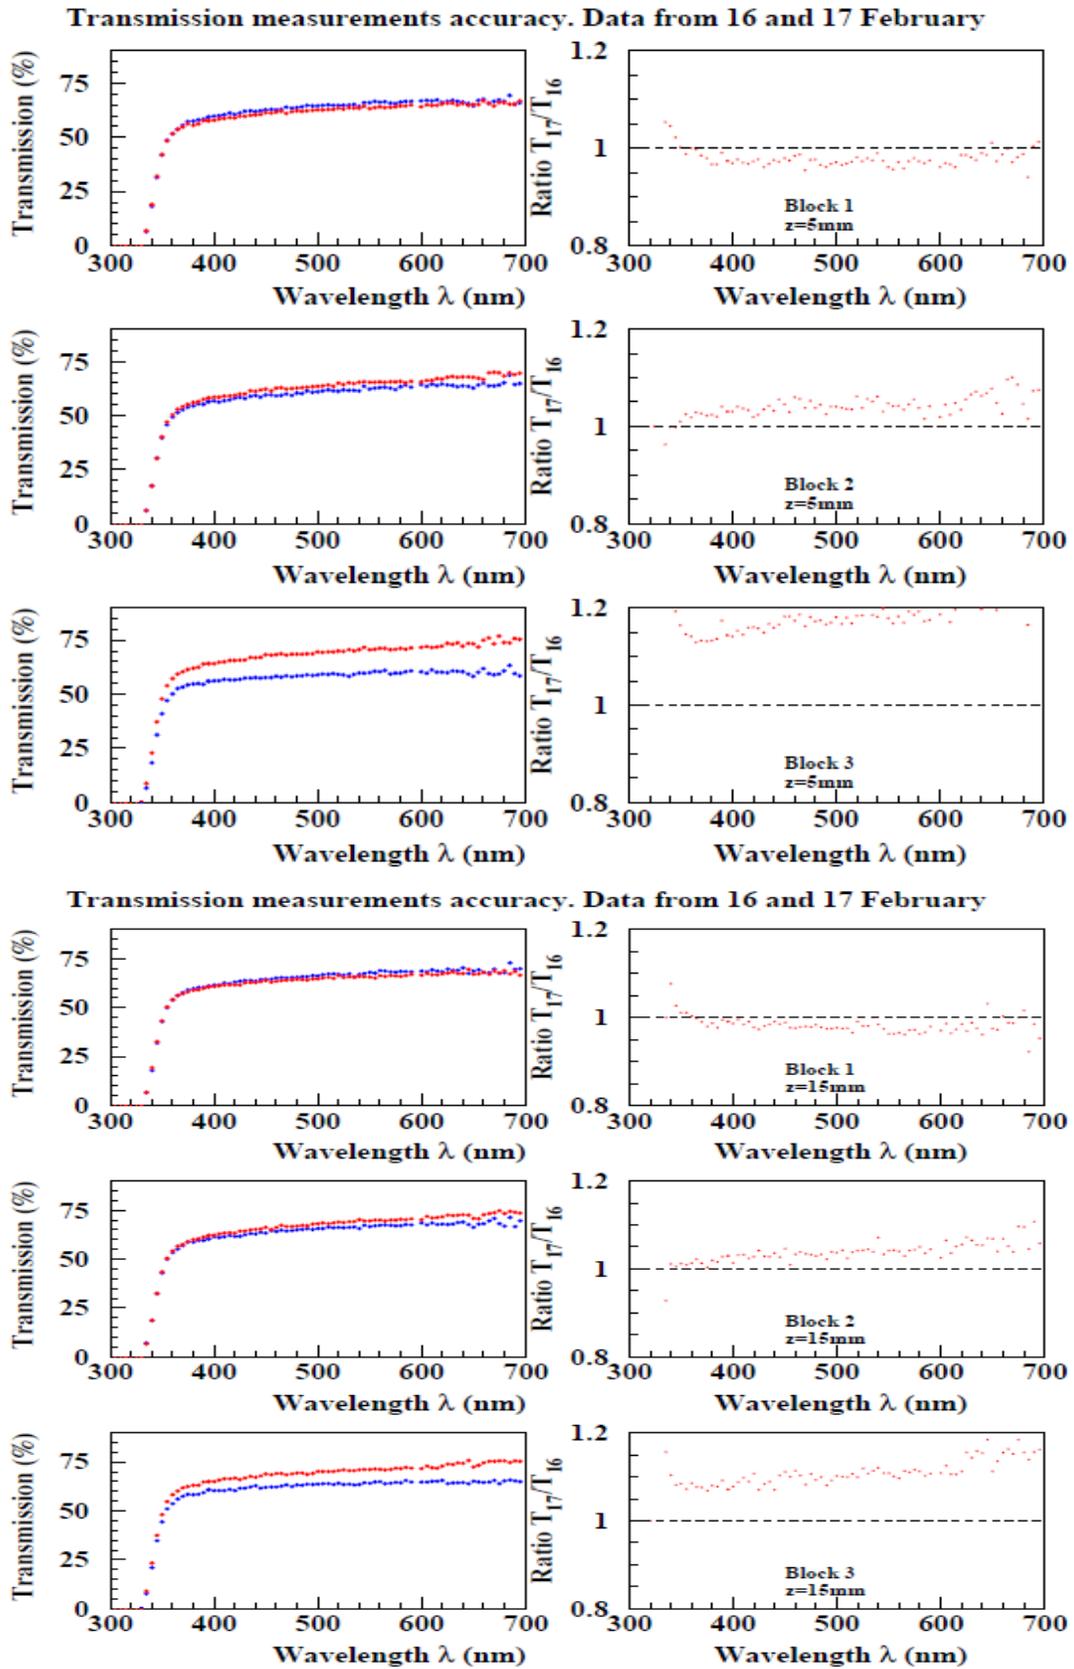
- We found systematic differences between JLab and Idaho measurements. We found that the accuracy strongly depends on positioning of the crystal relative to the fibers and on the relative adjustment of the fibers.
- Fig. 5 shows the transmittance for crystals #1-3 measured on 16 and 17 February (in Idaho) and their ratios. Comparison of these measurements gives a qualitative number on the accuracy of the transmission measurements performed before irradiation of the blocks. The systematic difference between these two measurements on average ranges between ~5% and ~15%.

Fig.5: Transmission for blocks #1-3 measured before irradiation on 16 and 17 February and their ratios. (Top panel for the position $z=5\text{mm}$, and bottom for $z=15\text{mm}$).

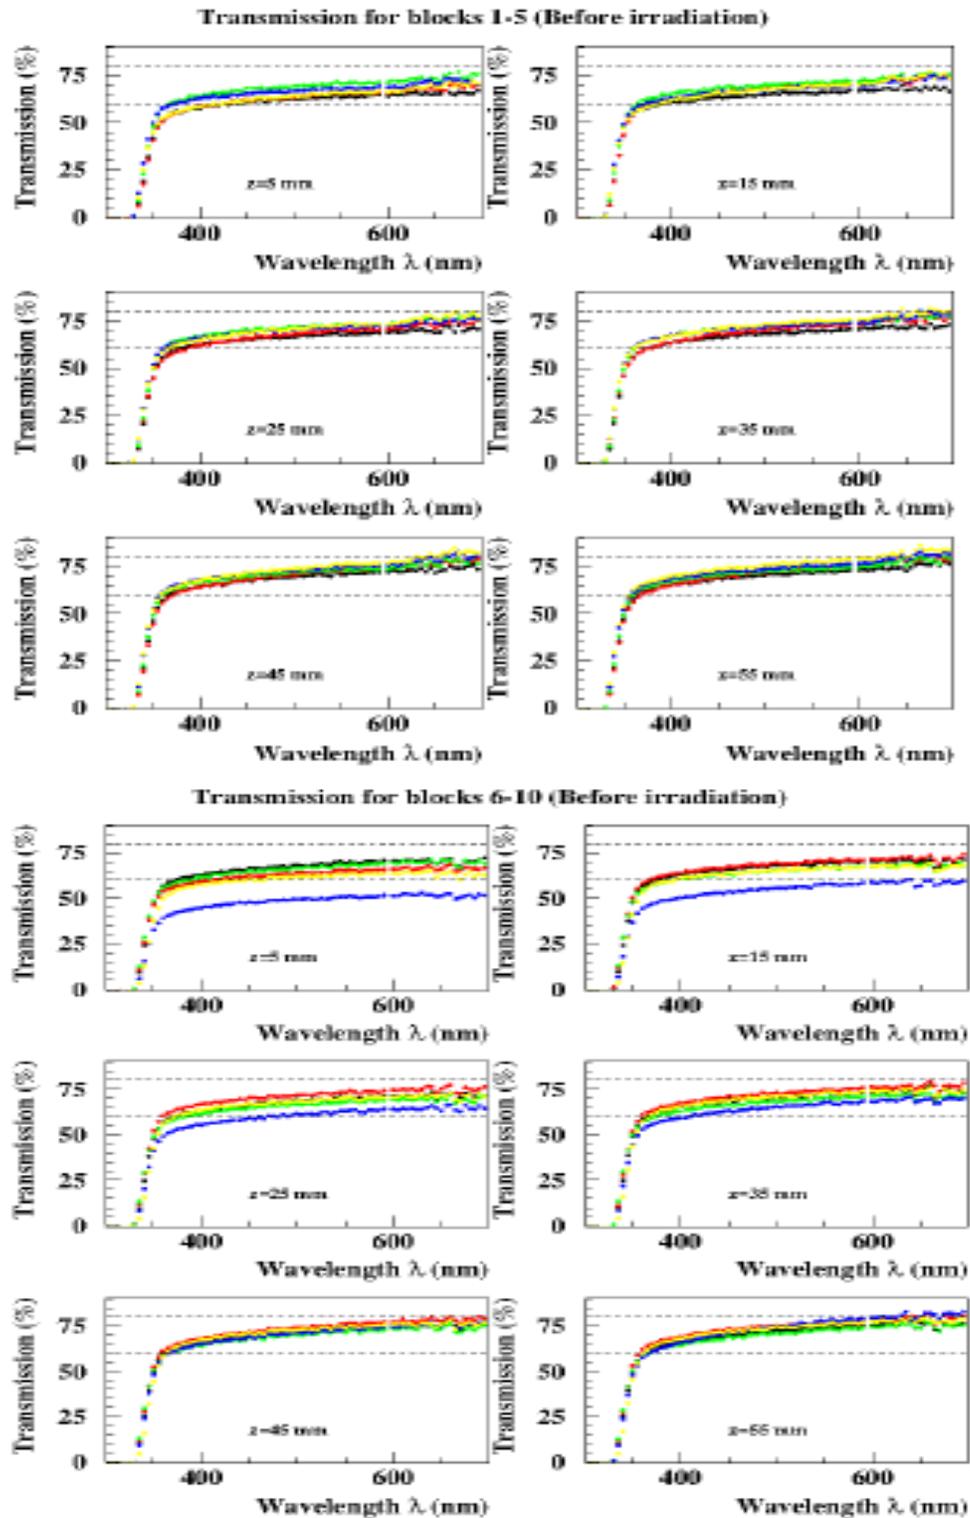
- Nevertheless, when we carefully adjusted the setup, the reproducibility of the measurements was $\sim\pm 5\%$. Transmissions for all 10 crystals before irradiation are shown in Fig.6.

Fig.6: Transmission of PbWO_4 in the transverse direction at different distances from the front of crystals measured in Idaho before irradiation. Data for different crystals are plotted in colors. Blue indicates crystal #9 – the crystal with the worst transmittance of this batch.

- All PbWO₄ crystals were thermally annealed at 200 C° following the procedure that we used earlier: ~10 hour ramp up, ~ 10 hour anneal, and ~10 hour ramp down.
- All crystals' transmission was measured in the transverse direction at 5, 15, 25, 35, 45 and 55 mm from their front face.
 - Data show the uniformity for all crystals along their length, but with noticeable spread from crystal to crystal. The worst quality we found was crystal #9.

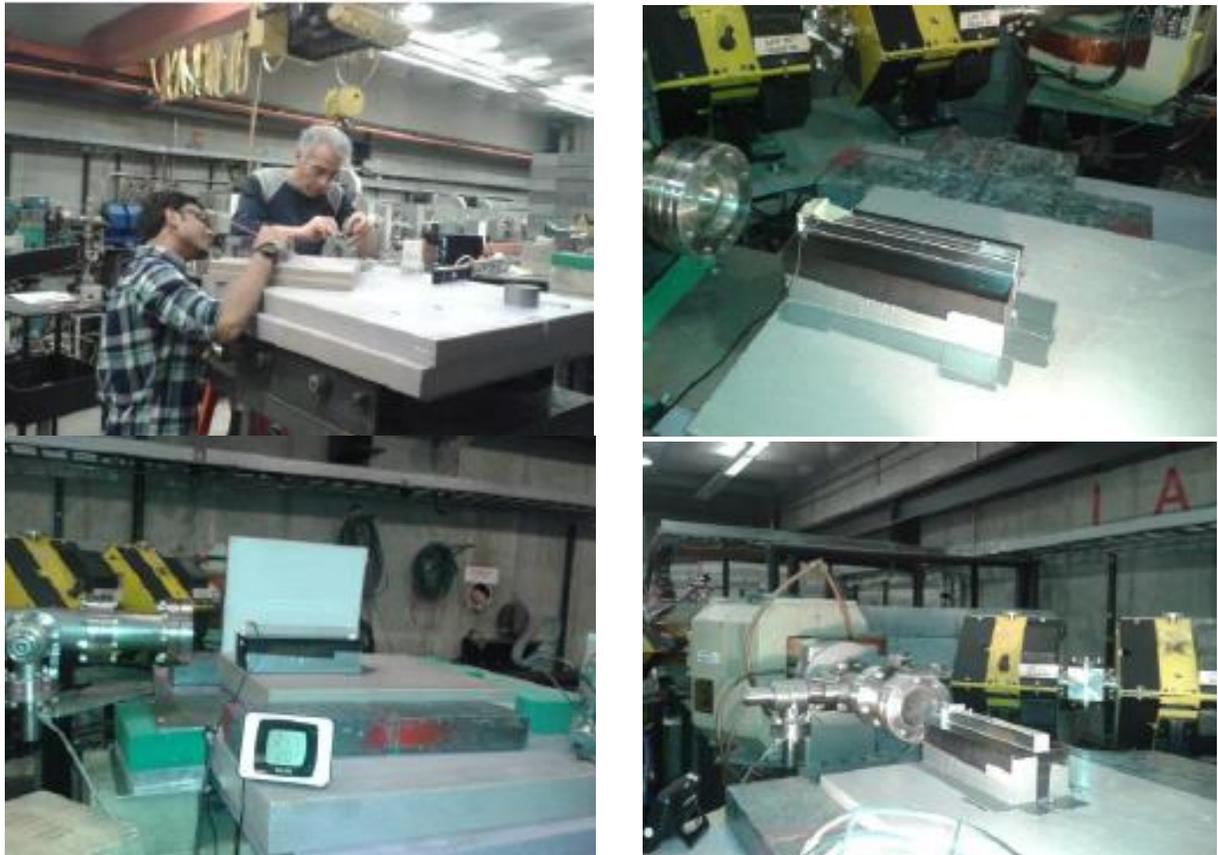
- We installed an adjustable table as close to the beam pipe as possible and positioned the crystal support at 10.75 cm from the beam exit window.

Fig.7: Details of the installation and positioning of the crystal relative to the beam.

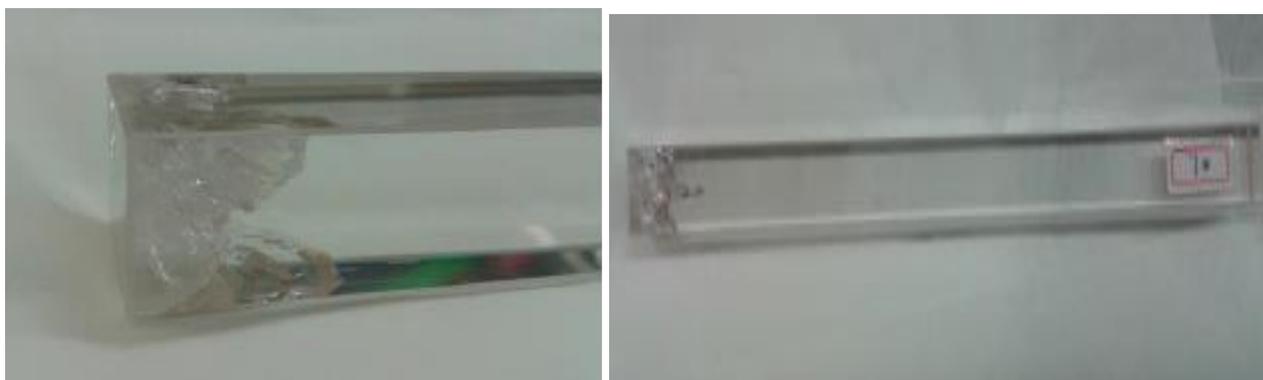
- Then we increased beam rate to 100 Hz keeping the beam current and width unchanged (111 mA per pulse and 100 ns). Temperature of the crystal near frontal area increased from $\sim 25^\circ\text{C}$ to $\sim 42^\circ\text{C}$ in less than 10min, and crystal cracked sooner than we stopped beam (see figure Fig.8 below).

Fig.8: Block #1 damage due to irradiation at dose rate ~ 13 Mrad/h. Rapid and not uniform rise temperature cracked the crystal sooner than we could stop the beam.

- After such a fiasco (crystal #1 cracked) we decided not to exceed the dose rate of 1.3 Mrad/h, and test all other 9 crystals at this dose rate, but doubling the exposure time (from 10min to 20 min) and keeping our eyes on the thermometer during the run.
- Crystals #2-10 were irradiated at a dose rate of 1.3 Mrad/h for 20 min. On average, the temperature near the frontal area of the crystals during exposure increased from 74-77°F (at start) to 97-98°F (at the end). Beam parameters and conditions of irradiation are listed in Table I.

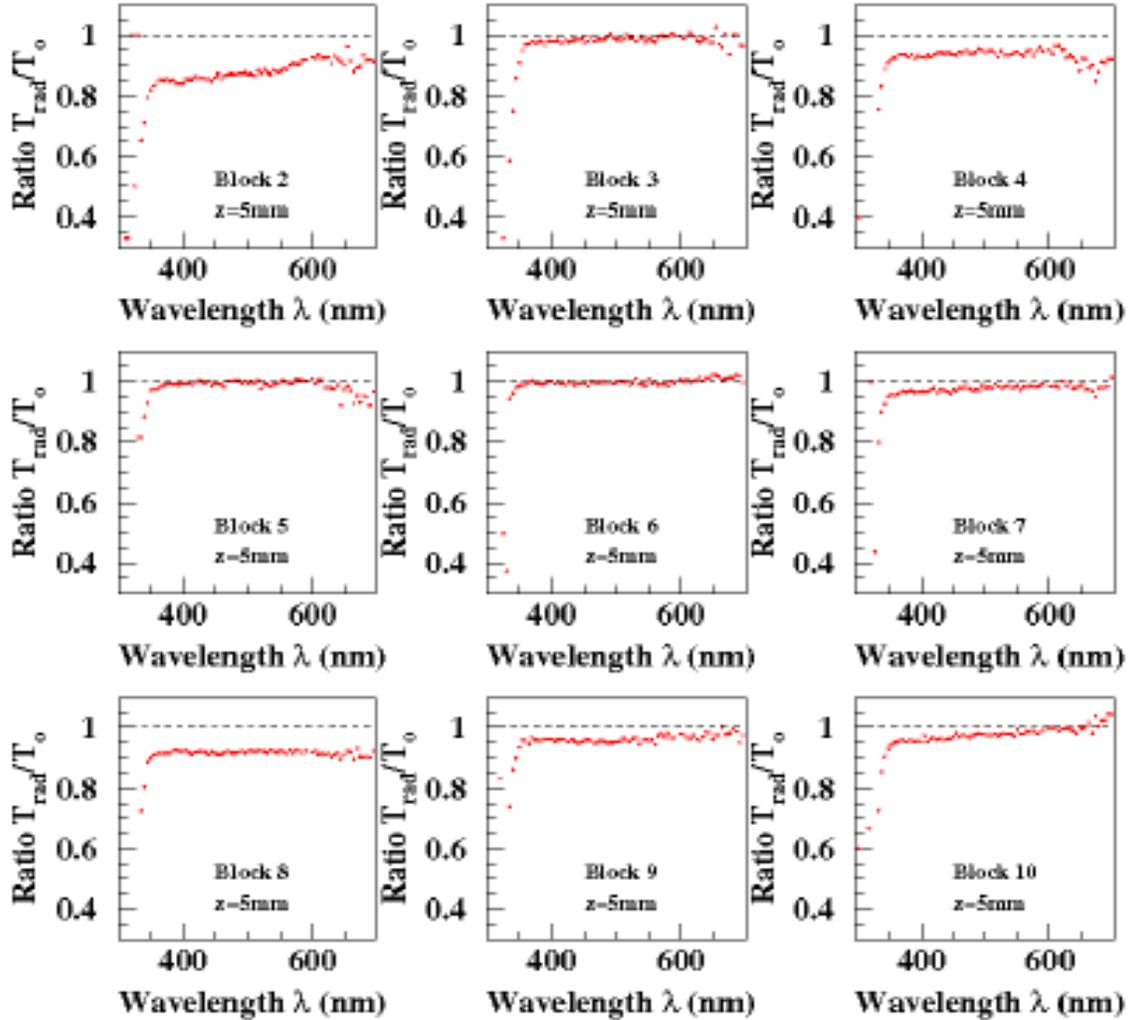
Transmission PbWO_4 blocks after 432 krad irradiation at dose rates 1.3 Mrad/h

- Transmission some of blocks changed more than 15% after an accumulated dose of 432 krad (at a dose rate of 1.3 Mrad/h). Some of blocks can handle this dose without noticeable damage.

Fig.9: Transmission degradation of the PbWO_4 blocks after 432 krad accumulated dose at dose rates of 1.3 Mrad/h. Ratio of transmissions after and before irradiation reflects the level of crystal degradation. For example, crystal #6 shown in the center panel was not damaged significantly.

- Degradation of transmissions for positions far from the front of crystals decreases with the distance and are comparable to the accuracy of our measurements.

- Since beam time was limited on Feb 20, we selected pair of crystals: #2 and #3, and #6 and #8. One crystal from each pair (#3 and #6) did not show noticeable damage after 432 krad dose received on 17 February, while the second (#2 and #8) was damaged about 10-15% (see Fig.9).
- Before the start of the irradiation tests we did transmission measurements of these crystals. The goal was to estimate the level of their spontaneous recovery after 60 hours of receiving a 432 krad dose (on Feb 17) and to determine the starting condition of the crystals.
- As we expected, the transmission of some of the crystals improved within 2 days due to spontaneous recovery. Fig.12 shows the ratios of transmission for crystals 2, 3, 6, 8 and 10 measured after 60 hours of receiving a dose of 432 krad and before being irradiated again.

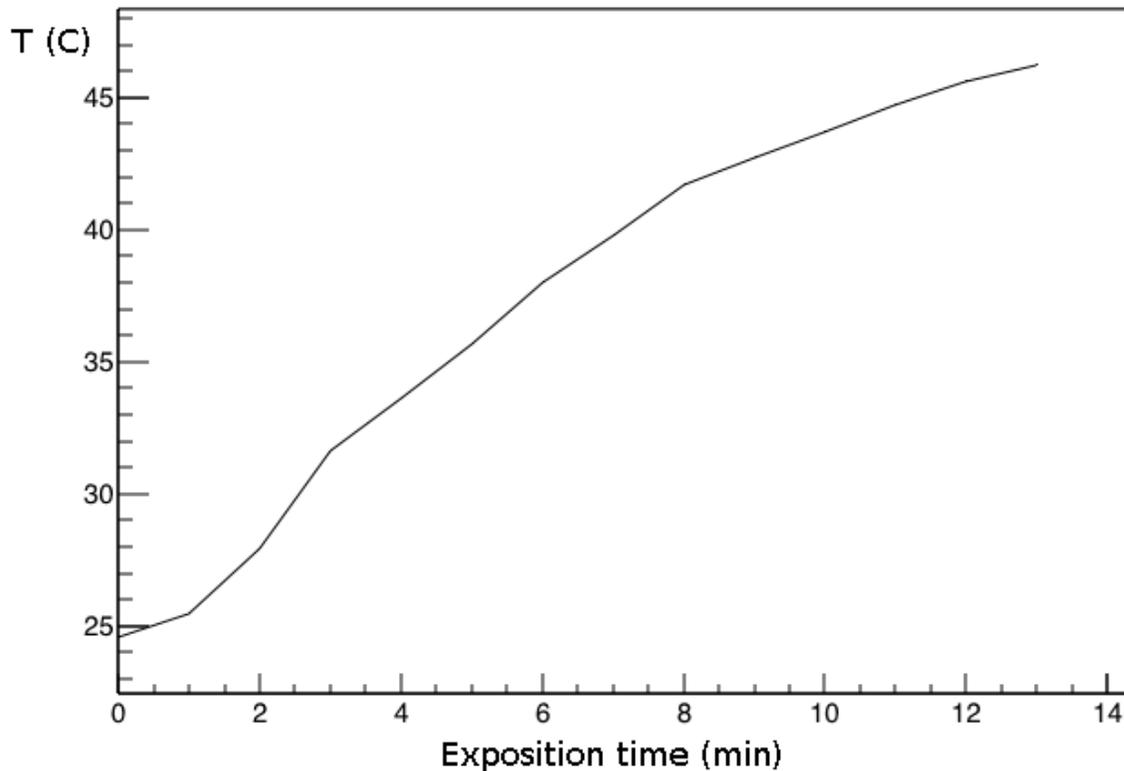
Temperature Gradient for ~2.6 Mrad/h on block #01

- Since this study was potentially dangerous for crystals, we first tested the damaged crystal #1. We used the other end of crystal #1, set two thermometers on top of the crystal, one on the front face area, the second on the middle of the crystal. The plan was to expose the crystal for 20 min at a dose rate of ~ 2.6 Mrad and follow the rise of temperature. After 13 min exposure at dose rates of 2.6 Mrad/h, the temperature of crystal #1 increased from 76.3 °F to 115.2 °F and crystal cracked.

Fig.10: Temperature increase for the block #1 during irradiation at dose rate of ~2.6 Mrad/h. Crystal cracked after ~13 min, when the temperature near the frontal area ramped up from 25 °C to 48 °C.

- This test made it clear that we could not go to higher dose rates, but we could potentially increase the exposure time.
- To reach higher level of accumulated dose we exposed each crystal several times with a 20-30 min pause. (For example, expose crystal #2 for 20 min at a dose rate of 1.3 Mrad/h, then take out crystal #2 and expose crystals #3 and #4 each for 20 min. While we expose crystals #3 and #4, the temperature of crystal #2 will decrease and the block would be ready for the 2nd exposure).

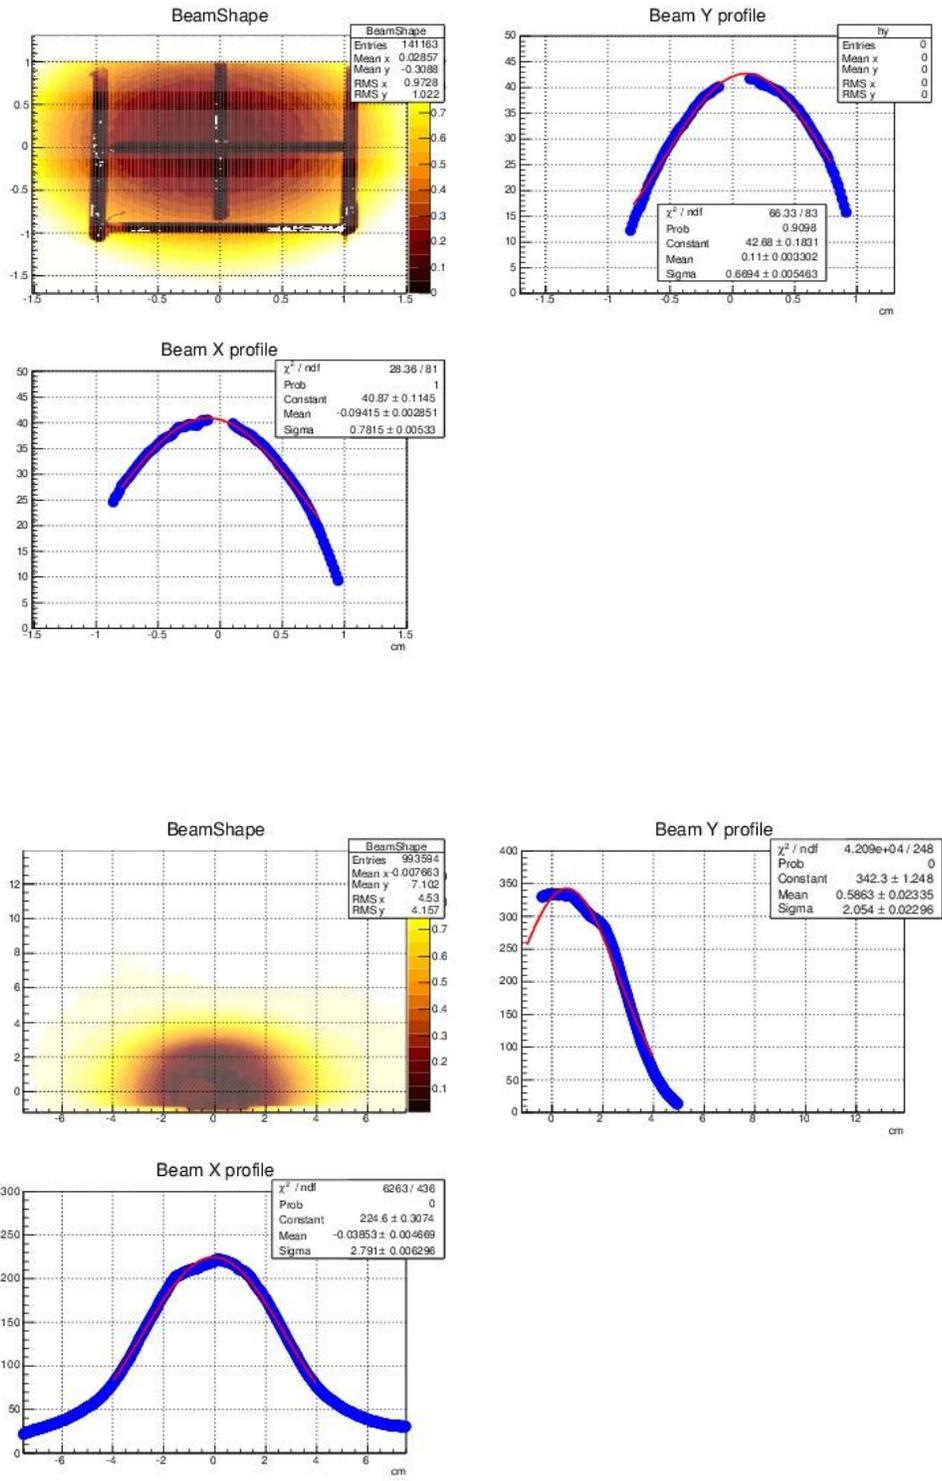
- Since after 17 February tests we found that the beam profile was too small (σ_x and $\sigma_y \sim 2-3$ mm), we decided to place the blocks further (~33 cm) to get a more homogeneous irradiation (and heat load) on the crystal.
- Beam profile was measured by two plates located on front and back of the crystal. The front plate at 33cm from the beam exit ($\sigma_x \sim 0.8$ cm, $\sigma_y \sim 0.7$ cm). The rear plate at 53 cm from the beam exit window ($\sigma_x \sim 2.8$ cm, $\sigma_y \sim 2.1$ cm).
- Beam profiles as measured on Feb-20's tests are shown in Fig.11.

Fig.11: Front (top) and rear (bottom) profile of the beam at the beginning of Feb-20's tests. Front plate was located at 33cm from the beam exit ($\sigma_x \sim 0.8$ cm, $\sigma_y \sim 0.7$ cm), the rear plate at 53 cm from the beam exit window ($\sigma_x \sim 2.8$ cm and $\sigma_y \sim 2.1$ cm).

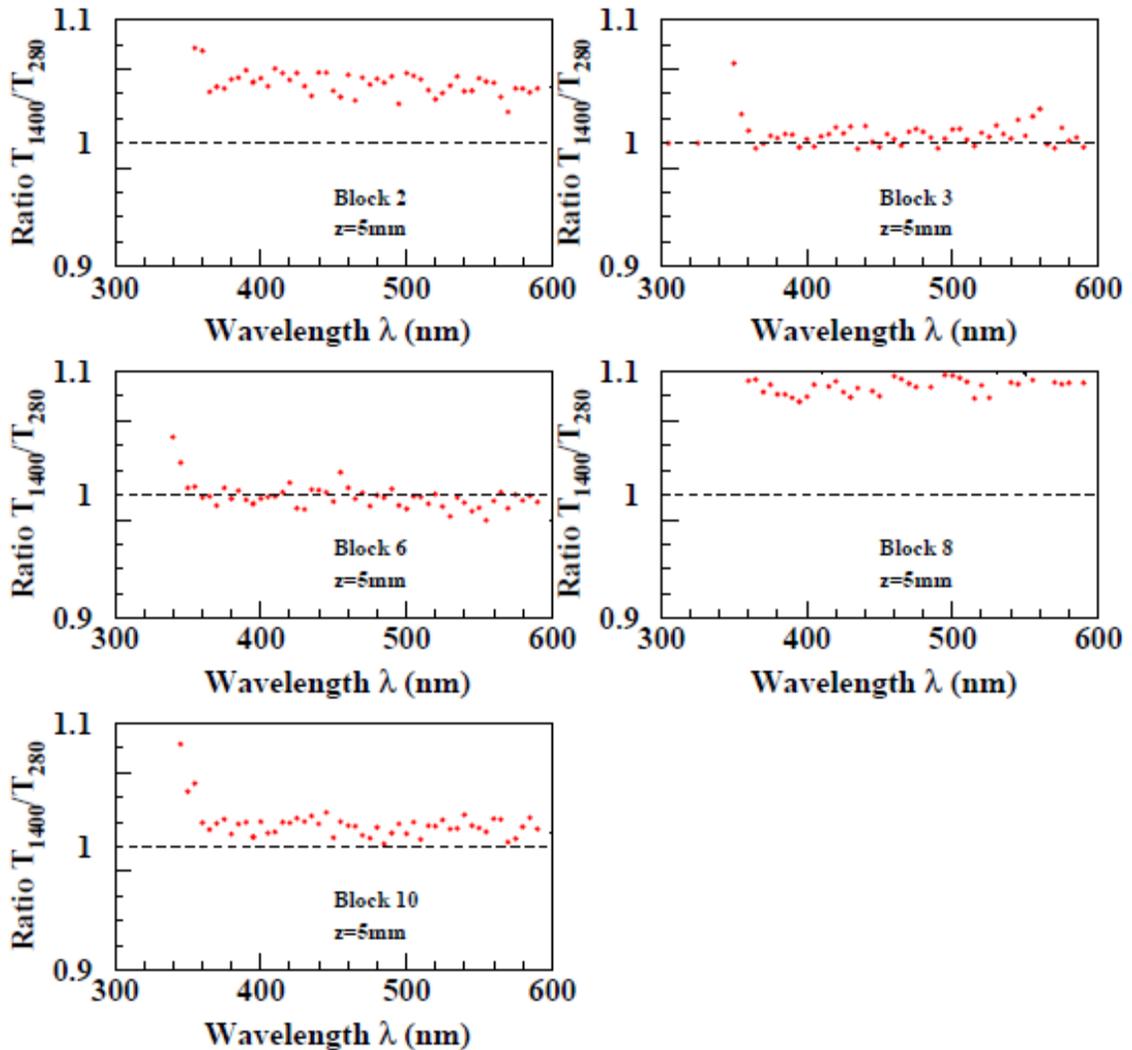
Spontaneous recovery PbWO_4 after 60 hrs. Total dose 432 krad, rate 1.3 Mrad/h

Fig.12: Spontaneous recovery of crystals from a 432 krad dose damage, 60 hours after irradiation.

- No noticeable damage to the crystals was observed after irradiation, up to an accumulated dose of ~2 Mrad at a dose rate of 1.3 Mrad/h.
- Some of the crystals show ~10-15% damage after a 432 krad dose, which partly spontaneously recovered after 60 hours.
- Prior to irradiation with a dose rate of 1.3 Mrad/h, the temperature in the frontal area of the crystals ramped up at a rate of ~0.5 °C/min. A rise in temperature in the frontal area of more than ~12-15 °C may crack the crystal due its bad thermo-conductivity.
- After an accumulated dose of ~2.1 Mrad, the crystal frontal area shows a 55-60 mkrad γ -activity.

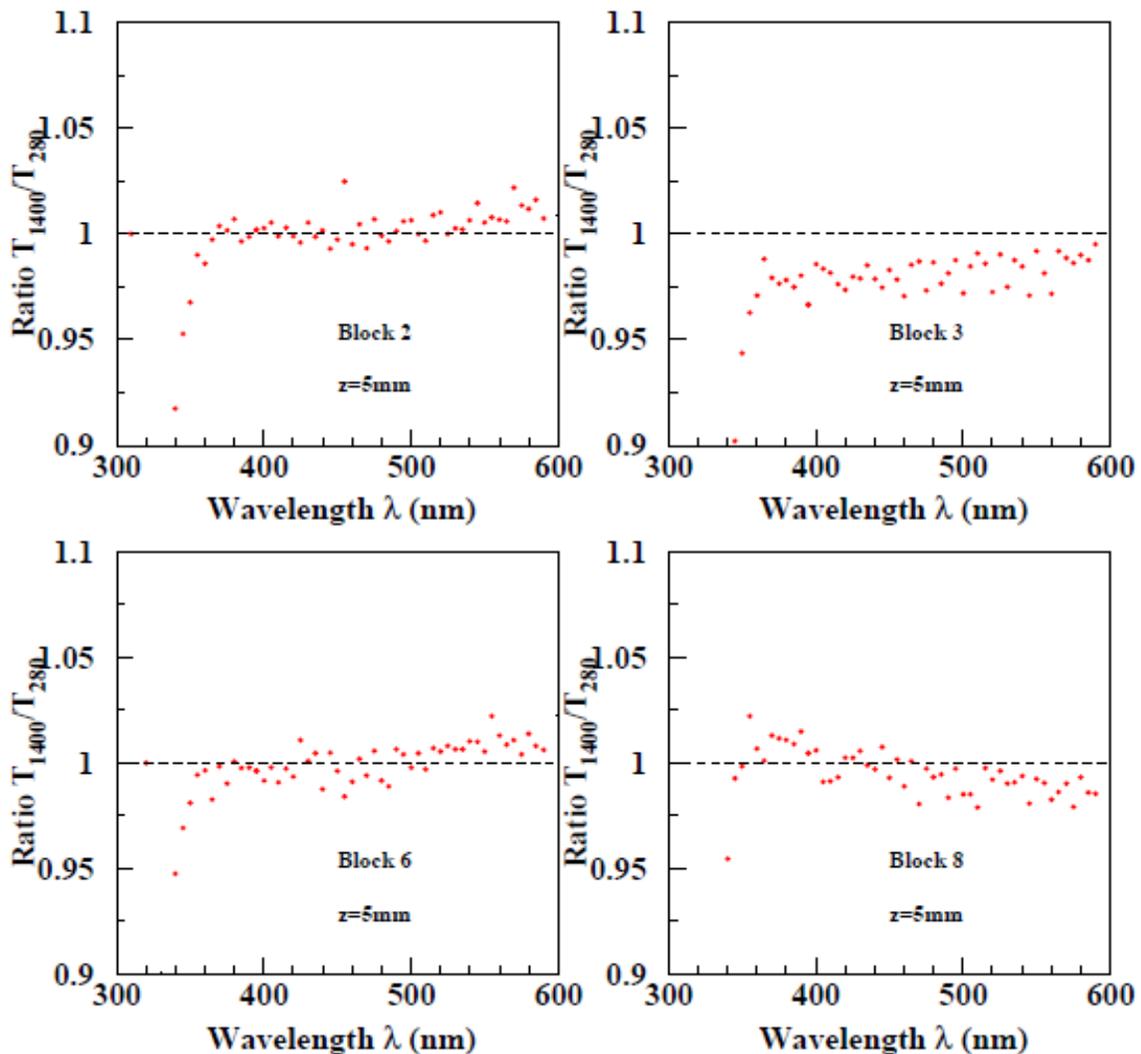
(Transmit. 2.16Mrad)/(Transmit. 432krad and 60 hrs recovery), rates 1.3 Mrad/h

- While we exposed one of the crystals, we did transmission measurements for the crystal which had already been irradiated.
- By swapping and periodically irradiating crystals we reached accumulated doses of ~ 2 Mrad. Meanwhile, transmission measurements showed no further degradation. Moreover, some of the crystals showed improvements relative to their condition after the initial dose of 432 krad.
- For some of the crystals, after a ~ 864 krad dose, we observed a slightly yellow color on the frontal area, within ~ 1 - 2 mm from the surface. This yellow color disappeared during further irradiation.
- Fig.13 shows the ratios of crystal transmission after an accumulated dose of 2160 krad with respect to the transmission measured after 60 hours of spontaneous recovery from a 432 krad dose. All irradiation took place at a dose rate of 1.3 Mrad/h.

Fig.13: Ratios of crystal transmissions after an accumulated dose of 2160 krad with respect to the transmission measured after 60 hours of spontaneous recovery from a 432 krad dose. All irradiation took place at a dose rate of 1.3 Mrad/h.
