Summary recent discussions
and trouble-shooting of various
beam problems originating at
injector

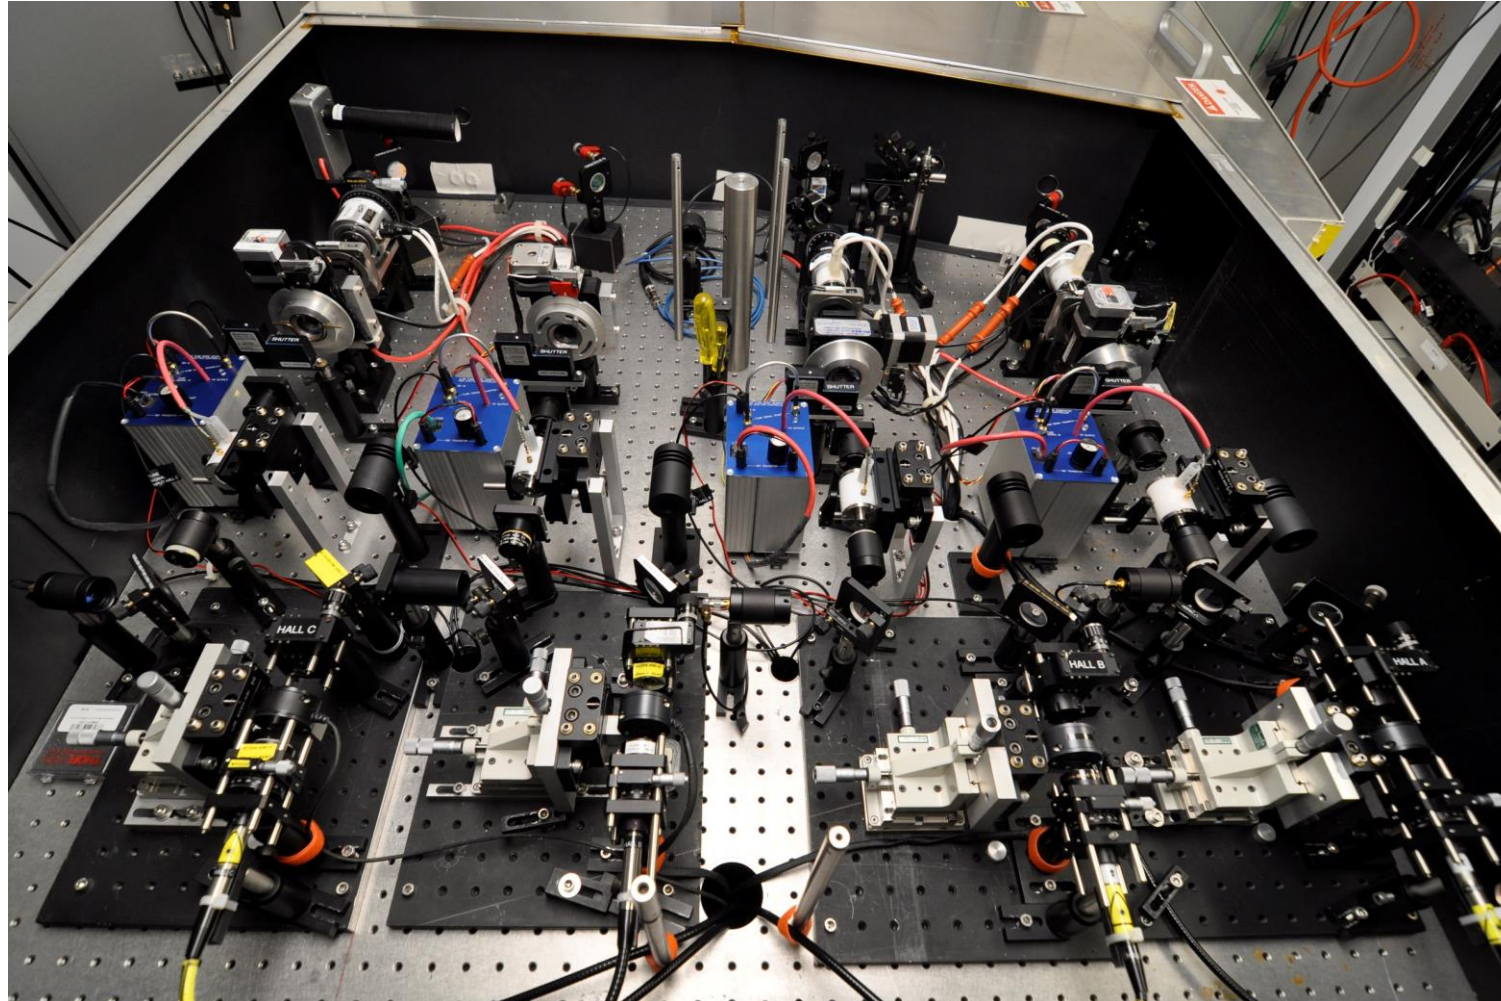
“Tune Mode Generator” is more than a Tune Mode Generator

- Creates machine-safe viewer and tune modes
- Also part of our fast-shutdown system/machine protection

Halfwave plate and/or shutter might not be responding as requested when the common power supply is asked to perform multiple tasks simultaneously

“Easy Button” now configured to implement steps consecutively
