U.S. DEPARTMENT OF  
**ENERGY**

Office of  
Science

## **Accident Investigation Report**

**Electrical Shock Accident  
Resulting in Employee Injury at SLAC  
on December 27, 2022**

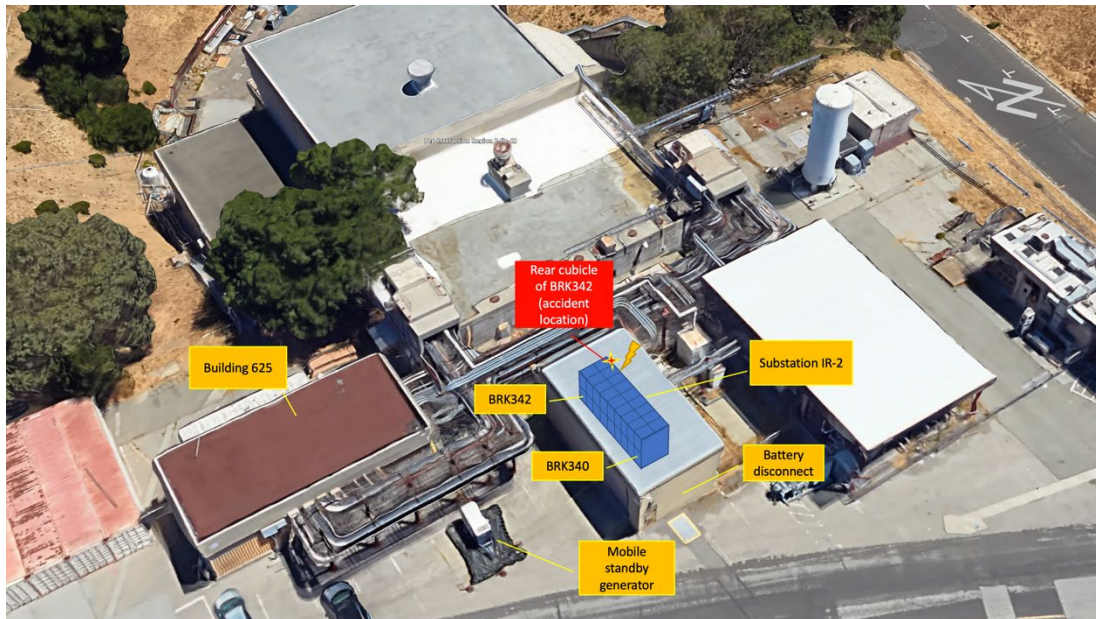
**Figure 1-4: View of IR-2 Substation Area with rendering of IR2 Switchgear and location of accident inside Building 626.**

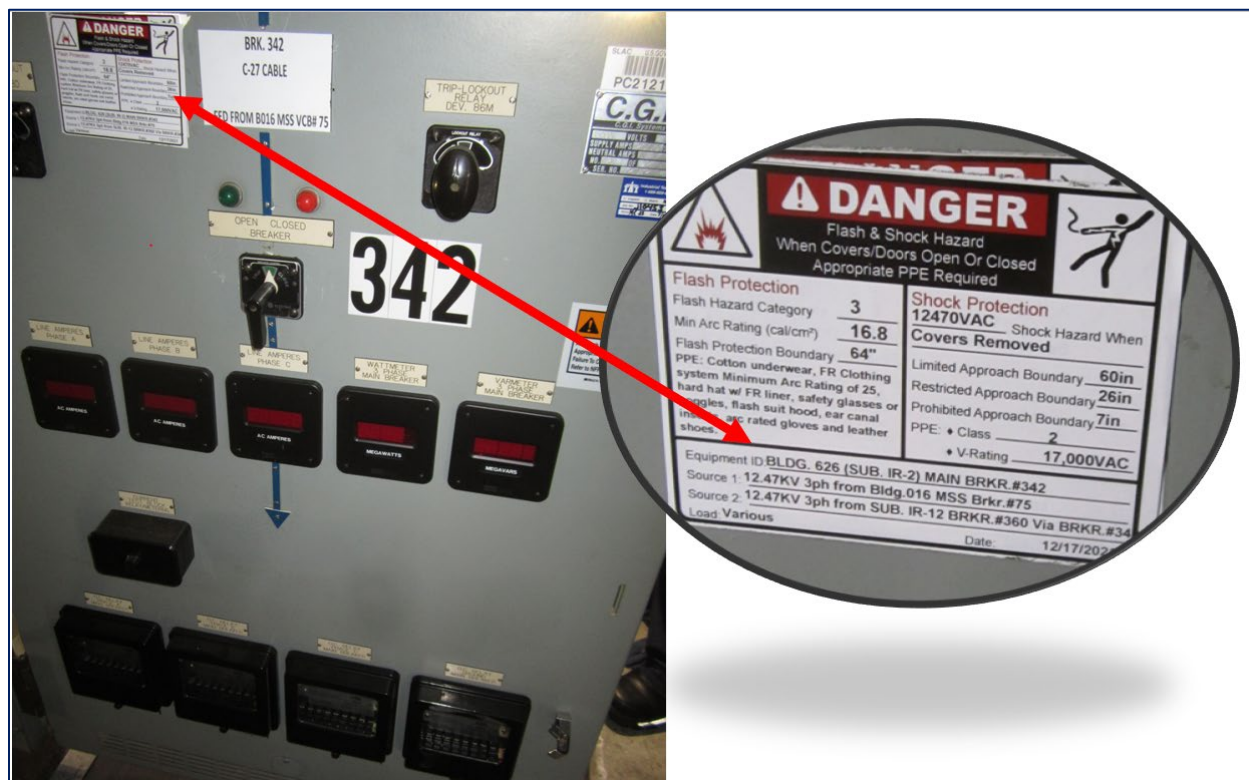
**Figure 2-8: Arc flash label on BRK342 (B626/IR-2) showing BRK75 as a source.**

At this point HVE2 noticed the BRK342 arc flash label listed two separate sources (Figure 2-8). SLAC's standard practice for all arc flash labels is to include source (fed from) information. HVE2 was concerned that the label indicated that BRK75 at the MSS was one of the sources and shared their concern with HVE1. However, HVE1 did not acknowledge or respond to the verbal communication.

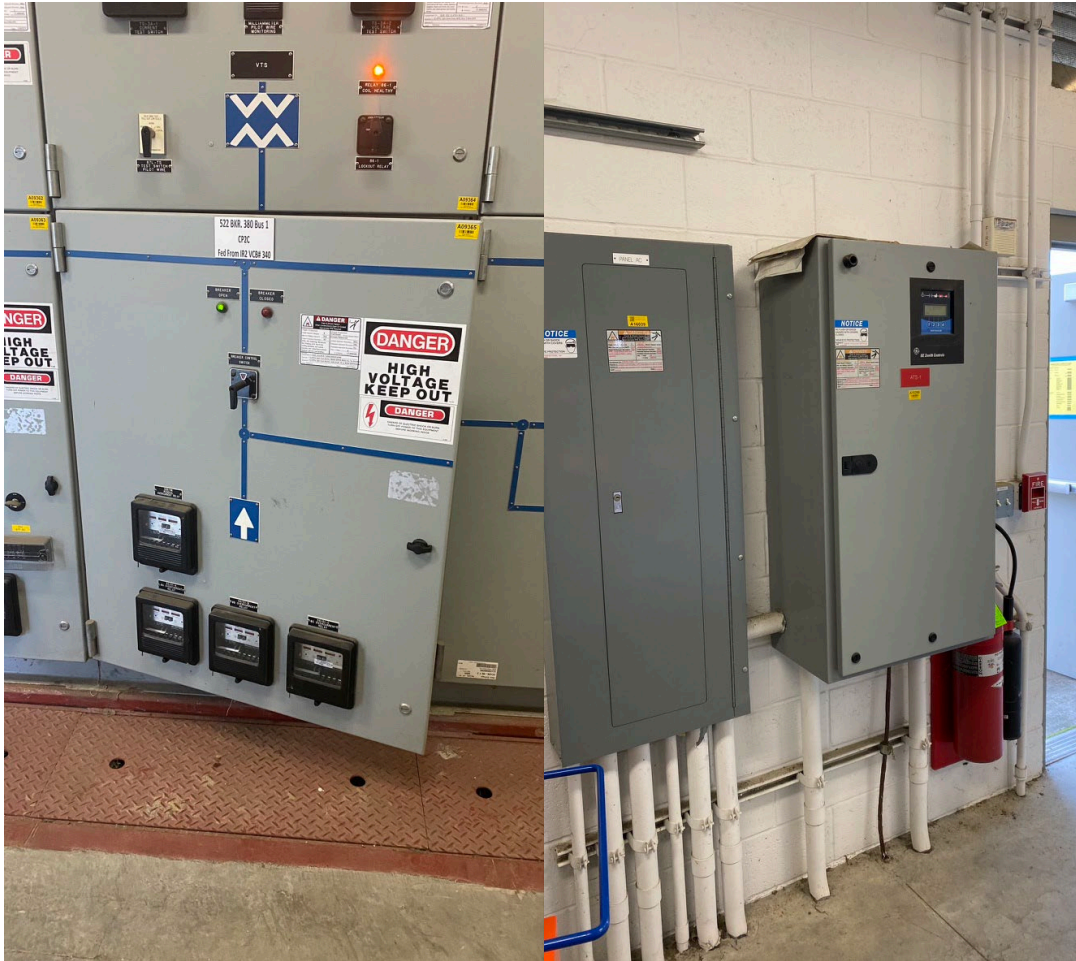
**Figure 2-9: S522 Substation, BRK380 at left, ATS at right.**

HVE1 contacted FOC and informed them that switching at Building 626 was completed at 0801. After leaving Building 626, HVE1 went to S522 to discuss the ATS transfer with HVE3 and HVE4 (Figure 2-9). HVE4 expressed concern that BRK75 was still closed, energizing S522. Although HVE1 acknowledged the concern, they did not recognize that BRK75 was still feeding the line side of BRK342, and that IR-2 switchgear was therefore still partially energized.

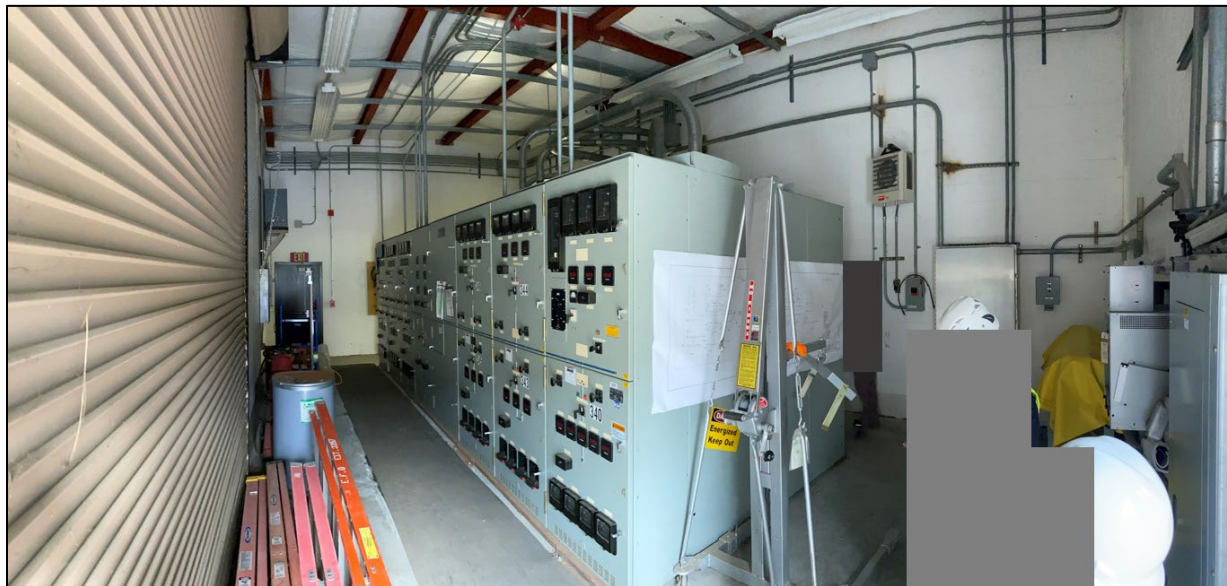
**Figure 2-10: View of IR-2 Switchgear from NW entrance door of Building 626.**

HVE1 asked HVE3 for assistance inside Building 626. HVE1 followed HVE3 as they entered the building through the northwest entrance door (streetside) (Figure 2-10), walked behind the switchgear, and proceeded to the rear cubicle of BRK342.

HVE3 observed that the door to the cubicle was already unlatched and cracked open but thought that the switchgear was deenergized. HVE3 had not applied a personal LOTO lock to any of the lockboxes or isolation points. HVE1 and HVE3 were wearing only their arc-rated daily wear and rain gear.

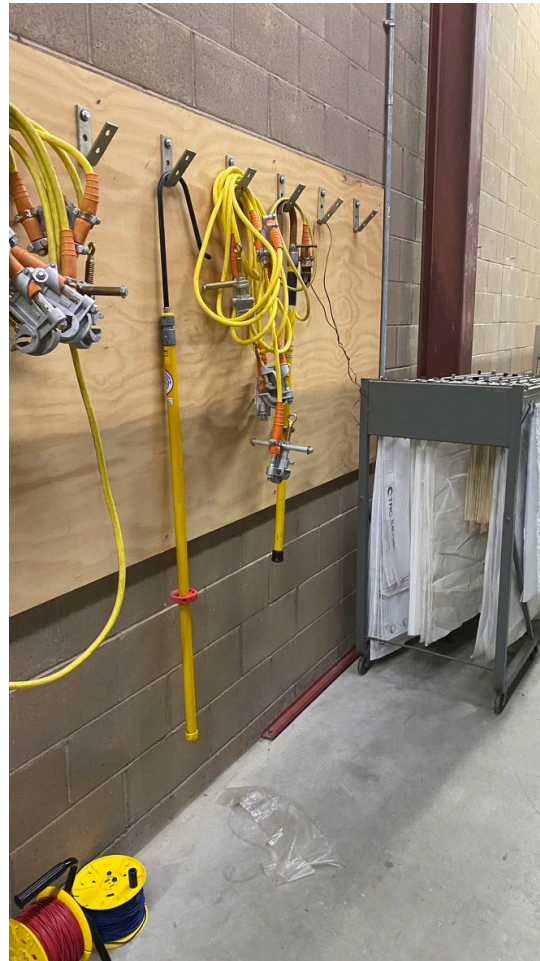
By grabbing HVE1 by the coat tail, HVE3 successfully removed HVE1 from the cubicle and interrupted the shock. However, they also put themselves at significant risk of becoming a second victim. During the interview, HVE3 immediately recognized that they put themselves in danger by the manner in which contact release was performed. The Board observed in walkarounds of other substation buildings at least two insulated rescue hooks stored on wall hooks next to grounding clusters (Figure 2-12). No rescue hook was staged in Building 626.

**Figure 2-12: Example of insulated rescue hook stored in the Master Substation.**

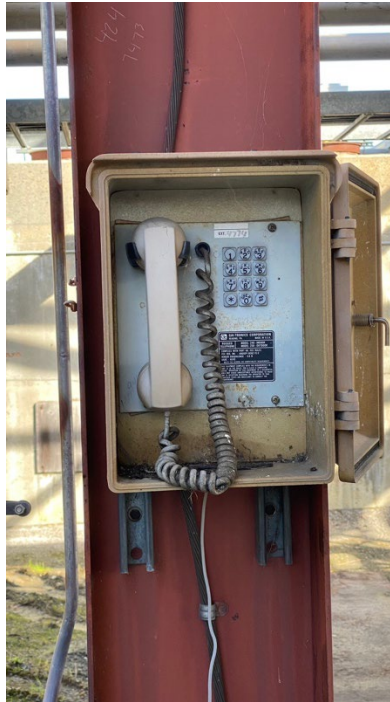
could happen immediately or anytime within the following 24 hours, and the risk is significantly more pronounced for high voltage shocks. The SLAC stance on AEDs is that electrical workers do not need to know the location of the nearest AED since they should just call roving SLAC EMT's. However, response time was delayed by not immediately calling extension 5555 on a landline. The Board noted that a landline was present on the IR-2 Pump Pad directly outside of Building 626 (Figure 2-13) but could not determine whether it had been used to report the event. The phone did not have any labels to indicate how to activate extension 5555. From its physical appearance alone it seemed non-functional, but it was still operational.

**Figure 2-13: Functional landline phone located at IR-2 Pump Pad.**

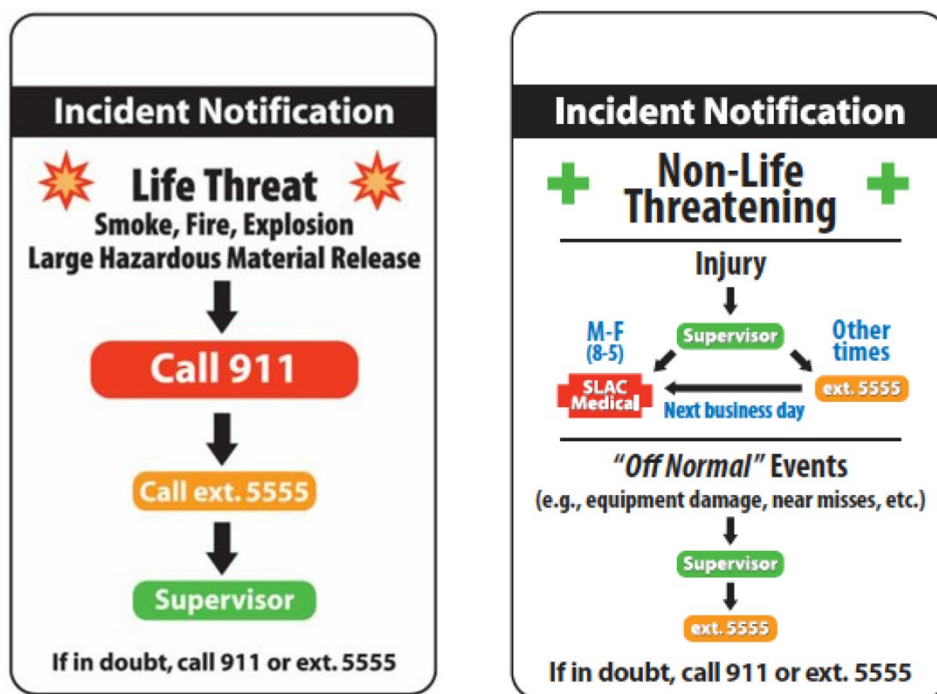
There is no indication that calling extension 5555 from a cell phone will fail to reach SLAC Security. The Emergency Management procedure includes an image of SLAC Incident Notification cards (Figure 2-14) that does not show the appropriate full number. There is no mention in the document that activating SLAC EMTs with an AED requires calling extension 5555, or that it could also be activated using the SLAC radio system.

**Figure 2-14: Incident Notification Card as illustrated in Emergency Management: Emergency Notification, Response, and Reporting Procedures.**

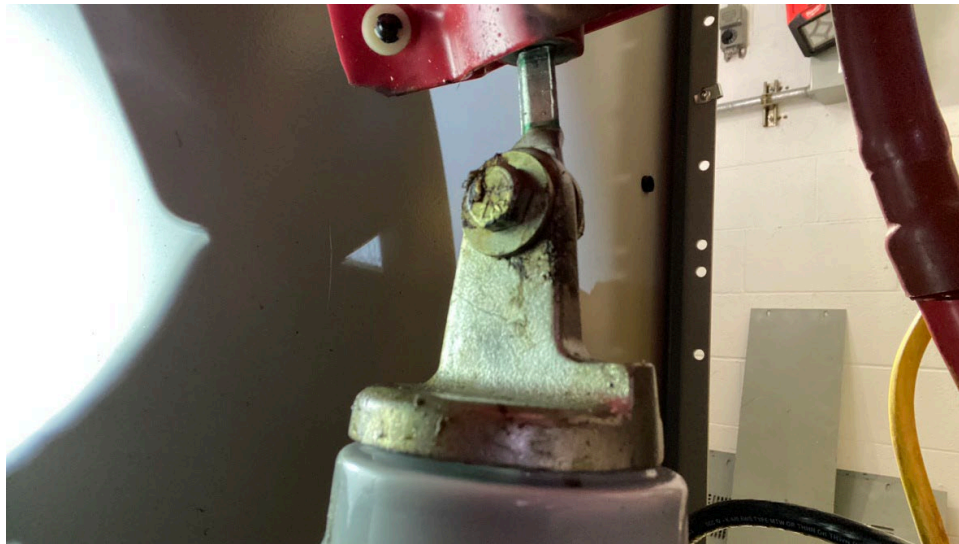
**Figure 2-18: Rear view of the phase A surge arrester bolted connection showing deposits and slight thermal discoloration.**

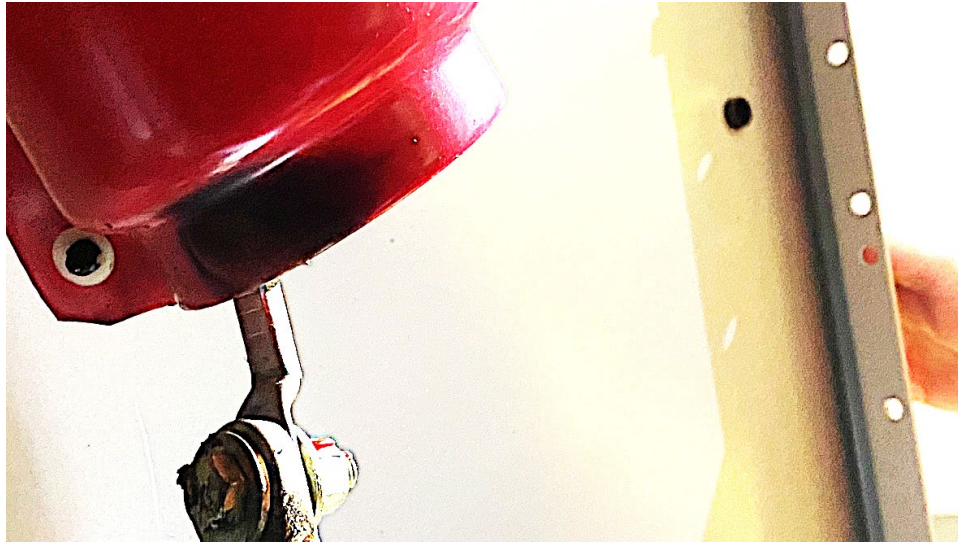
**Figure 2-19: Rear view of the phase A surge arrester insulating boot showing some soot deposits.**

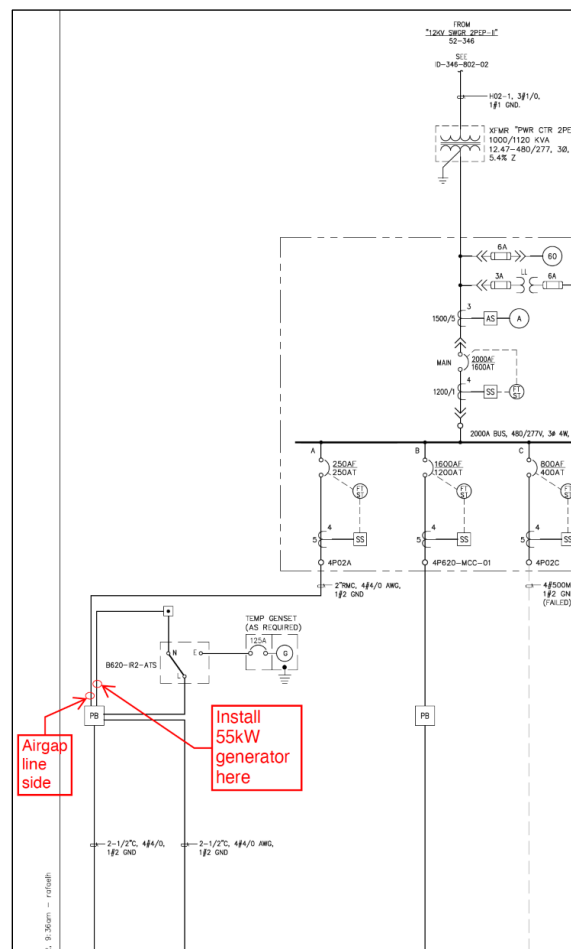
The SOW for the LVEs in phase one included connecting a temporary generator to the normal power supply of an ATS. The ATS feeds the IR-2 Sump Pumps and was considered a critical load that merited both normal and backup power during the maintenance outage. This would result in two (2) mobile generators connected to a single ATS: one mobile generator is permanently connected to the emergency side of the ATS, and a second mobile generator would be temporarily connected to the normal side of the ATS (Figure 3-1). This connection to the normal side of the ATS was to be made inside a junction box that also contained the load side feeder from the ATS to the loads.

The EWP directs air gapping in a 480V junction box on the normal power supply to the ATS, without isolating and locking out power from the mobile generator on the emergency power supply of the ATS.

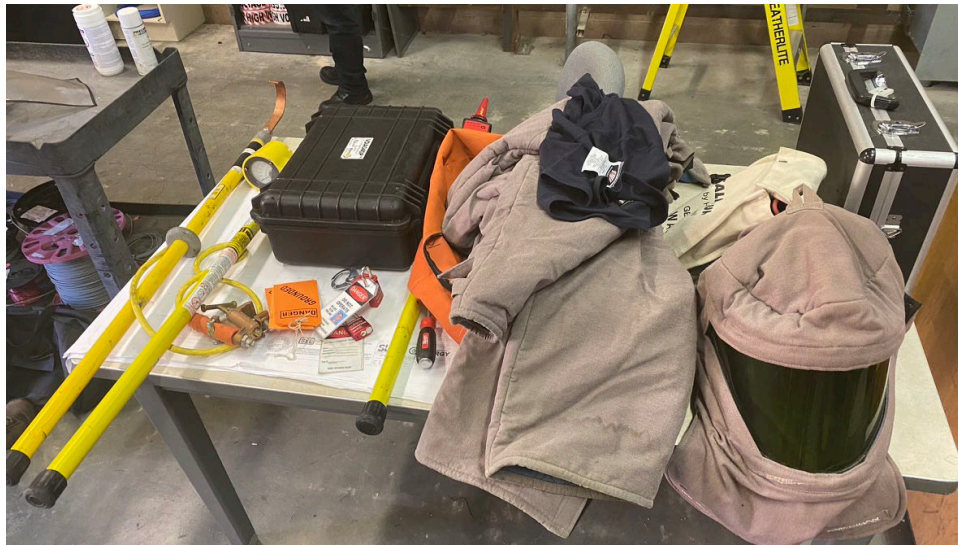
Both the proximity tester (Amprobe TIC 300 Pro) and the contact tester (Bierer VDA040P) used at SLAC are of capacitive type. This means that they only detect AC voltage, and will not detect stored energy in a cable, which is a DC charge.

**Figure 3-6: Example of PPE staged in preparation for ZVV and grounding at MSS BRK75 on 1/18/2023.**

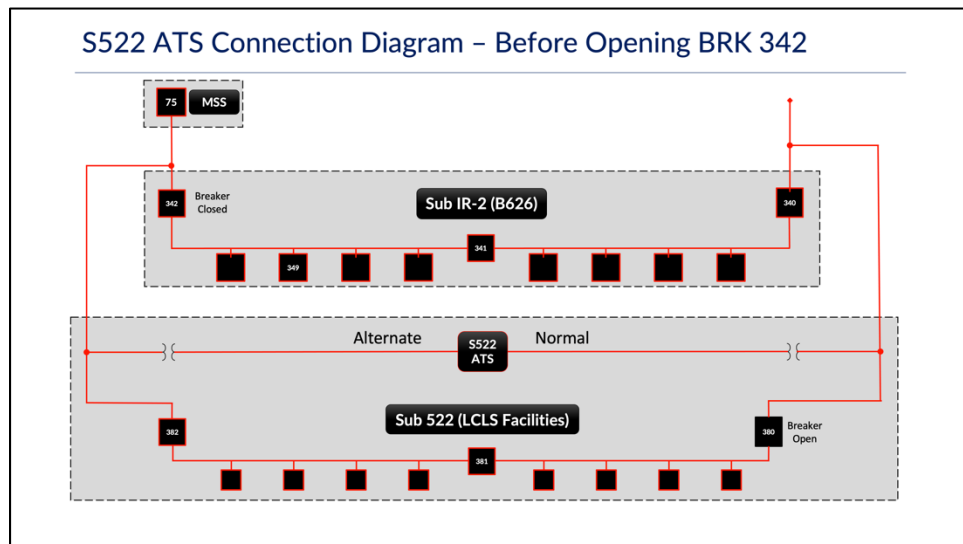
The ATS normal power source was selected to the line side of BRK380, which used to be fed from BRK75. After the reconfiguration that eliminated the direct feeder to IR-2 and S522 Bus 1 (sometime before 2019), the line side of S522 / BRK380 was now only fed from IR-2 through BRK342 (Bus 2 main), the BRK341 (tie) and BRK340 (Bus 1 main) (Figure 3-15). So, when BKR342 at IR-2 was opened, the normal supply to the ATS was interrupted and it transferred to the line side of BRK382, which was fed directly from BRK75 (Figure 3-16). This ATS configuration was unnecessarily complex. Control power interruptions from unrelated switching at IR-2 could have been eliminated if the ATS was reconfigured such that the normal side was the line side of BRK382. More importantly, the lack of updated drawings either in the field or in the EWP prevented ready diagnosis and forced the electricians to rely on expert knowledge alone.

**Figure 3-15: S522 ATS status on 12/27/2022 right before opening BRK342. The ATS is powered from both sides but is connected to the Normal Source on the right.**

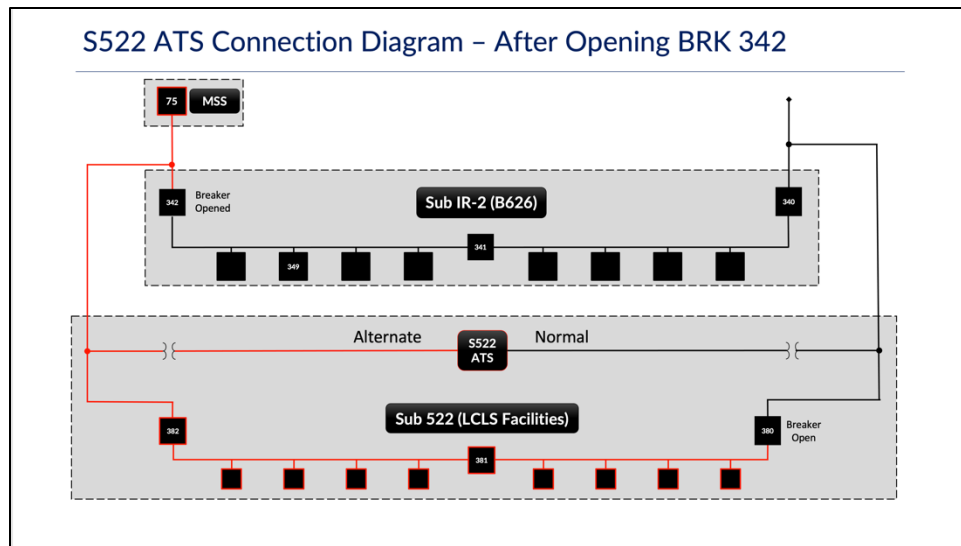
**Figure 3-16: S522 ATS status on 12/27/2022 right after opening BRK342. The ATS is powered from the Alternate Source on the left. After a few seconds, the ATS transferred to the Alternate Source.**

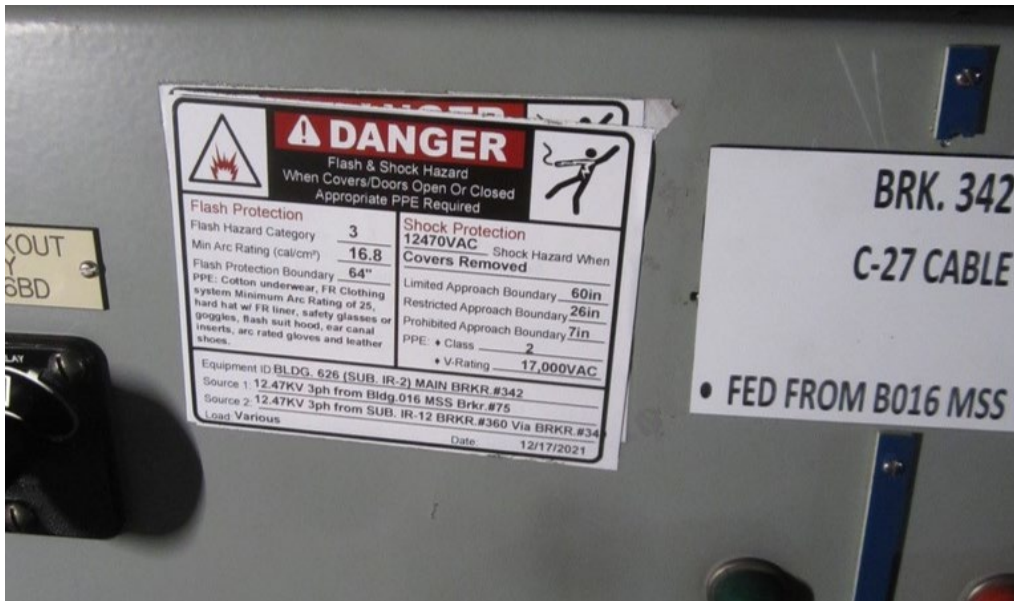
The condition of arc flash labels was less than adequate. Although SLAC has a practice of including the source (fed from) information directly on the label, some of these are out of date. The EWP's do not list arc flash information and just state “wear proper PPE,” with the expectation that qualified persons can use the labels to determine the appropriate controls. However, the condition of arc flash labels does not permit reliable field usage.

**Figure 3-17: BRK342 Arc flash label indicates an arc flash boundary of only 64", whereas it should be 59 feet.**

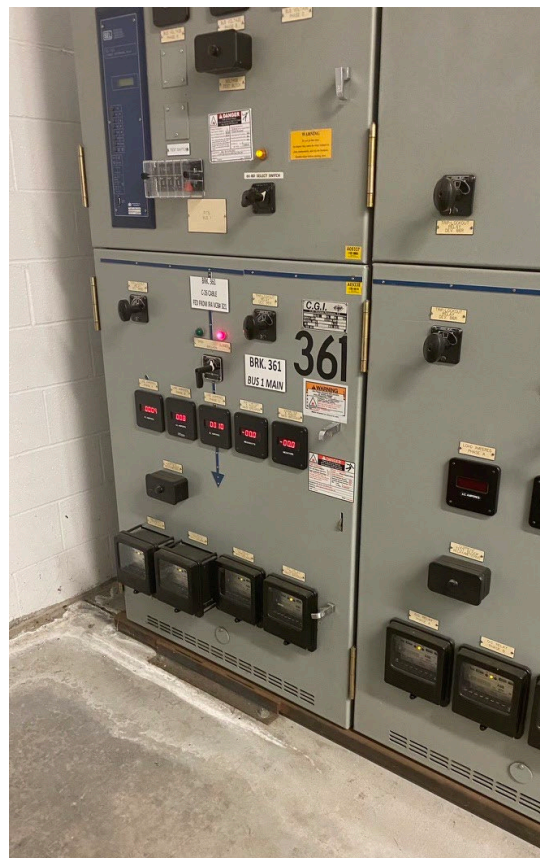
- Newer labels were placed on the main breakers at IR-2 and S522 to reflect the configuration change in 2021. However, all of the old labels remain in place on the other breakers. Even older labels (dated 2008) are on the rear doors of S522.
- IR-12, BRK361 is labeled as “Fed from IR-4,” whereas it is IR-12 that feeds IR-4. The three arc flash labels on BRK361 have different values and do not match.
- IR-12, BRK363 had an arc flash label dated 2015 on BRK363 that showed MSS BRK41 as a source, even though there is a temporary sign above saying it is fed from Sub 45S.
- S522, BRK380 has an arc flash label on the rear cubicle that incorrectly states that it is fed from MSS BRK75.
- Arc flash labels throughout the site have started to fade, some to the point of becoming completely illegible.

**Figure 3-18: BRK361 in IR-12 is labeled as "Fed from IR-4," whereas it is IR-12 that feeds IR-4. The three arc flash labels have different values and do not match.**

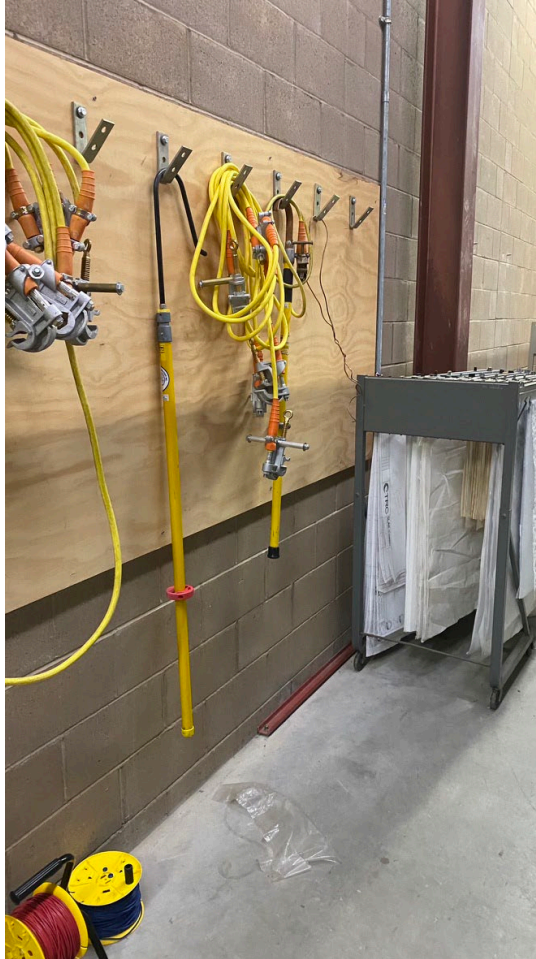
- Chapter 8 does not include an emergency response section that would include safe contact release and actions needed to activate EMS, rapidly obtain an AED, and make the scene safe. While insulated rescue hooks were noted in multiple substations (Figure 3-22), none were present in Building 626, and these are not used or staged as part of emergency preparedness. Emergency call numbers posted inside substations are several years out of date.

**Figure 3-22: Insulated rescue hook stored in the Master Substation.**

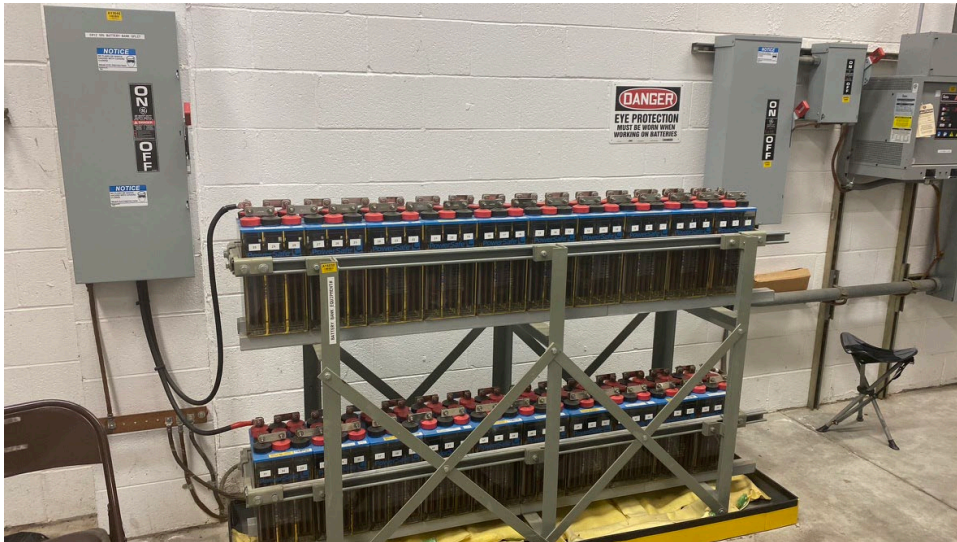
- Multiple instances of uncontrolled, exposed live parts were noted inside substation buildings:
  - 120 VDC battery banks are left exposed to unintentional contact. The CEE directed that the battery bank inside IR-2 substation was to be covered with temporary insulating blankets before allowing the Board to enter. Other substations, such as IR-12 and S522, had the same recognized condition that was not mitigated. (See Figure 3-25 through Figure 3-27.)

**Figure 3-26: Battery bank at IR-12 Substation with exposed energized terminals.**

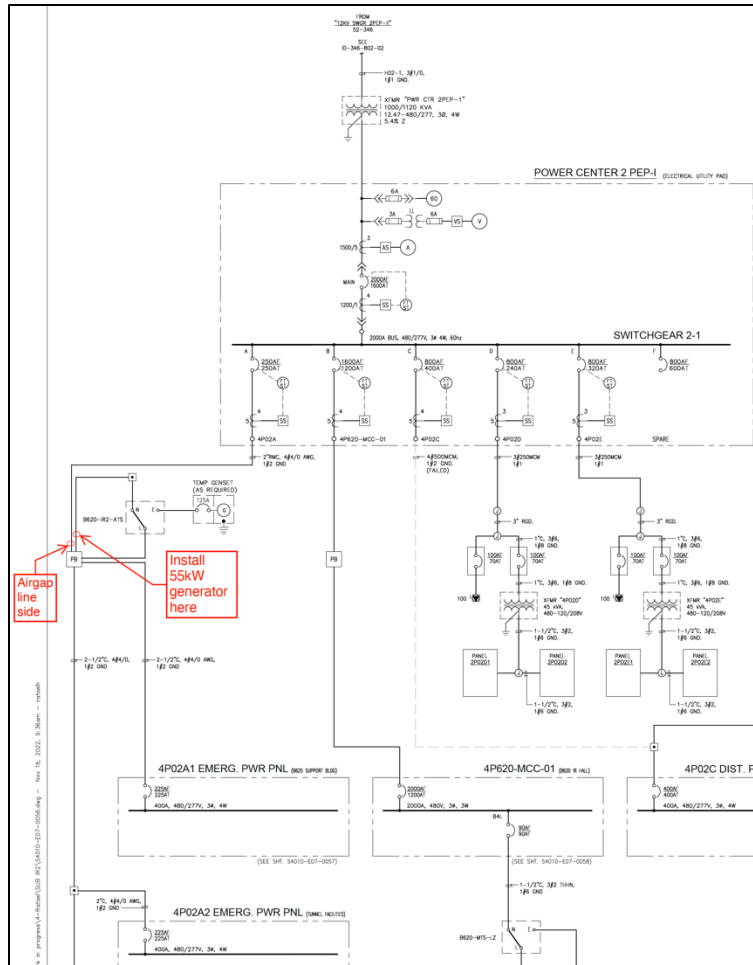
- LV Electricians were directed by the EWP to perform a simple LOTO at 2PEP-I, Breaker A to perform air-gapping of normal power to the ATS at Building 620 (Figure 3-30). However, the work was to be performed inside a junction box that also contained the load side feeder wires from the ATS. This should have also required LOTO isolation of the emergency generator, and therefore a Complex LOTO.

**Figure 3-30: Cropped capture of single line drawing attached to EWP showing where to air gap the normal power to the ATS. The load side feeder runs through the same enclosure. Breaker A in Power Center 2 PEP-I is directly upstream and is fed from BRK346 in IR-2 substation.**

- Isolating at 2PEP-I, Breaker A when the upstream power was already secured by EIP1 presents a different challenge. Since there was no power on the line side of 2PEP-I Breaker A, a ZVV downstream would not prove that the isolation was correctly implemented. A better solution would have been to develop a separate lockbox, with an EIP that added one group LOTO lock to LB8 and another to the generator.

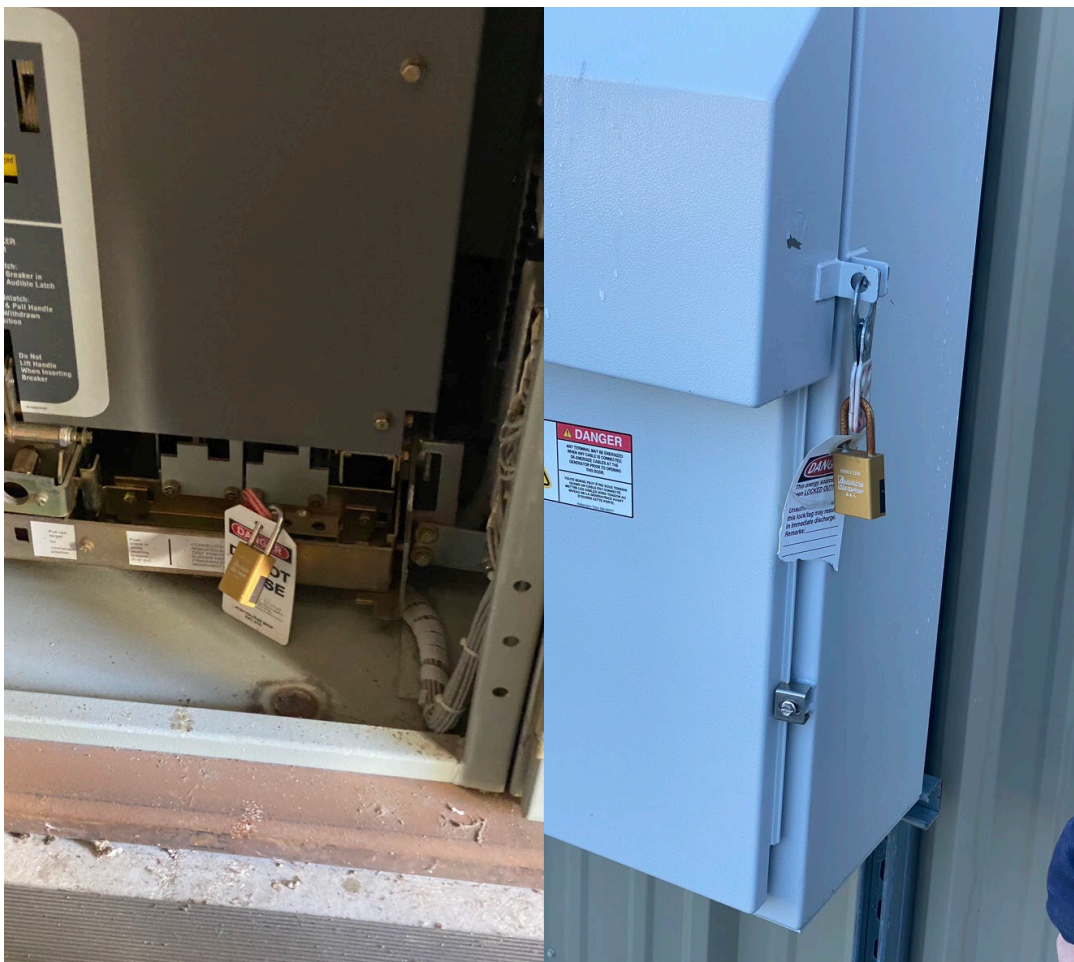
- Contrary to Chapter 51, Group LOTO locks were consistently applied without the Group LOTO tags to identify them as associated with a Group Lockbox.
- Contrary to Chapter 51, administrative locks are used with red and black Danger tags that are identical to the red, white, and black danger tags used for control of hazardous energy (Figure 3-31). This was observed throughout all visited spaces. When questioned, the Board was told this was an acceptable practice.

**Figure 3-31: Examples of administrative locks applied with LOTO tags.**

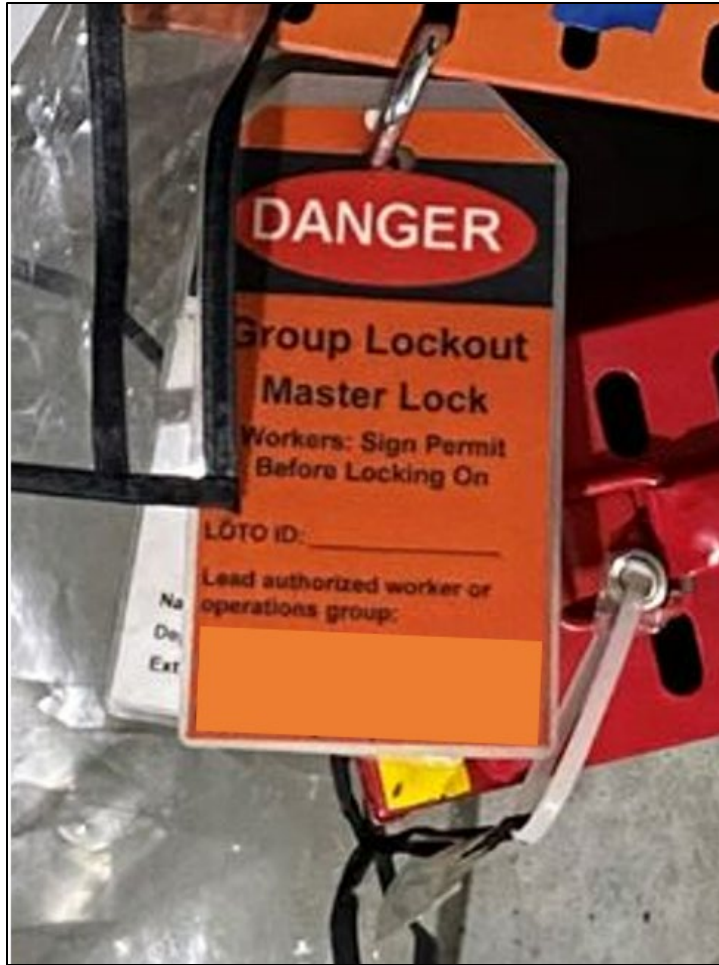
**Figure 3-32: Group Lockout Master Lock Tag.**

- The lockbox was identified with green duct tape as “IR-12 Lockbox”, whereas it was used for IR-2.
  - An orange Group Lockout Master tag (Figure 3-32) was still attached to the lockbox with the HV Supervisor’s personal LOTO lock. No LOTO ID was written on the tag, and it had HVE1’s name on it. (HVE1 had not been onsite since 12/27/2022.)

- Only one key was in the box, for the lock applied to BRK360 at IR-12. The associated EIP also had BRK75 isolated and grounds applied. However, the key for BRK75 had already been removed to close BRK75 and reenergize S522 at the end of the 1/03/2023 outage. The condition of the lockbox, with the orange tag, would indicate that the full LOTO was still established.

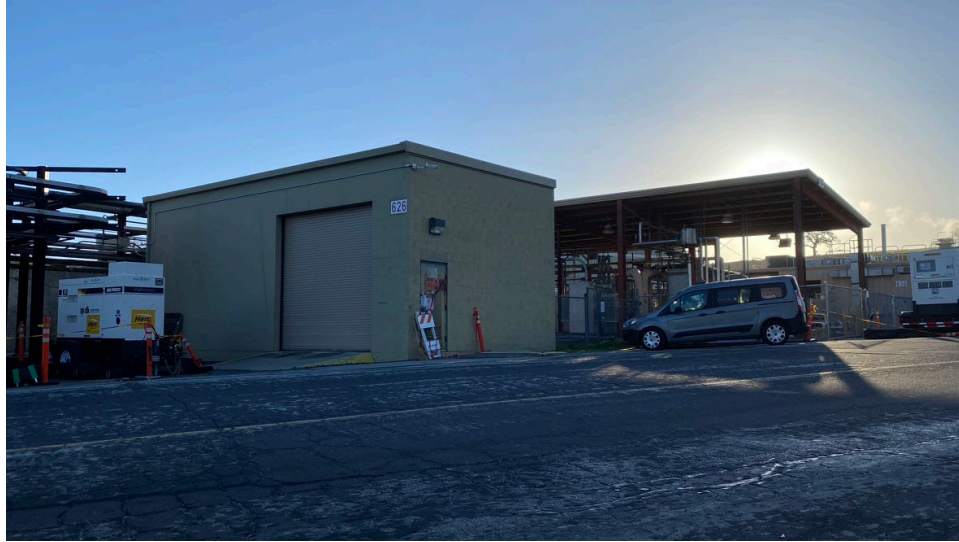
**Figure E-1: Building 626, housing IR-2 Substation, front door view.**

**Visual examination of the IR-2 switchgear supports the Board's conclusion that HVE1 sustained a high voltage shock from hand to hand and was not injured by an arc flash. Further, condition of maintenance or quality of installation was not a factor in the event.**

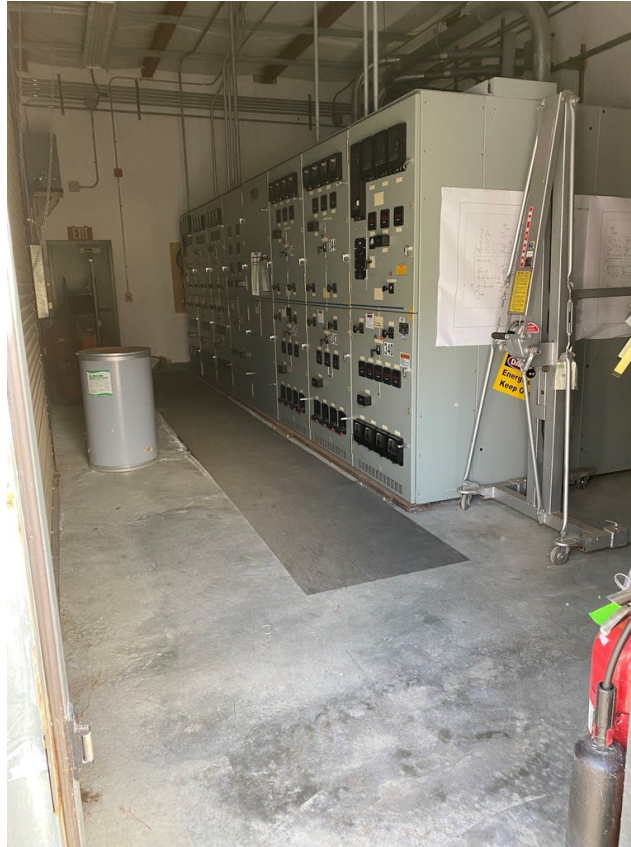
**Figure E-2: IR-2 Switchgear, viewed from front door entrance. BRK340 is the closest and BRK342 is the farthest.**

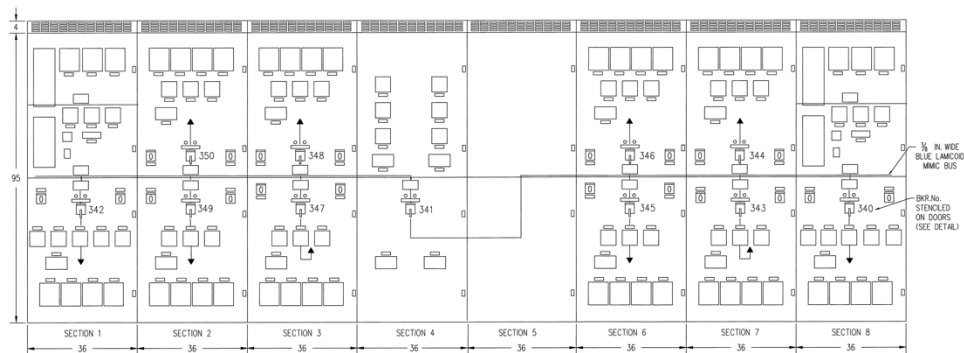
**Figure E-3: Front sketch of IR-2 Switchgear. BRK342 cubicle is on the left.**

IR-2 switchgear is of standard Medium Voltage Metal Clad Switchgear construction with eleven rackable vacuum circuit breakers. IR-2 substation is built with two main breakers (Breakers BRK340 and BRK342), two buses (bus 1 and bus 2), a single tie breaker (Breaker BRK341), and eight feeder breakers (Breakers BRK343 through BRK350).

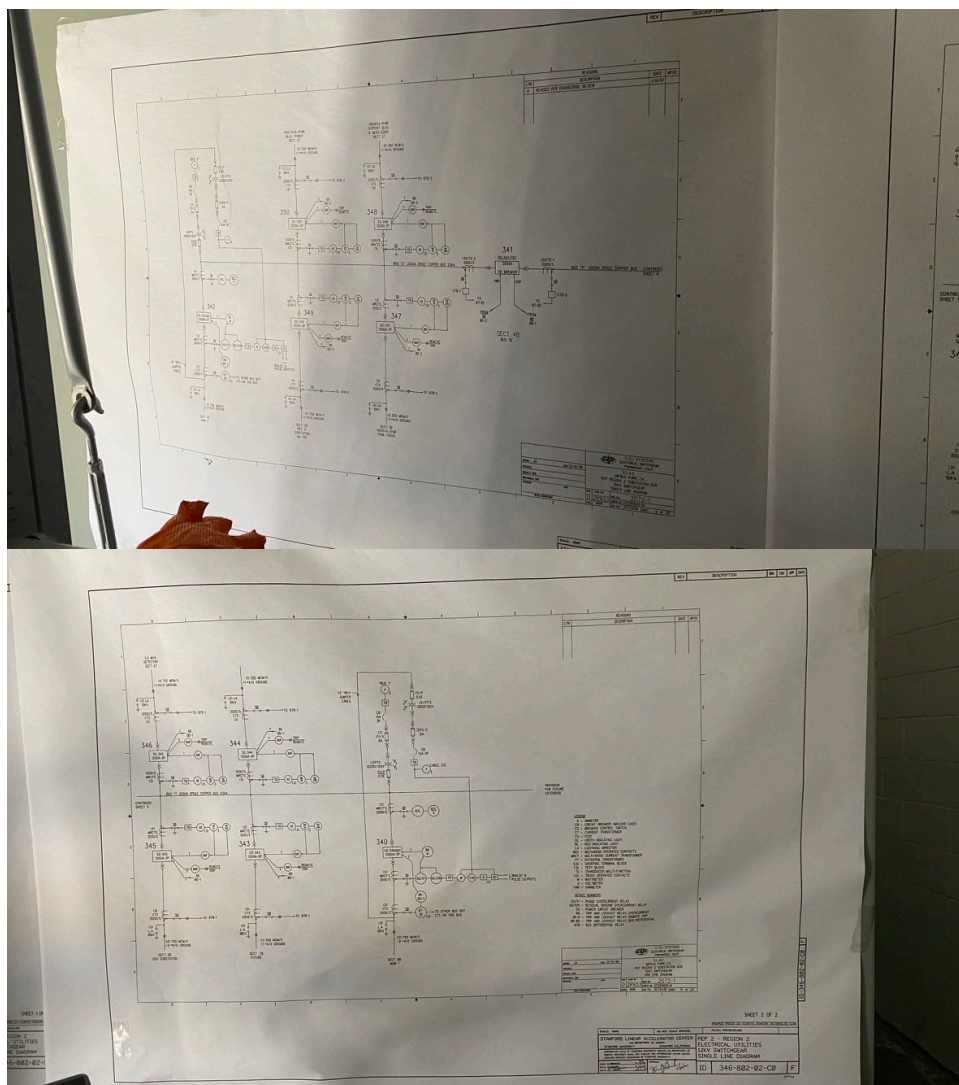
Substation drawings were posted on the side of the switchgear nearest the front entrance. The drawings were prints of the original manufacturer's drawings and did not show specific connections to the MSS, IR-12 or S522.

**Figure E-5: Drawings posted on the side of IR-2 do not show connections to MSS, S522 or IR-12.**

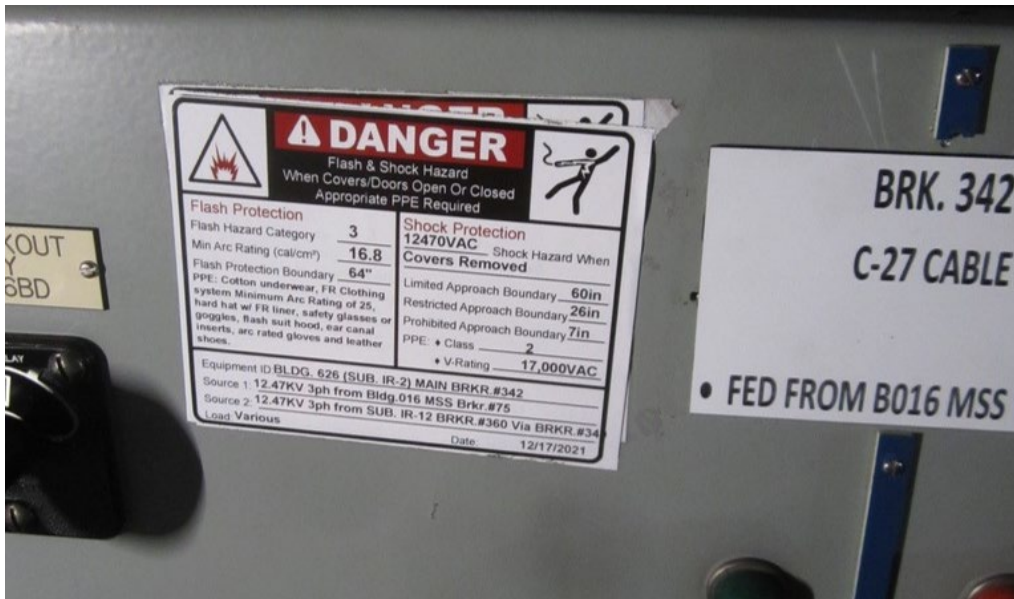
The arc flash labels on BRK340 and BRK342 are dated 12/17/2021 and indicate an arc flash incident energy of  $16.8 \text{ cal/cm}^2$  at a 36" working distance, with an arc flash boundary of only 64". The arc flash boundary is too low for that incident energy and working distance. The Board inquired with EPD, and corrected values were provided:  $21.88 \text{ cal/cm}^2$  at a 36" working distance, with an arc flash boundary of 59 feet. The arc flash label dates of 12/17/2021 align with the last feeder cable configuration change performed in 11/2021.

**Figure E-6: BRK342 Arc flash label indicates an arc flash boundary of only 64", whereas it should be 59 feet.**

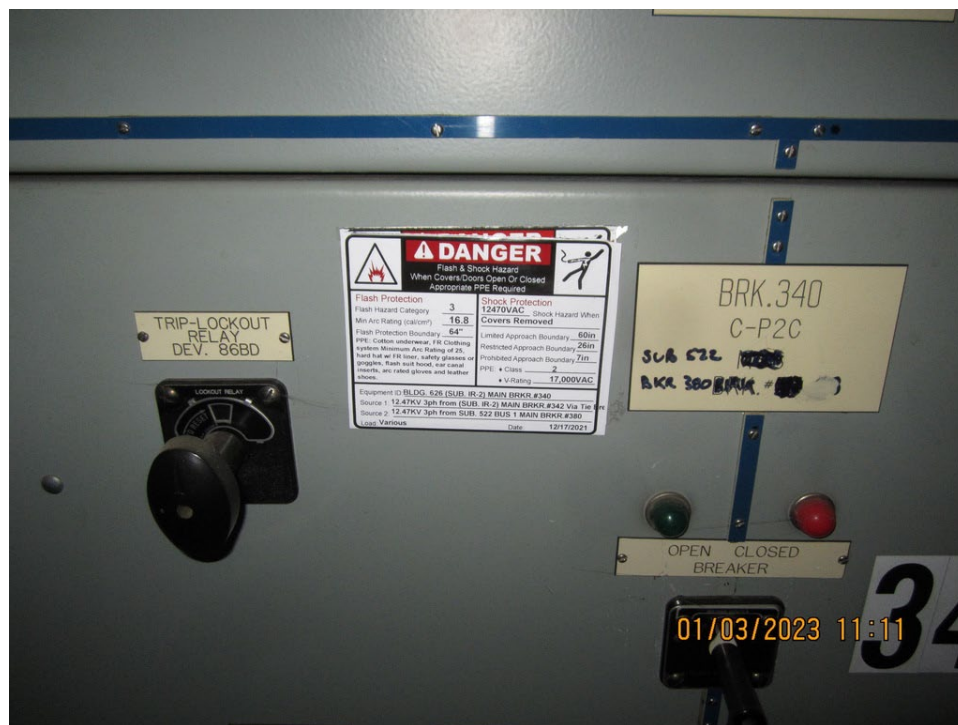
**Figure E-7: BRK340 Arc flash label indicates an arc flash boundary of only 64", whereas it should be 59 feet.**

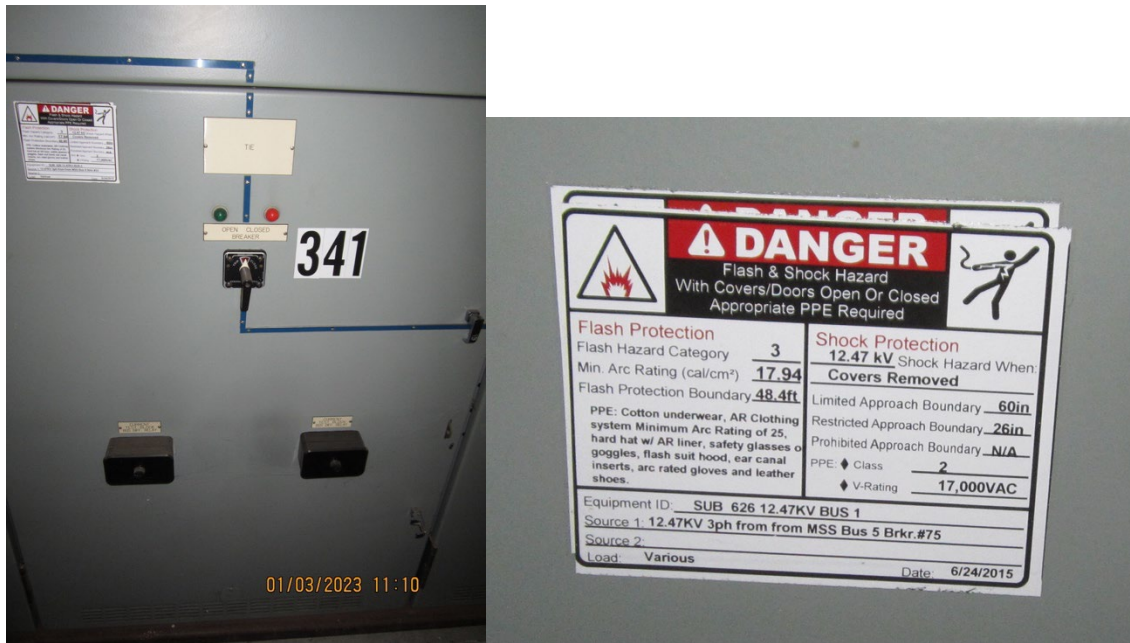
All of the other breakers have arc flash labels dated from 6/24/2015. The tie breaker, BRK341, has the 2015 label, showing an arc flash incident energy of  $17.94 \text{ cal/cm}^2$  at a 36" working distance, with an arc flash boundary of 48.4 feet.

**Figure E-8: BRK341 Arc flash label is still from 2015 and shows arc flash boundary of 48.4 feet.**

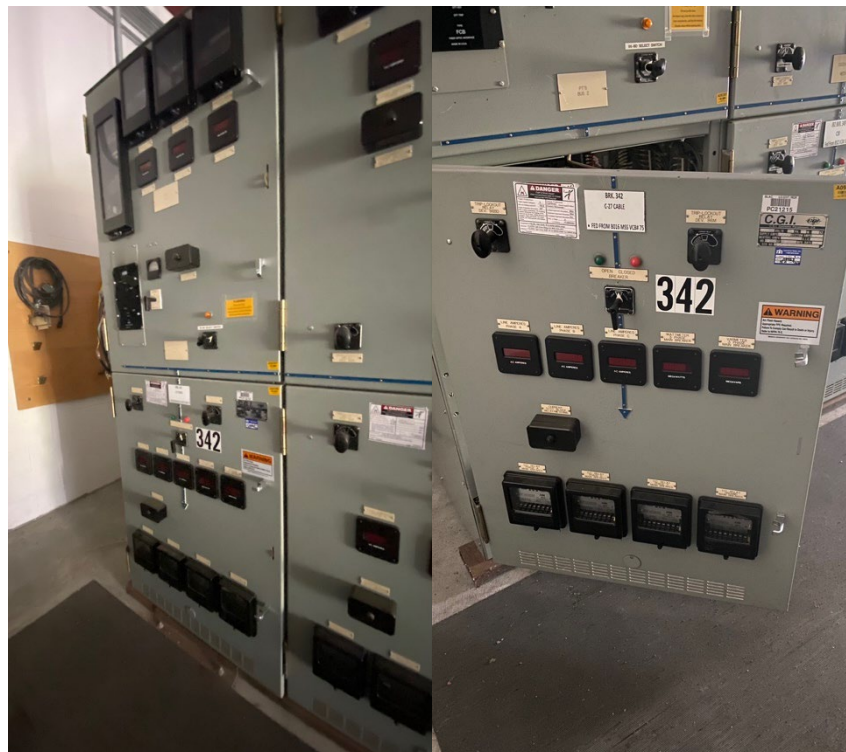
**Figure E-9: Front view of BRK342.**

The front cubicle of BRK342 was in satisfactory condition. There was no indication of damage. The breaker was locked out in the racked-out position.

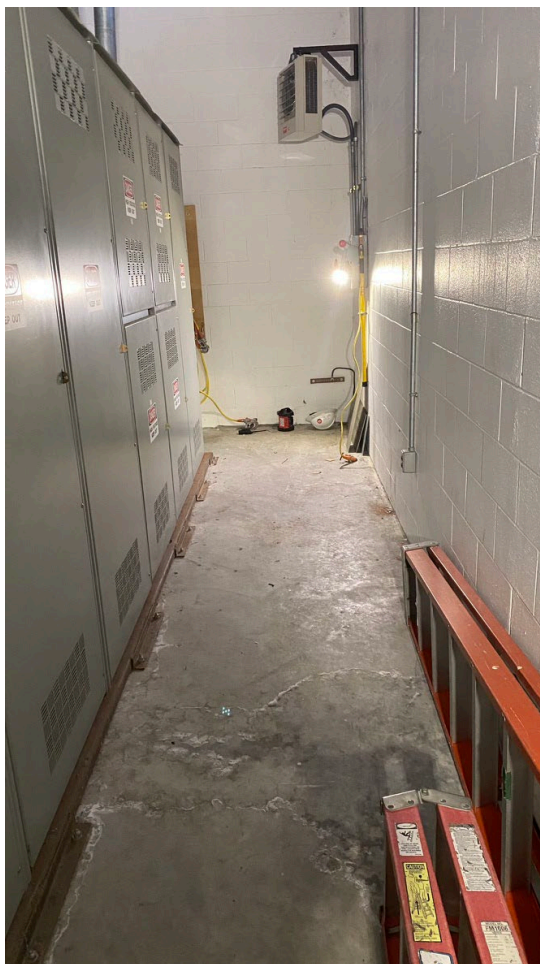
The access and working clearance around the rear of BRK342 cubicle were clear of obstructions. The distance between the cubicle door and the building wall was measured at 56", 16" less than the minimum 72" required for 12.47 kV, condition 2 in the NEC Table 110.34(A).

**Figure E-11: View of clear access at the rear of IR-2 switchgear. BRK342 rear cubicle is farthest.**

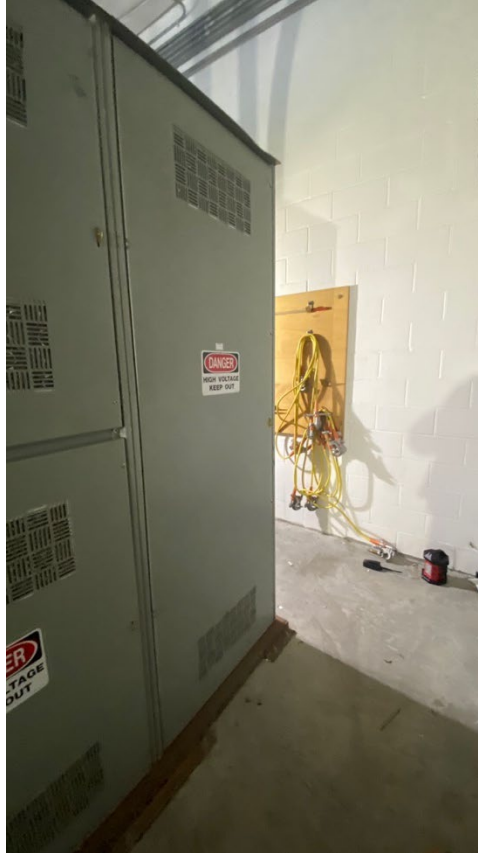
**Figure E-13: Rear door of BRK342 cubicle.**

There is minimal damage. The point of contact for the right hand is clearly visible about 40” up the edge of the open enclosure. There is a blackened and heat-damaged area, with some of the paint missing in the middle. The pattern was verified to be consistent in size and shape with the right-hand glove inside web between the thumb and index finger.
