U.S. DEPARTMENT OF  
**ENERGY**

Office of  
Science

## **Accident Investigation Report**

**Electrical Shock Accident  
Resulting in Employee Injury at SLAC  
on December 27, 2022**

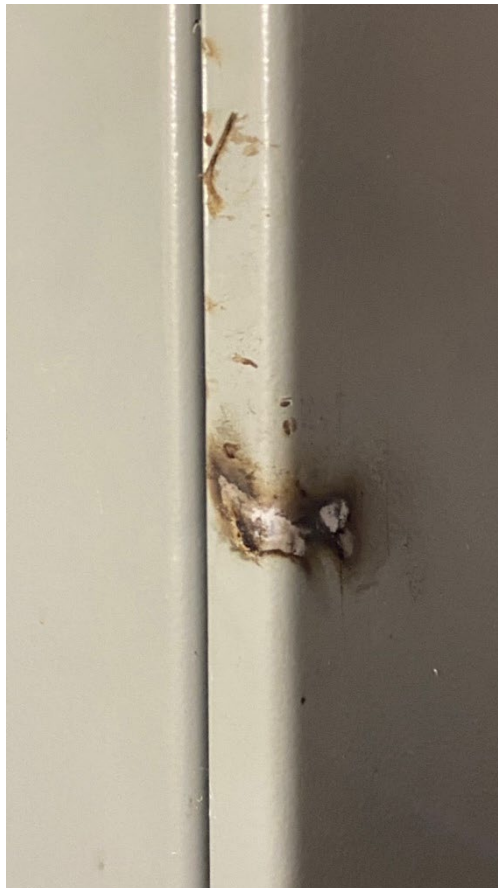
**Figure E-15: Close-up of shock contact area for right hand.**

There is minimal damage. The point of contact for the right hand is clearly visible about 40” up the edge of the open enclosure. There is a blackened and heat-damaged area, with some of the paint missing in the middle. The pattern was verified to be consistent in size and shape with the right-hand glove inside web between the thumb and index finger.

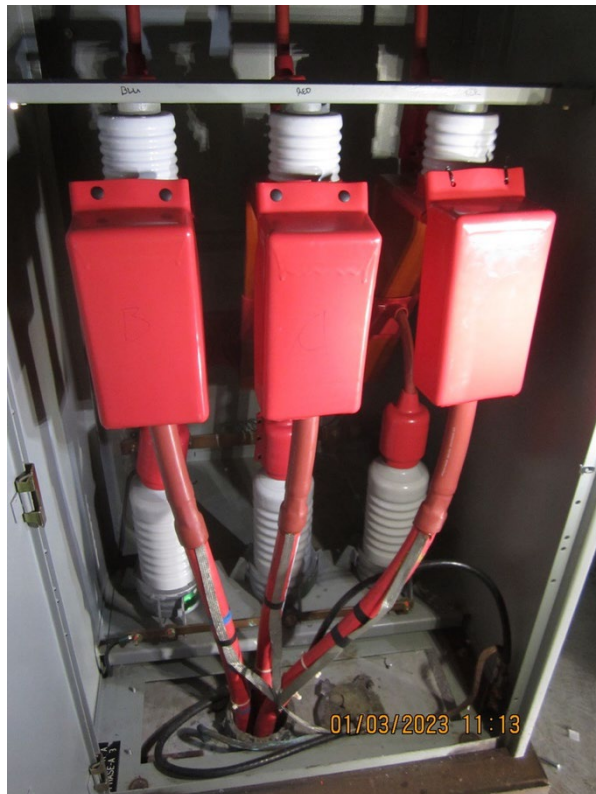
**Figure E-17: View of BRK342 rear cubicle without protective grounds applied (1/3/2023).**

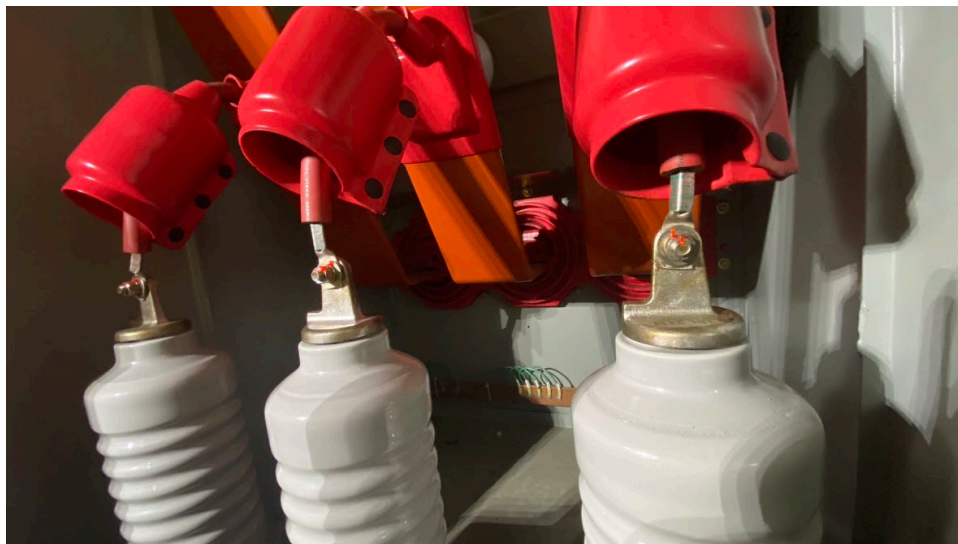
**Figure E-20: All three Surge Arrestors with insulation boots lifted.**

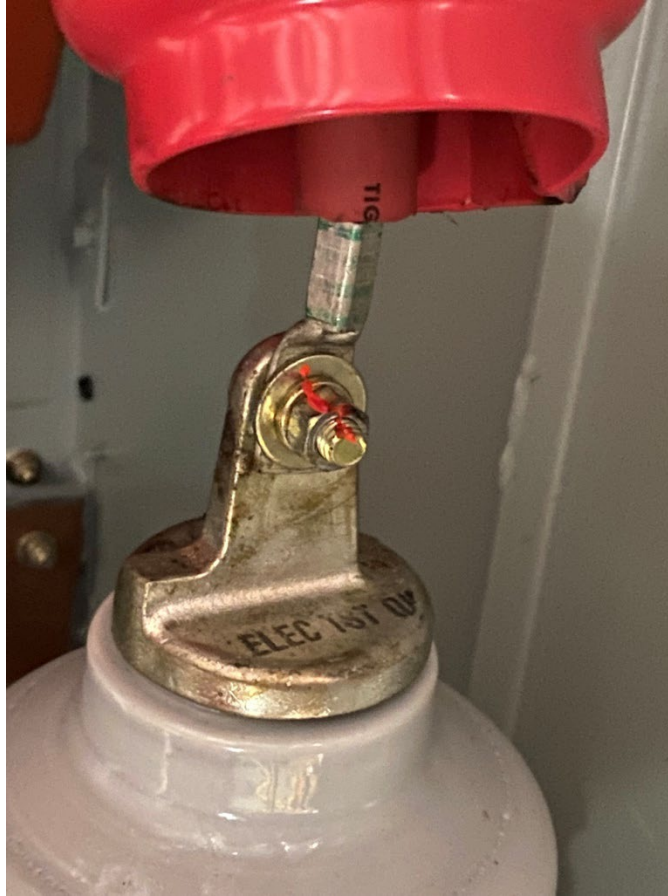
**Figure E-21: Top of Phase A Surge Arrestor showing minimal heat discoloration on the front.**

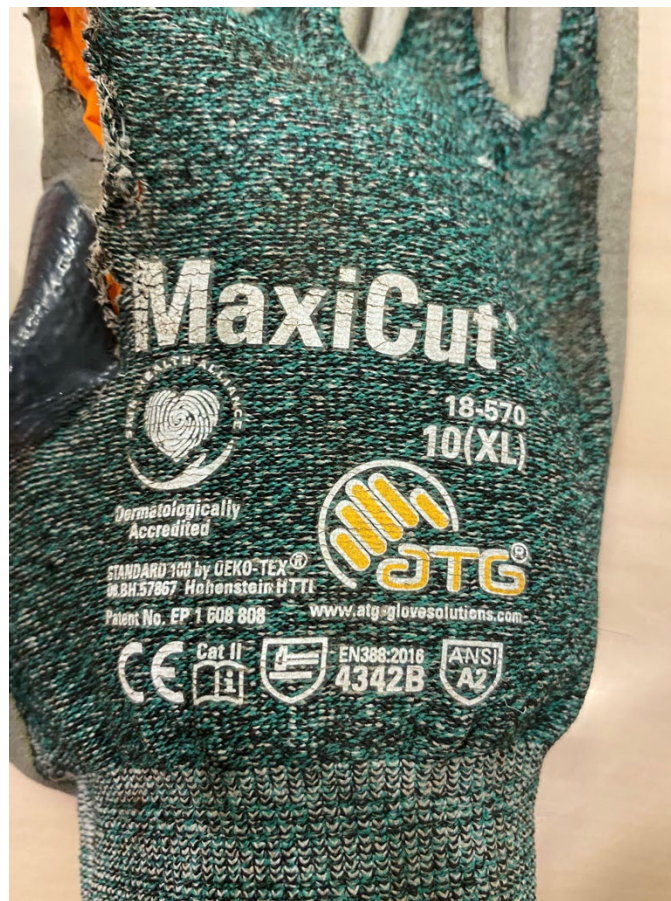
**Figure F-3: Work glove was a cut-resistant glove.**

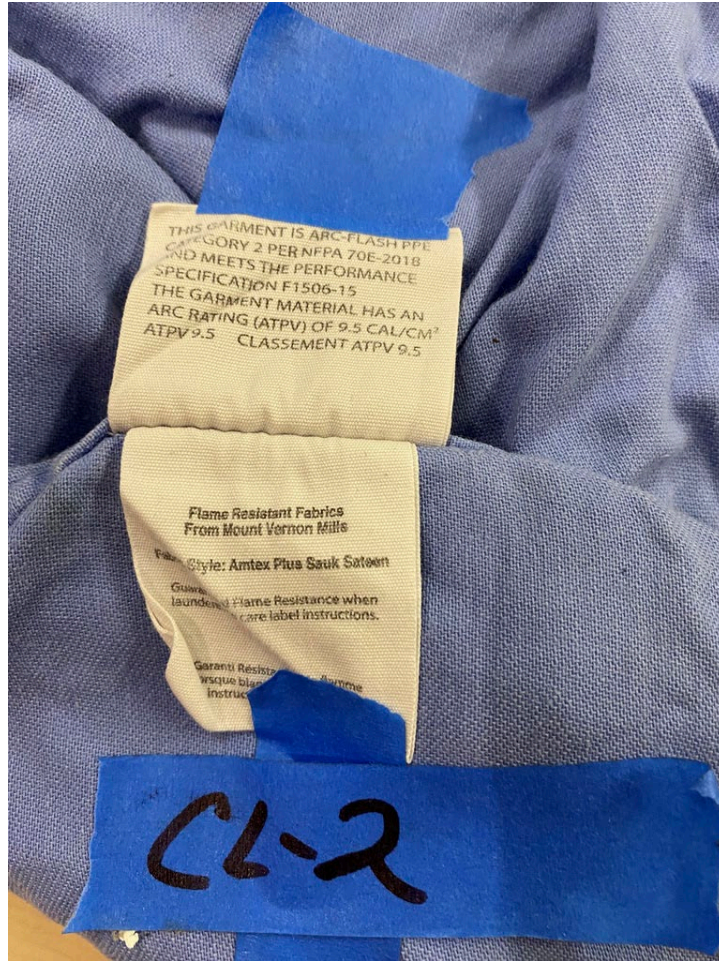
**Figure F-7: Arc-rated shirt rated at 9.5 cal/cm<sup>2</sup> (ATPV).**

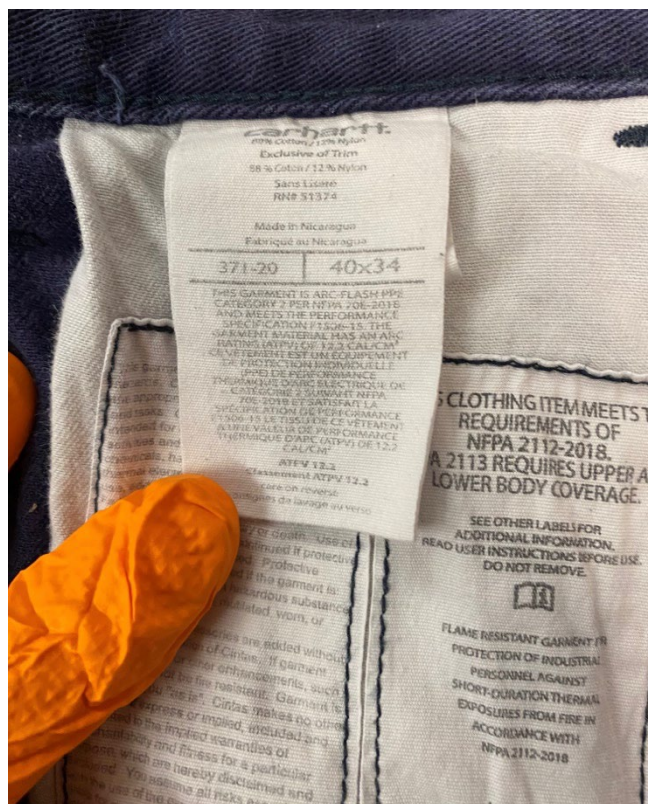
**Figure F-9: Arc-rated pants are rated at 12.2 cal/cm<sup>2</sup> (ATPV).**

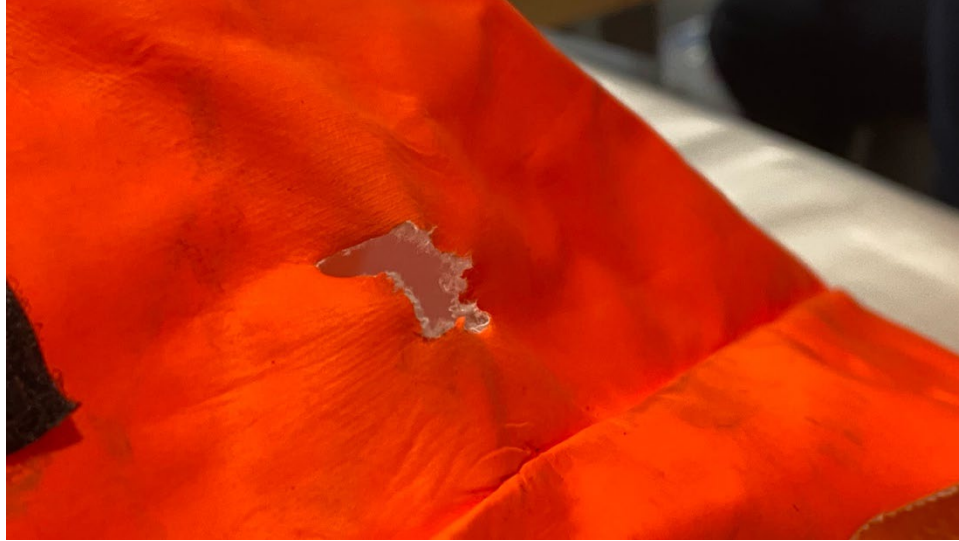
**Figure F-12:** Outside of left sleeve cuff there is a small open hole with minor heat shrinkage and wrinkling. Possible arcing point.

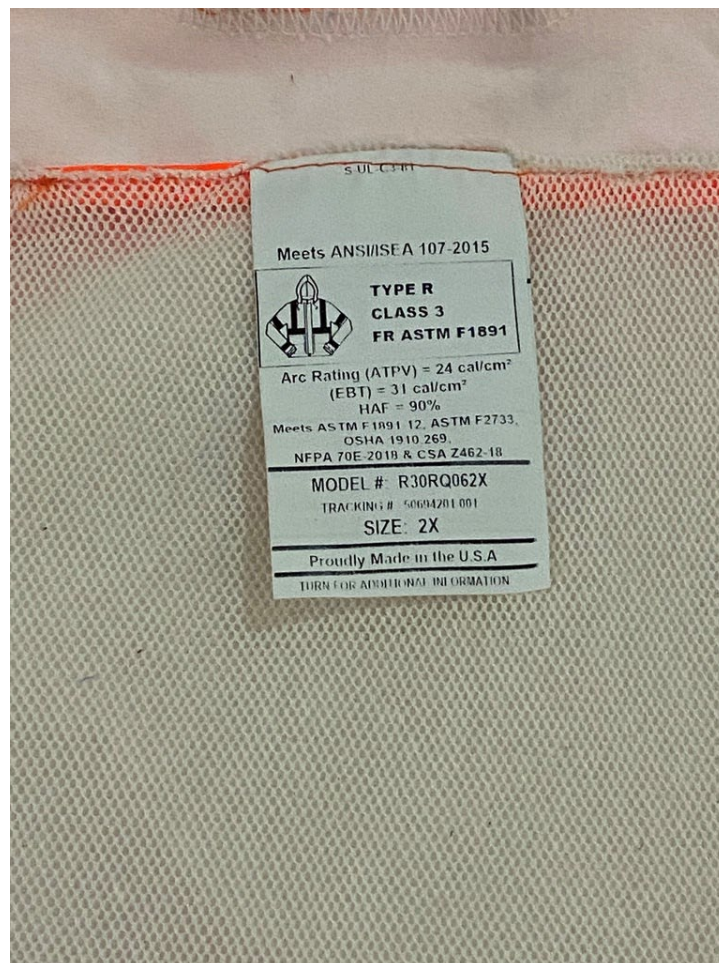
**Figure F-13:** Arc-rated raincoat is rated at 24 cal/cm<sup>2</sup> (ATPV) and 31 cal/cm<sup>2</sup> (EBT)\*

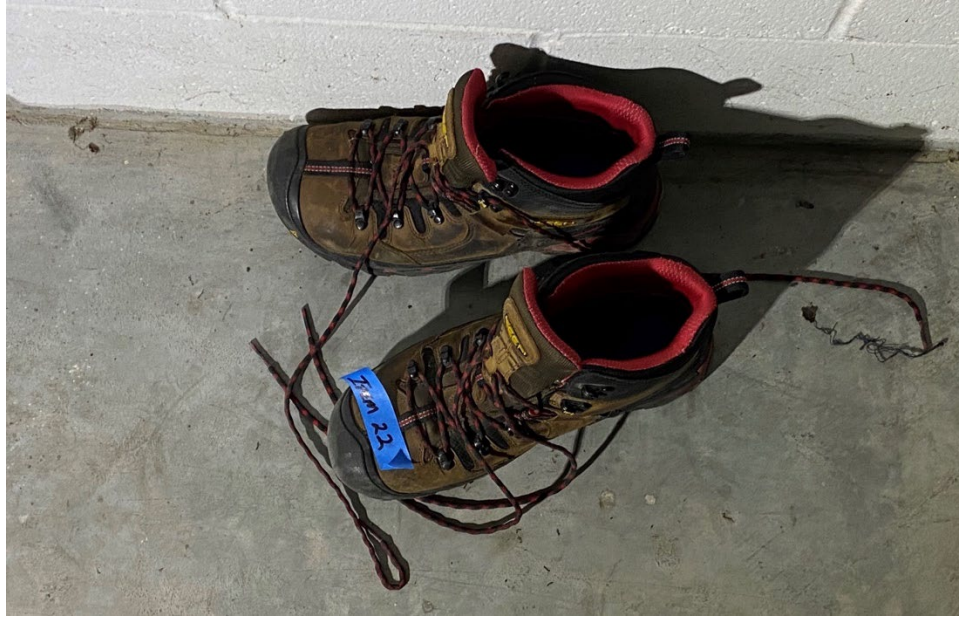
**Figure F-14: Work boots.**

The Board performed a visual examination of HVE1’s work boots and one white sock that remained at the scene. There was no visible evidence of a shock exit point from the feet. The work boots appear relatively new, are in good condition, and are Electrical Hazard (EH)-rated per ASTM F2413. EH rating means that the boots are constructed and manufactured so that the footwear outsole provides a supplemental form of protection to the wearer from hazardous step potential (the difference in electrical potential between the feet) while standing on the ground. They are capable of withstanding the application of 18,000 VAC at 60 Hz for 1 min with no current flow or leakage current in excess of 1.0 mA under dry conditions when tested as per lab conditions. Unlike dielectric overshoes, these are not credited as shock protection PPE since they are not regularly tested and can be easily compromised with nails and tacks commonly found in industrial and construction settings. However, should a shock occur, they can provide a limiting resistance to lower shock current through the soles of the feet.

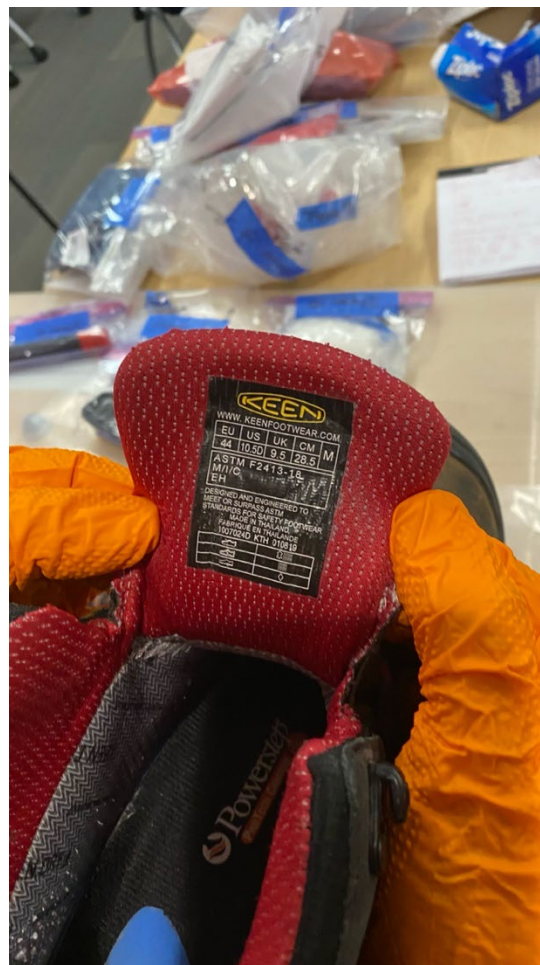
**Figure F-15: Work boots are EH-rated.**

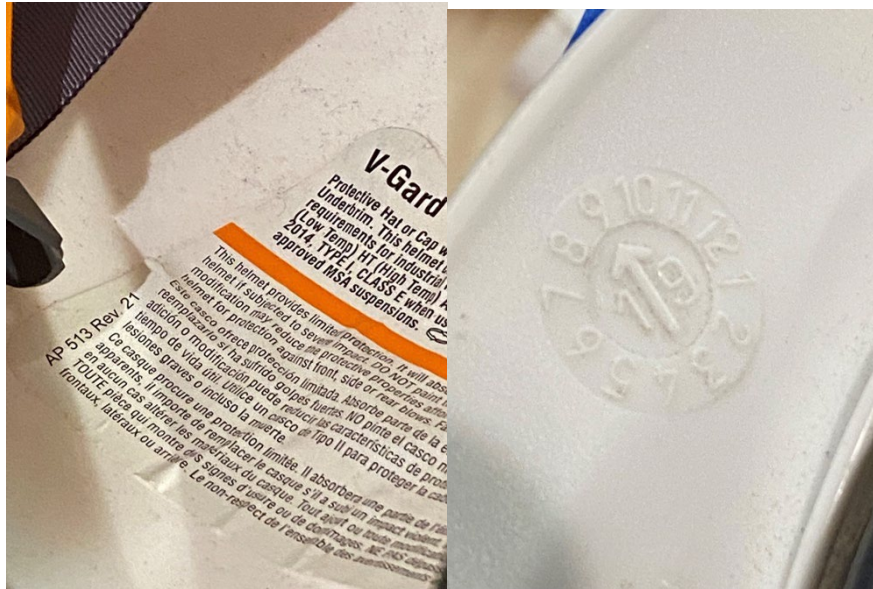
**Figure F-17: Hard hat was of Class 1 Type E and was manufactured in 2019.**
