NPS Detector Noise Mitigation Tests (addl. follow-up)

August 26 2022

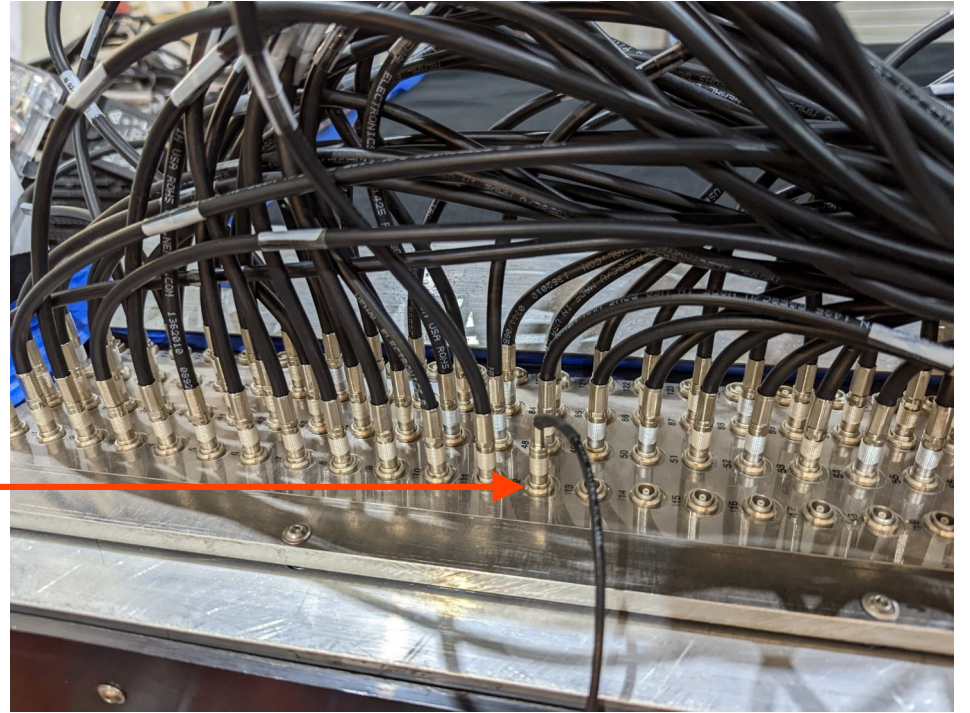
Characteristic Noise (Single Trig)

PMT1
(~2 V Pk to Pk)

PMT2
(~2 V Pk to Pk)

PMT3
(~1V Pk to Pk)

PMT4
(~500 mV Pk to Pk)

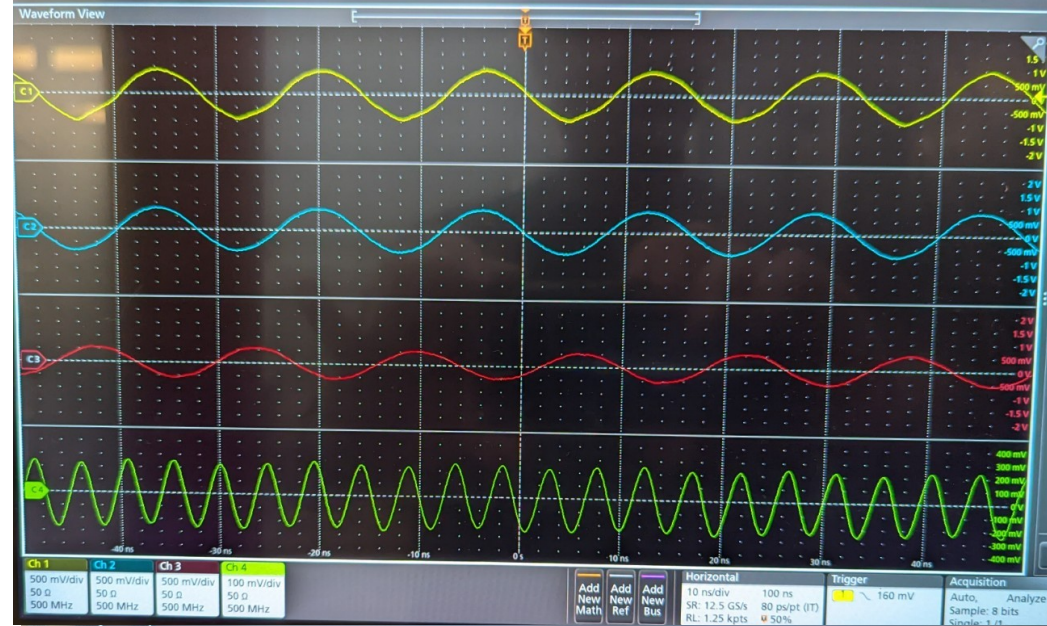
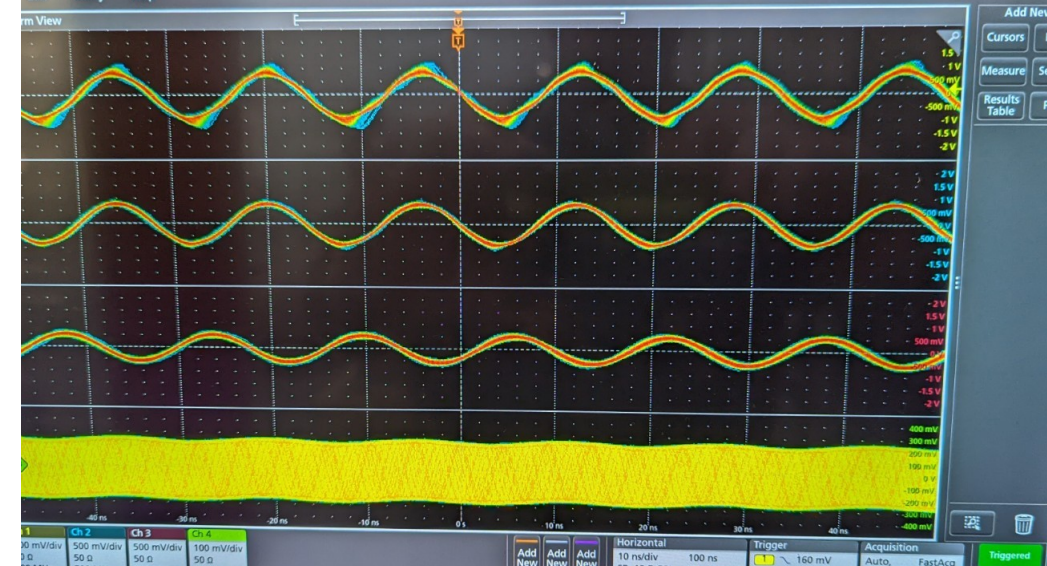
- Noise returns when more PMTs powered up
- Characteristic noise frequency is different in shielded column, interesting...
 - Trace 1–3 in shielded column (~70 MHz)

- Trace 4 in original column (~200 MHz; as before)
 - Suggests noise is not simple antenna pickup, something in the circuit is ringing?
- Fast Acq. mode indicates triangular wave features

- Does that tell us anything about the source?
- PMTs are cross talking?
 - Could explain resonant noise in adjacent PMTs?
 - Hints of the 70 MHz ripple is also present as an envelop around Trace 4 from column 0 (ignore phase difference, scope cable lengths were not perfectly matched)

- Noise in a single shielded PMT went away (<1mV) when power removed to 16 bases in new shielded column (leaving only 2 powered)
 - Noise issues is aggravated/induced by signals in nearby PMTs

- We also tried contacting a new thick ground cable to NPS frame and to a solid earth ground to see if it helped
 - No visible effect on noise
