Energy Locks in CEBAF

Michael Tiefenback, Dec 13, 2023

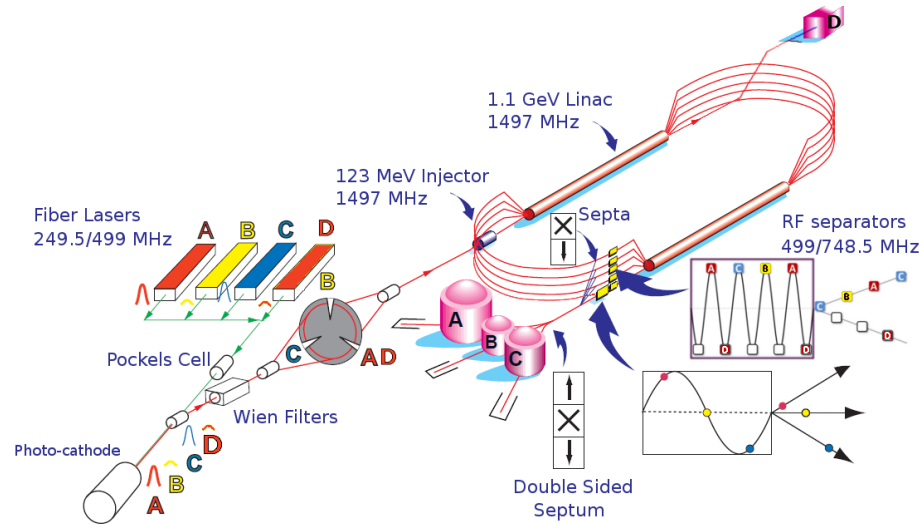
Accelerator Layout

- Energy Regulation -- three regulation points:
 - Injector (nominal 123 MeV at North Linac injection)
 - North Linac (nominal energy gain 1090 MeV)
 - South Linac (nominal energy gain 1090 MeV)

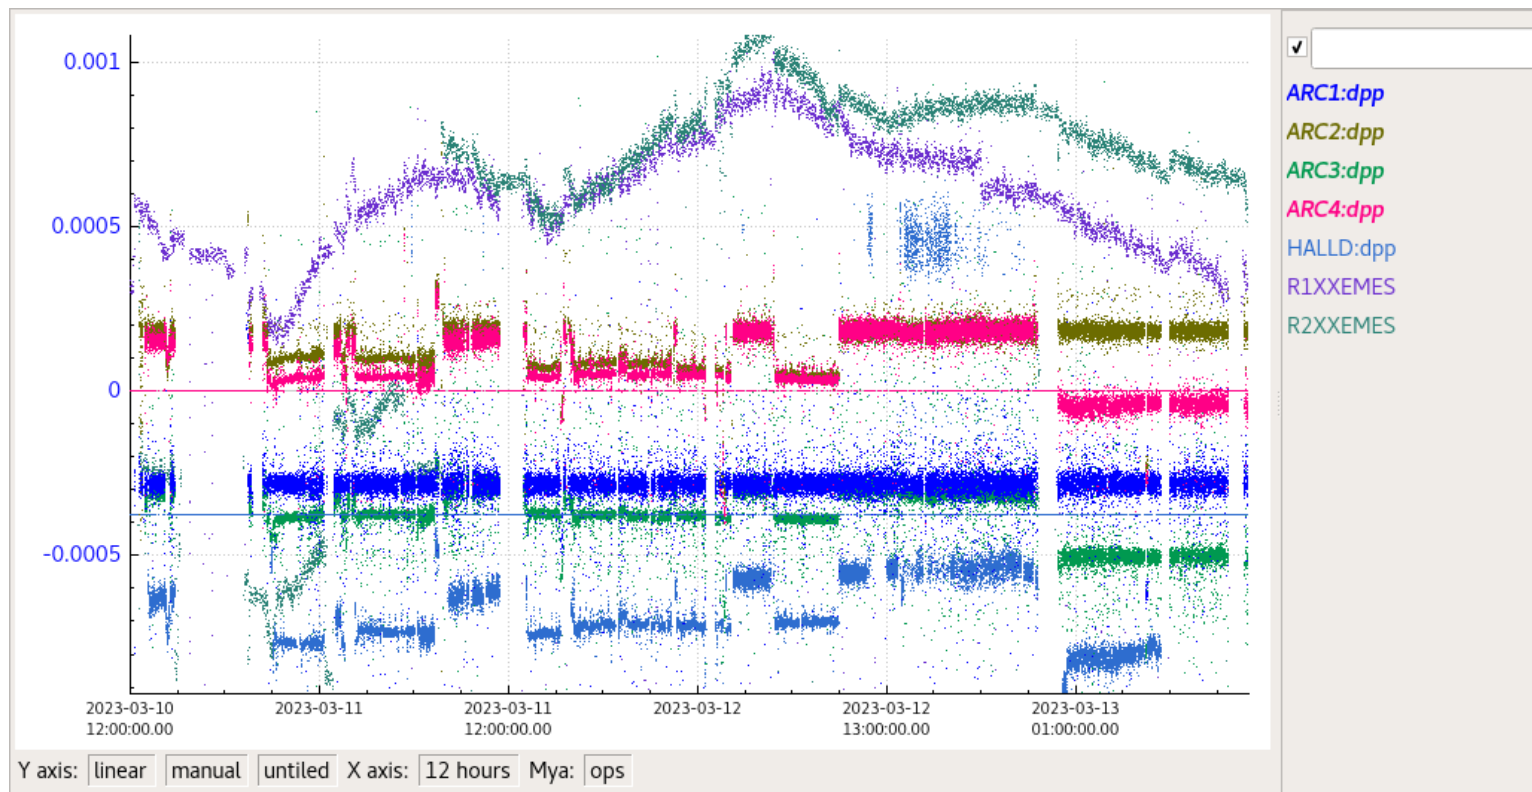
Archived Example March 2023

- Linac energy drift compensated by elock
- ARC[34]:dpp steps ~1 a.m. NOT seen in ARC[12]:dpp
- Suspect BPM induced artifacts (halls on/off, other current changes)

- Linac acceleration field not completely stable:
 - Energy locked to trajectory in arc
 - Energy lock changes GSET in selected cavities
 - Sum of $GSET * CavityLength$ drifts (slowly)
- Higher arc momenta can show step changes
-
