Trim Card Diagnostic and Replacement Procedure

Document Number: ACC-PR-01-004

Procedure Overview

This procedure is used to guide accelerator operators and EES technicians through the process of diagnosing problems associated with magnet trim power supply cards, and when necessary, replacing defective trim cards that fail to respond to initial diagnostic troubleshooting processes.

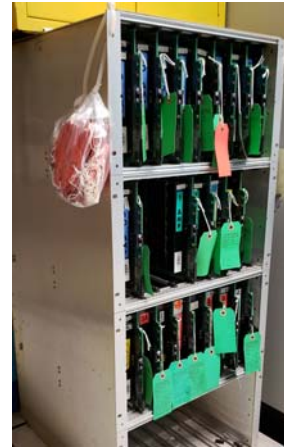
Figure 2-2: Spares Rack in MCC Equipment Room

- a. Locate the trim card spares rack in the MCC Equipment Room (see Figure 2-2).
 - b. Select a green-tagged card with a label that matches the **Trim Card Label** information recorded in [Step b on page 5](#).
5. Obtain and don the PPE specified in [Step 2 on page 2](#) before beginning work.
 6. Proceed to the front of the trim rack where the defective trim card is located.

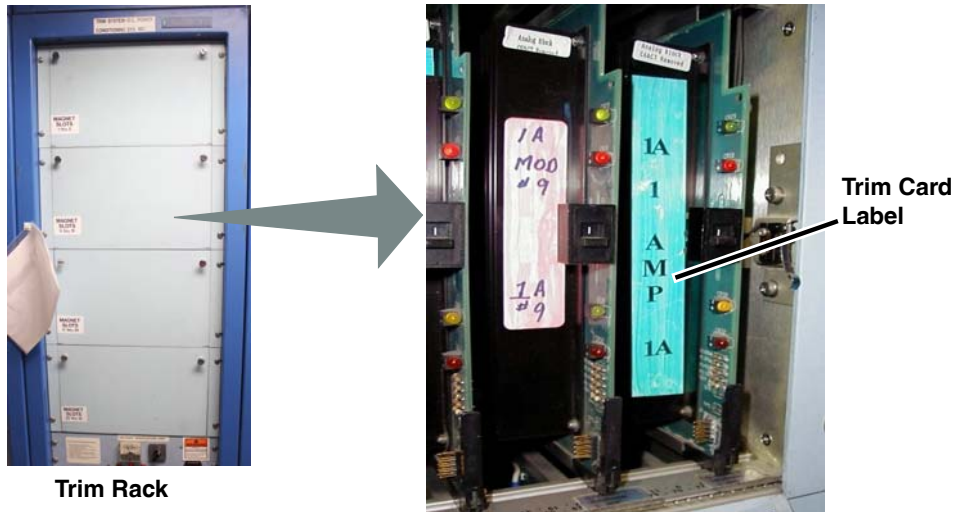
Figure 2-3: Trim Card Front Panel

CAUTION: Ensure that the replacement trim card label exactly matches the **Trim Card Label** recorded in [Step b on page 5](#). Trim cards are labeled on the front edge (see [Figure 2-3](#), below). Grabbing the wrong card may delay the repair.

NOTE: There are four trim card bays per rack with eight cards per bay (for a total of 32 separate trim card channels). Trim Channel 1 is the first slot of the top bay. Trim Channel 32 is the last slot of the lower right-most bay.

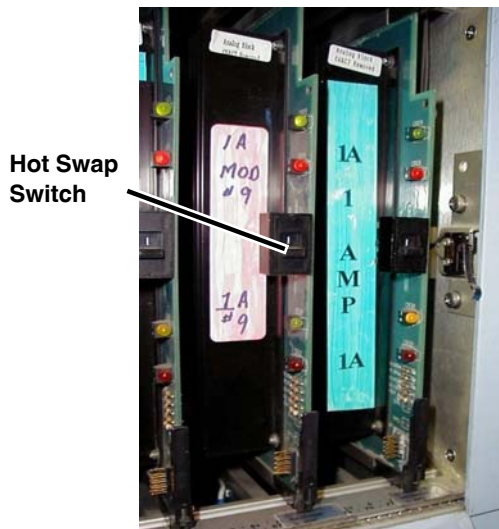
Figure 2-4: Hot Swap Switch

CAUTION: If the hot swap switch on a trim card is in the “1” position when the trim card is inserted, electrical arcing will occur causing damage to the connector contacts on the card and to the connector at the back of the trim card slot.

- a. Move the hot swap switch on the card from the “1” position to the “0” position (see [Figure 2-4](#), below).

- a. Move the hot swap switch from the “1” position to the “0” position (see [Figure 2-4 on page 6](#)).

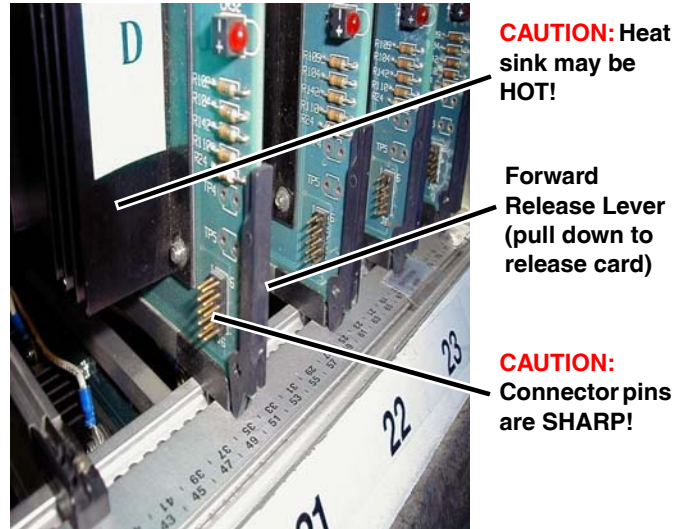
Figure 2-5: Forward Release Lever

- b. **Wait at least 20 seconds before proceeding to Step c, below.** This allows magnet current to bleed off and prevents other cards in the rack from going off loop when the card is removed.
- c. Locate the forward release lever at the **BOTTOM** front edge of the faulted trim card (see [Figure 2-5](#)).
- d. Grab the top of the forward release lever (see [Figure 2-5](#)), and pull it toward you. The trim card will move slightly toward you and come loose from its connector in the rear of the chassis.
- e. Return the forward release lever to the “up” position such that it is seated against the card (see [Figure 2-5](#)).

CAUTION: The heat sink on recently operated trim cards may be HOT, and the connector pins are SHARP (see [Figure 2-5](#), below). Protect yourself by wearing the required PPE (leather or mechanics gloves inspected to be in good condition).

- b. Grab the top of the forward release lever (see [Figure 2-5 on page 7](#)), and pull it toward you. The trim card will move slightly toward you and come loose from its connector in the rear of the chassis.
- c. Return the forward release lever to the “up” position such that it is seated against the card (see [Figure 2-5 on page 7](#)).
- d. Push the card into the connector until you feel it seat comfortably into the connector at the rear of the slot.
- e. Verify that the front of the card lines up with the other trim cards in the chassis.
- f. Move the hot swap switch from the “0” position to the “1” position.

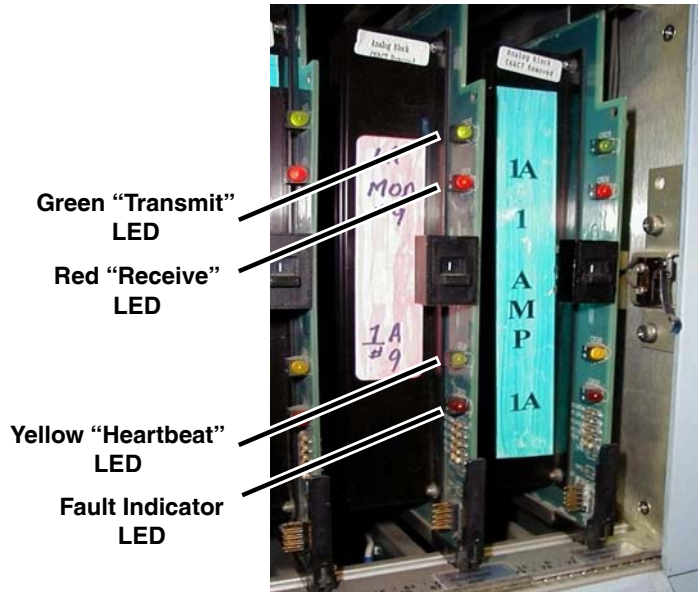
Figure 2-6: Trim Card LEDs

- i. Are the transmit, receive, and heartbeat LEDs (see [Figure 2-6](#)) on the front edge of the card now indicating proper function by blinking rapidly?

NOTE: The fault indicator LED, shown in [Figure 2-6](#), should *not* be illuminated if the trim card is functioning properly.

16. Verify that the card is functioning properly by observing the yellow “heartbeat” LED, the green “transmit” LED, and the red “receive” LED (see [Figure 2-6 on page 8](#) for LED locations). Are they all illuminated?

NOTE: The fault indicator LED, shown in [Figure 2-6 on page 8](#), should not be illuminated if the trim card is functioning properly.

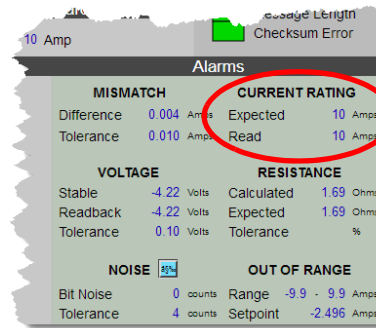
Figure 2-7: Trim Card Expert Screen

18. Call the MCC, and under **Current Rating** on the *Trim Card Expert* screen for the magnet, have them compare the **Expected** and **Read** values (see Figure 2-7 to the right). Are these values the same?

NOTE: If the **Expected** and **Read** values don't match, both will be highlighted in **RED**, indicating a trim card fault.

“Expected” and “Read” values must match

- YES NO** → A. When the **Expected** and **Read** values don't match, the trim card is faulty and could damage the magnet. Return to [Step 2 on page 5](#) and repeat the replacement process with a different card from the spares supply, being very careful to match the **Trim Card Label** information on the *Trim Card Expert* screen with the label on the spare trim card. Attach a red “Defective” tag to the failed card. If a second trim card fails in the same fashion, contact the System Expert.
