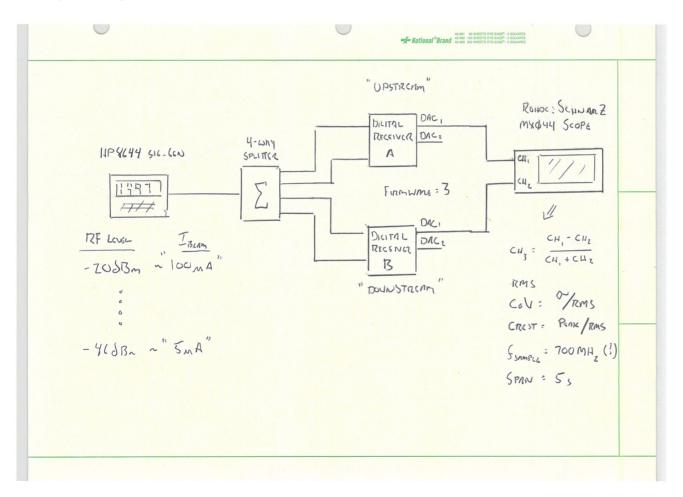
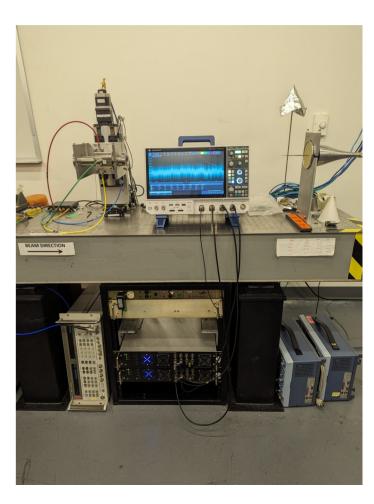
Input signals band-limited to 20 MHz

5 Second Time Span (500 ms/div)

$$\frac{Rx_A - Rx_B}{Rx_A + Rx_B}$$

...with spectrum to 1 MHz

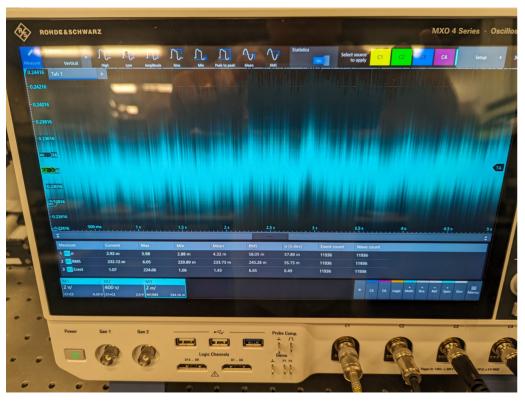
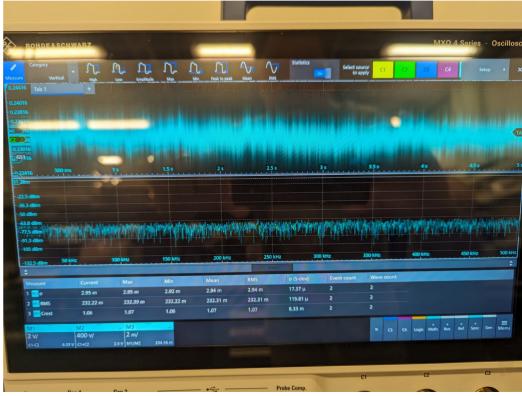
Coefficient of Variance vs RF Input

(Representing Beam Currents from 5-100 uA)

50 Ohm Test Load on Ch1 and Ch2:

CoV = 261.16 RMS = 324.72 C.F. = 128

...well within the measurement range

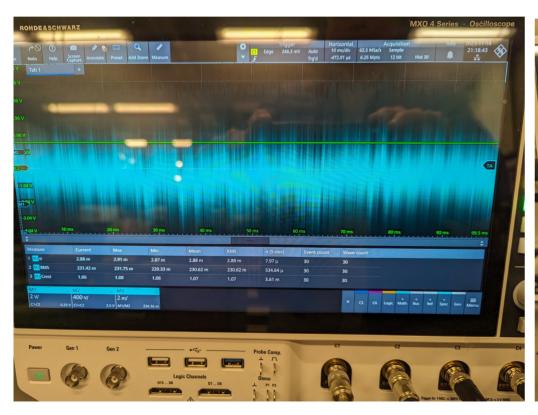
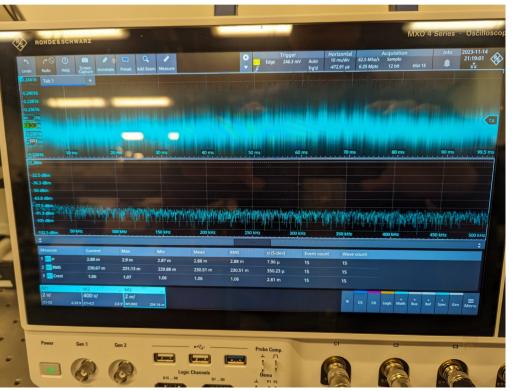
10 m-Second Time Span (1 ms/div)

$$\frac{Rx_A - Rx_B}{Rx_A + Rx_B}$$

...with spectrum to 1 MHz

...with spectrum to 15 kHz

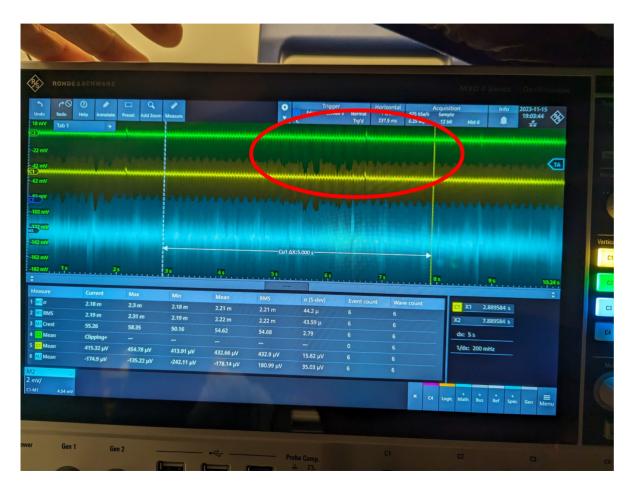
Measurements with Devi

RF ramp: -22.2 dBm to -20.2 dBm 0.01 dB steps

Ch B (a/c coupled, 5mV/)

Ch A (a/c coupled, 5mV/)

Ch A - Ch B (2 mV/)

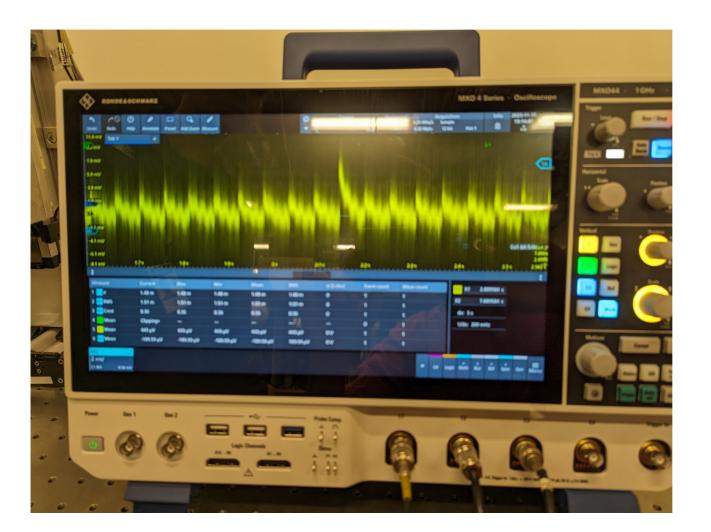
"Blip" occurs in same locations, and very close to Devi's receivers.

We are using the Unser firmware, so this suggests something ADC/DAC related?

Possible (likely?) Issue: INL, DNL

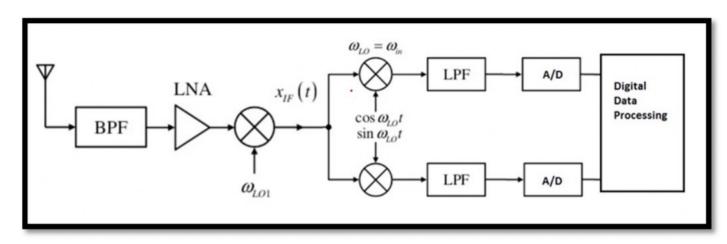
If True....At Least for ADC.....

Consider a non-zero IF architecture....

Input RF rolls through all ADC codes...homogenizing the output I/Q values

...avoids "hammering" same spot on the ADC.
